# INSPECTION REPORT

## *Hickory Creek*

*Part I – St. Joseph River to Marquette Woods Road*

*Berrien County, MI*

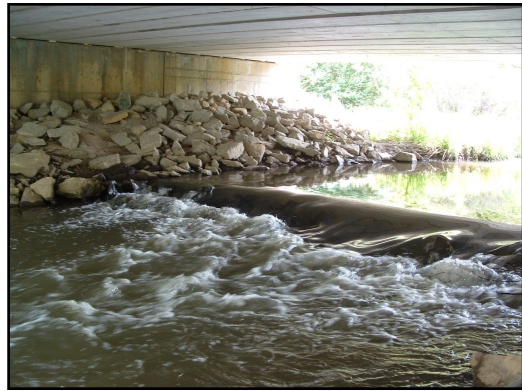
In general, the drain appears to be in a relatively stable, fair condition. The only drain crossing is a concrete bridge at M-63/Niles Avenue. The bridge appears to be in good condition although the configuration of the riprap scour protection beneath its deck appears to be causing a significant hydraulic restriction. At the time of the inspection, there was an approximately 2 foot head loss across the structure. With the exception of the head losses created by the riprap, the bridge appears to be appropriately sized although no formal hydrologic or hydraulic calculations were performed as part of this study.

**Figure 1: Head loss at M-63/Niles Ave**

- ❑ Sta. 6+00 – Install riprap splash pad at storm sewer outlet.
- ❑ Sta. 8+80 to 10+30 – Repair bank sloughing by use of bank protection or pull slopes and establish vegetation.
- ❑ Sta. 10+90 – Remove deadfall and debris.
- ❑ Sta. 36+70 – Adjust riprap scour protection beneath M-63/Niles Ave bridge to be at grade with the existing channel bottom.
- ❑ Sta. 0+00 to 36+70 – Remove sediment from drainage channel.

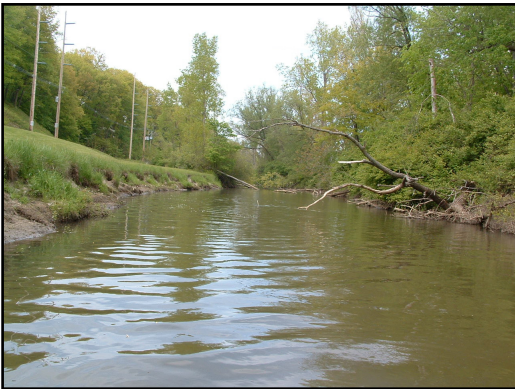
A typical drain cross section in this reach would have an approximate 25 to 35 foot water width and a 2 to 4 foot depth. The channel bottom is generally sandy with a few areas of deadfall and woody debris. The channel banks are generally sloped at 2 horizontal to 1 vertical or greater. The left channel bank is wooded on the downstream section, while on the upstream section some broken concrete riprap protect the bank as the marina parallels Hickory Creek in the overbank. The right channel bank varies between trees and brush and grassed areas. There was one isolated section of bank sloughing along the left channel bank.

**Figure 2: Typical Cross Section Reach A**

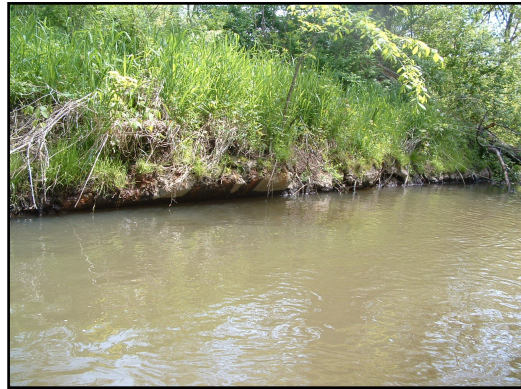
In general, the drain appears to be in a fair to poor condition. The two major crossings in this section are the concrete bridges at Washington Avenue and Cleveland Avenue. Both crossings appear to be in fair to good condition and properly sized. An abandoned railroad crossing is located at Station 43+30. Although the deck has been removed from this crossing, its abutments do constrict the channel down to approximately 16 foot width, which is approximately 10-15 foot narrower than the channel.

**Figure 3: Abandoned Railroad Crossing**

- ❑ Sta. 36+90 to 97+40 – Selective clearing of channel.
- ❑ Sta. 43+40 – Remove abutments from abandoned railroad crossing.
- ❑ Sta. 56+50 – Install sediment basin or trap near outlet of drain in left bank.
- ❑ Sta. 77+00 to 82+00 – Remove deadfall and debris jams.

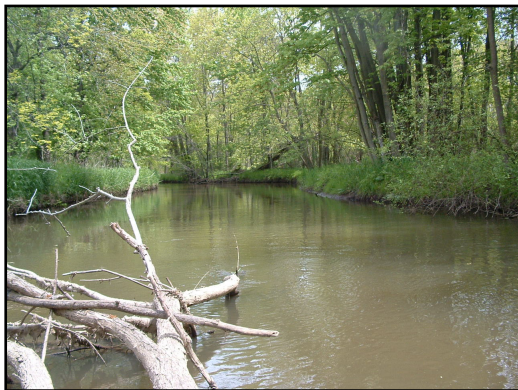
The overbanks in this floodplain are generally undeveloped and contain wetlands, wooded areas and tall grasses. The channel banks are generally sloped at 1 horizontal to 1 vertical or greater. A typical drain cross section in this reach would have an approximate 25 to 35 foot water width and a 1 to 4 foot depth. The water depth increased at the downstream end of the reach due to backwater effects of the constriction at M-63/Niles Avenue. The channel bottom is generally sandy with some areas of deadfall and woody debris.

**Figure 4: Typical Cross Section Reach B**

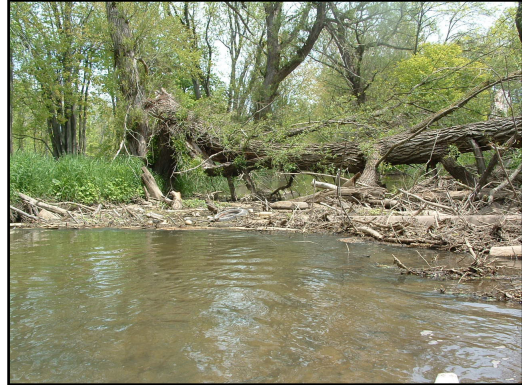
Very large deadfall jams are located near Stations 77+00 and 82+00. These jams are most likely are significant contributor to the recent flooding problems experienced near Cleveland Avenue. At the time of the inspection, the water level was approximately 3 feet below the top of the channel banks and the head loss across the jams was approximately 0.5 to 1.0 feet. The stream velocity was visibly higher downstream of the jam and the backwater effects of the jam appeared to extend up to Cleveland Avenue. During times of high flow, these jams could essentially act as dams until Hickory Creek floods out of bank and the

floodplain storage is utilized. Drain maintenance such as the removal of this deadfall would be aided by a cleared easement for the sanitary sewer that runs along the right channel bank between Washington Avenue and Cleveland Avenue.

**Figure 5: Deadfall Jam near Sta. 80+00**

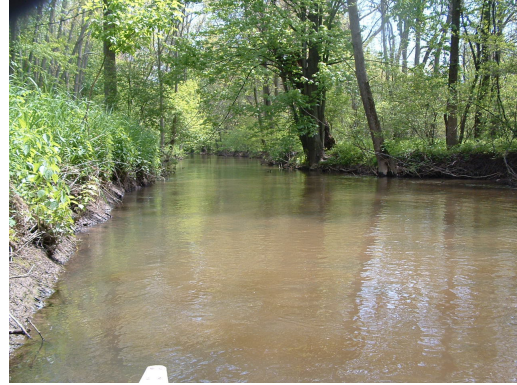
In general, the drain appears to be in a fair to poor condition. Consistent with all other study reaches, this section of Hickory Creek contains significant amounts of sediment. The sediment depths in this reach typically range from 1 to 2 feet. Channel banks in this section are often 1 horizontal to 1 vertical or greater. They range in height from 2 to 8 feet and often have bare soils exposed. Erosion along the channel banks is most likely a significant source of the sedimentation problems in Hickory Creek.

**Figure 6: Typical Cross Section Reach C**

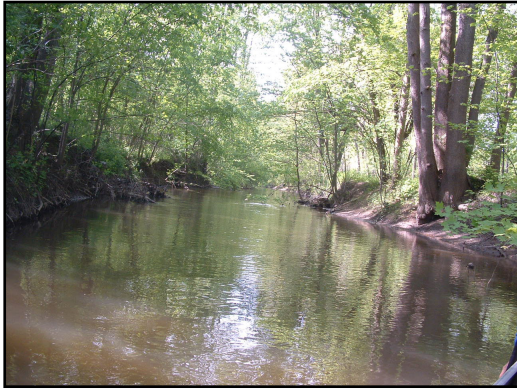
This study reach appears to be in fair to poor overall condition. The channel banks are often very steep in this section, with slopes of 1 horizontal to 1 vertical or greater. Vegetation is not very well established on the channel banks and bare soils are often exposed. Flow conditions in Hickory Creek were moderately turbid with a brown, murky appearance. The channel bottom is typically sandy and sediment depths varied between 0.5 and 2 feet.

**Figure 7: Typical Cross Section Reach D**

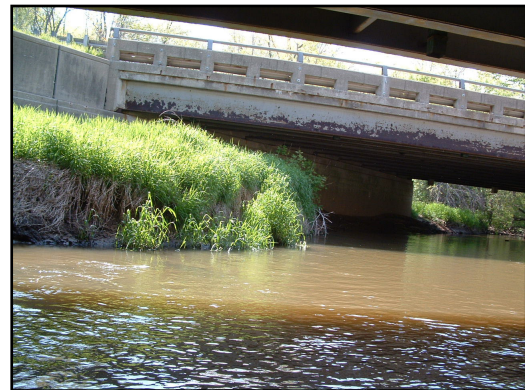
The crossing at Interstate 94 is composed of two separate steel beam bridge decks with one continuous concrete abutment. The crossing appears to be adequately sized and in fair condition. This bridge is much wider than the channel in this area and large sandbars have formed near the bridge abutments. The West Marquette Woods Road crossing is constructed of timber beams and has one center bridge pier approximately 16 inches wide. This crossing also appears to be in fair condition and properly sized.

**Figure 8: Looking at Sandbars below I-94 Bridge**
