ADDENDUM No. 1

PROJECT: **PUCKER STREET DAM REMOVAL**
CLIENT: **CITY OF NILES**
ISSUE DATE: 4/10/2019

RE: ***ASBESTOS INSPECTION REPORT FOR PUCKER STREET DAM, NILES,
MICHIGAN***

**RE: LEAD-BASED PAINT INSPECTION REPORT
PUCKER STREET DAM
NILES, MICHIGAN**

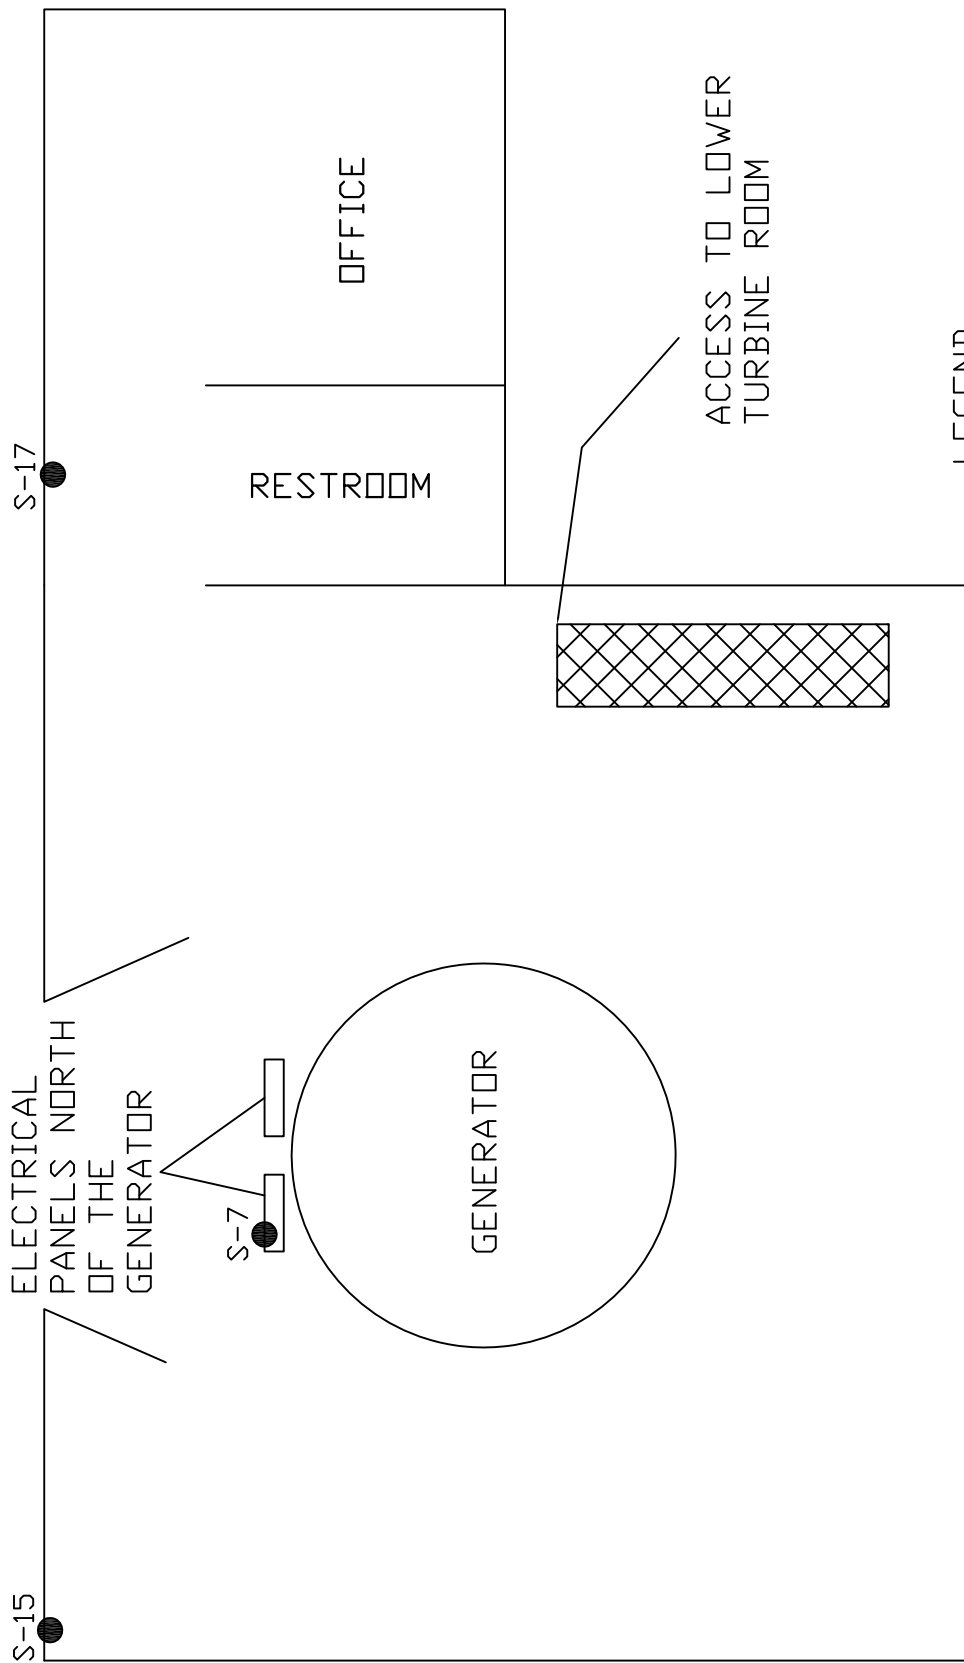
FIGURE 1
 ASBESTOS SAMPLE LOCATION MAP
 PUCKER STREET DAM PROJECT
 NILES, MICHIGAN

During the inspection, bulk samples were randomly collected from any suspected ACM's. The samples were then submitted to a NVLAP accredited laboratory for analysis using polarized light microscopy (PLM). A sample is considered an ACM if it contains more than 1% of asbestos. Thermal system insulation (TSI), ceiling tiles, floor tiles, drywall joint compound, plaster, stucco, fireproof doors, mastics, roofing tar, window glaze, and vermiculite are some examples of building materials that may contain asbestos. The attached Table 1 summarizes the sample results and Figure 1 shows the ACM sample locations.

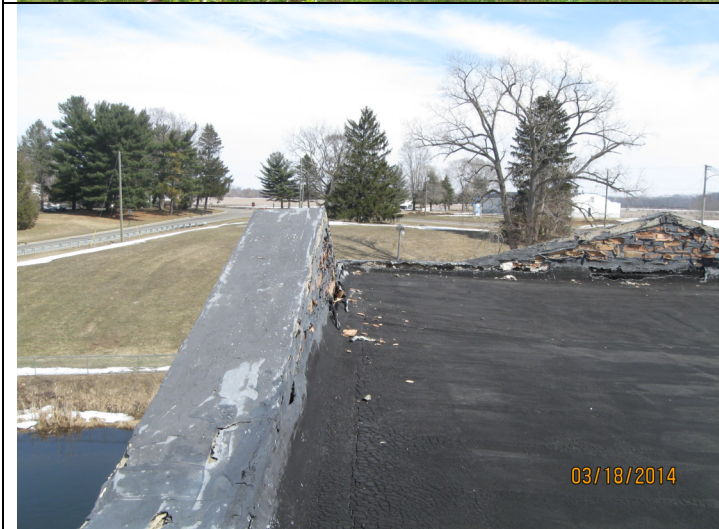
There is asbestos containing roofing tar (HM-12) covering the roof over the generator room and the office area. Sample numbers 15 and 17 contained 20% Chrysotile asbestos and no asbestos was detected in sample numbers 13 and 14. Even though sample numbers 13 and 14 (HM-11) did not contain any asbestos, all of the roofing tar shall be considered an ACM. This asbestos containing roofing tar is a Category I non-friable ACM. There is approximately 900 square feet of asbestos containing roofing tar.

**Asbestos containing roofing tar (HM-12)
covering the generator room roof.**

The asbestos containing roofing tar (HM-12) is a Category I non-friable ACM that does not need to be removed by a licensed asbestos abatement contractor as long as the material is not made friable during removal, demolition, or renovation. Anyone removing this ACM or demolishing the structure with this ACM in it shall have met the minimum training requirements set by MIOSHA. All of the roofing tar shall be disposed of at a licensed disposal facility approved for asbestos disposal. This includes any building materials (carpet, wood, concrete, metal, and brick) that still have the roofing tar attached to it. Waste shipment records shall be maintained by the generator, transporter, and disposal facility and be made available for inspection by the MDEQ and MIOSHA.

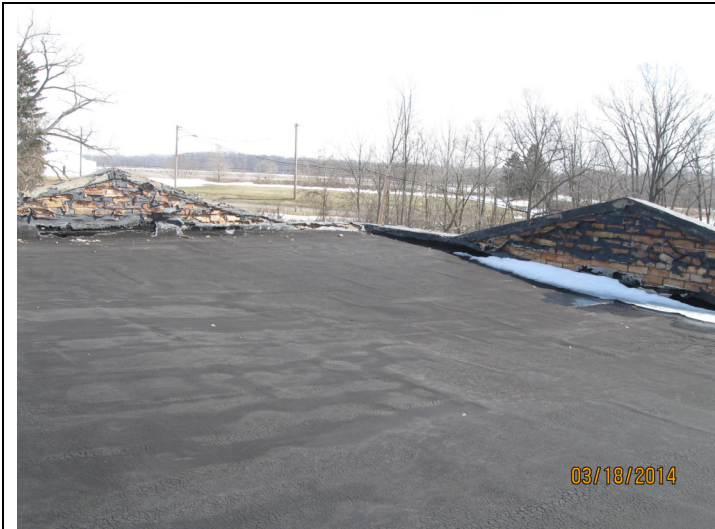
**Asbestos containing roofing tar (HM-12)
covering the generator room roof.**

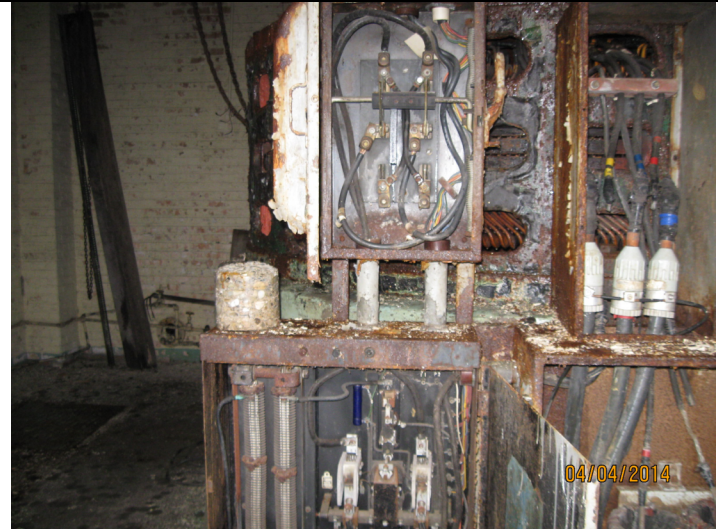
Inside the generator room, there are four electrical panels on the north side of the generator. The bottom right electrical panel has some electric wires that are coated with asbestos containing insulation (HM-6).

Sample number 7 contained 35% Chrysotile asbestos. This asbestos containing electric wire insulation is a Category II non-friable ACM. There is less than 1 cubic feet of this ACM.

A photograph showing four electrical panels mounted on a metal frame. The panels are heavily corroded and contain various electrical components, including wires and capacitors. A date stamp "04/04/2014" is visible in the bottom right corner of the image.	<p>The four electrical panels on the north side of the generator. The bottom right panel has some electrical wires coated with asbestos containing insulation (HM-6).</p>

The asbestos containing electric wire insulation (HM-6) is a Category II non-friable ACM that does not need to be removed by a licensed asbestos abatement contractor as long as the material is not made friable during removal, demolition, or renovation. Anyone removing this ACM or demolishing the structure with this ACM in it shall have met the minimum training requirements set by the Michigan Occupational Safety and Health Administration (MIOSHA). All of the asbestos containing wire insulation shall be disposed of at a licensed disposal facility approved for asbestos disposal. Waste shipment records shall be maintained by the generator, transporter, and disposal facility and be made available for inspection by the Michigan Department of Environmental Quality (MDEQ) and by MIOSHA.

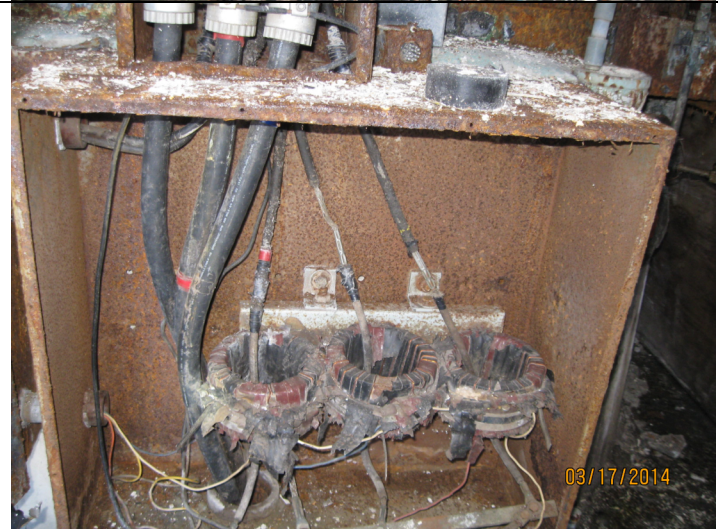
A photograph showing three thick black cables running through a series of copper wire coils. The coils are mounted on a metal frame and appear to be part of a generator or transformer. A date stamp "03/17/2014" is visible in the bottom right corner of the image.	<p>The three wires going through the coils of copper wire have asbestos containing insulation ((HM-6) covering the electric wire.</p>

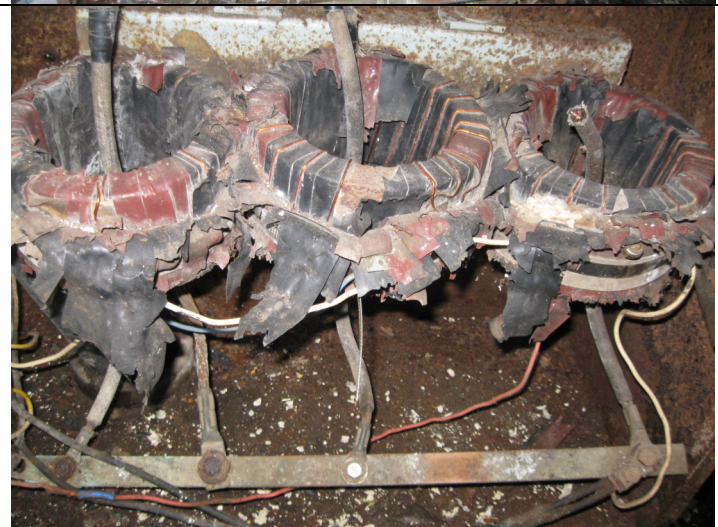
A close-up photograph of the three thick black cables as they pass through the copper wire coils. The cables are heavily insulated, and the surrounding metal structure is heavily rusted. A date stamp "03/17/2014" is visible in the bottom right corner of the image.	<p>The three wires going through the coils of copper wire have asbestos containing insulation ((HM-6) covering the electric wire. Sample number 7 was collected from the wire on the right that is cut.</p>

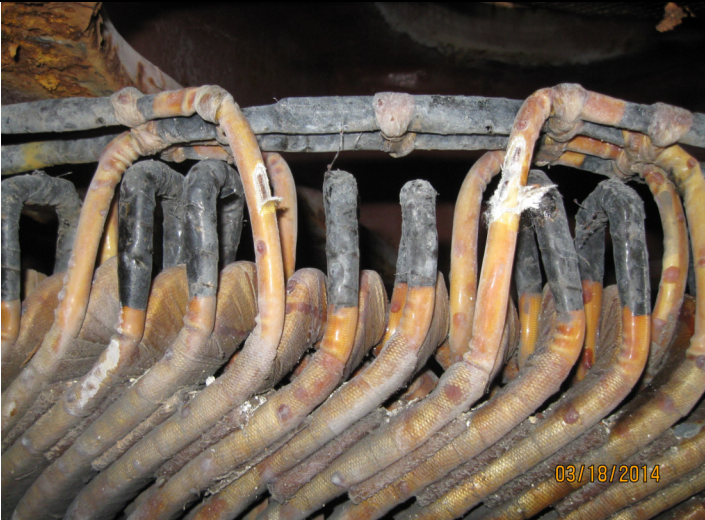
A close-up photograph of several thick, yellowish-orange cables with black and white markings, bundled together and secured with metal clamps. The date stamp '03/18/2014' is visible in the bottom right corner of the photo.	<p>Fiberglass coated wire (HM-7) on the generator wiring.</p>

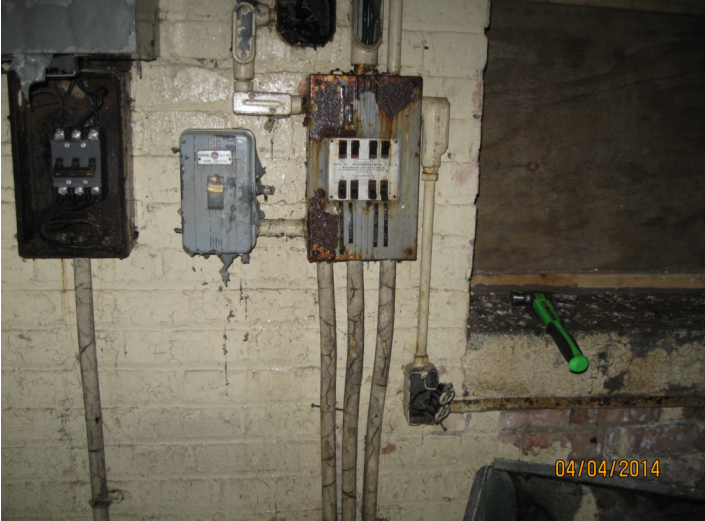
A photograph of an interior wall with three electrical meters. Below the middle meter, a bundle of wires is visible. A green-handled screwdriver is lying on the wall to the right. The date stamp '04/04/2014' is visible in the bottom right corner of the photo.	<p>Electric wire (HM-1) that was sampled from an outlet underneath the electric meter.</p>

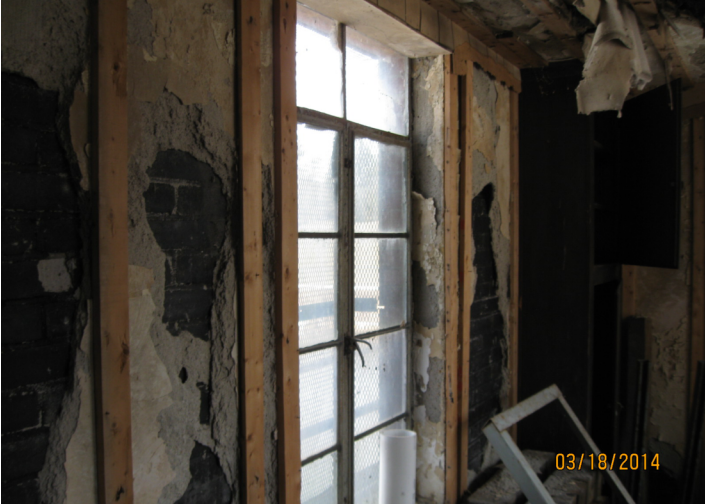
A photograph of a room with peeling and damaged plaster on the walls. A window with multiple panes is visible in the center, and some debris is on the floor. The date stamp '03/18/2014' is visible in the bottom right corner of the photo.	<p>Plaster (HM-8 and HM-9) on the walls of the office.</p>

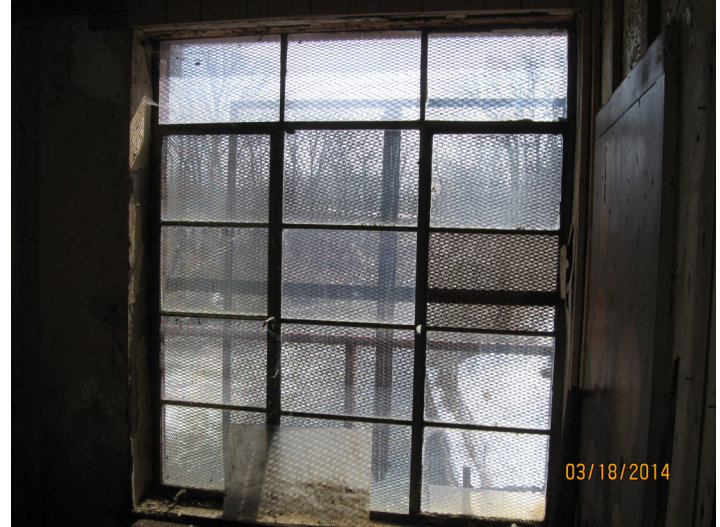
<p>A sample of window glaze (HM-10) was collected from this window on the south side of the office.</p>

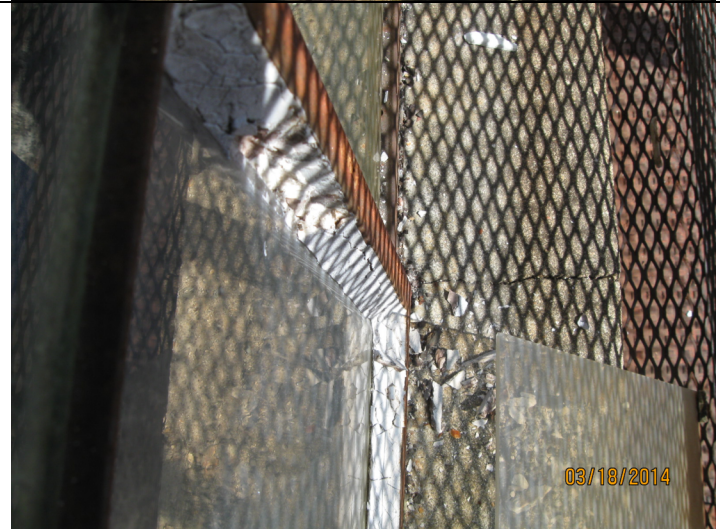
<p>A sample of window glaze (HM-10) was collected from this window on the south side of the office.</p>

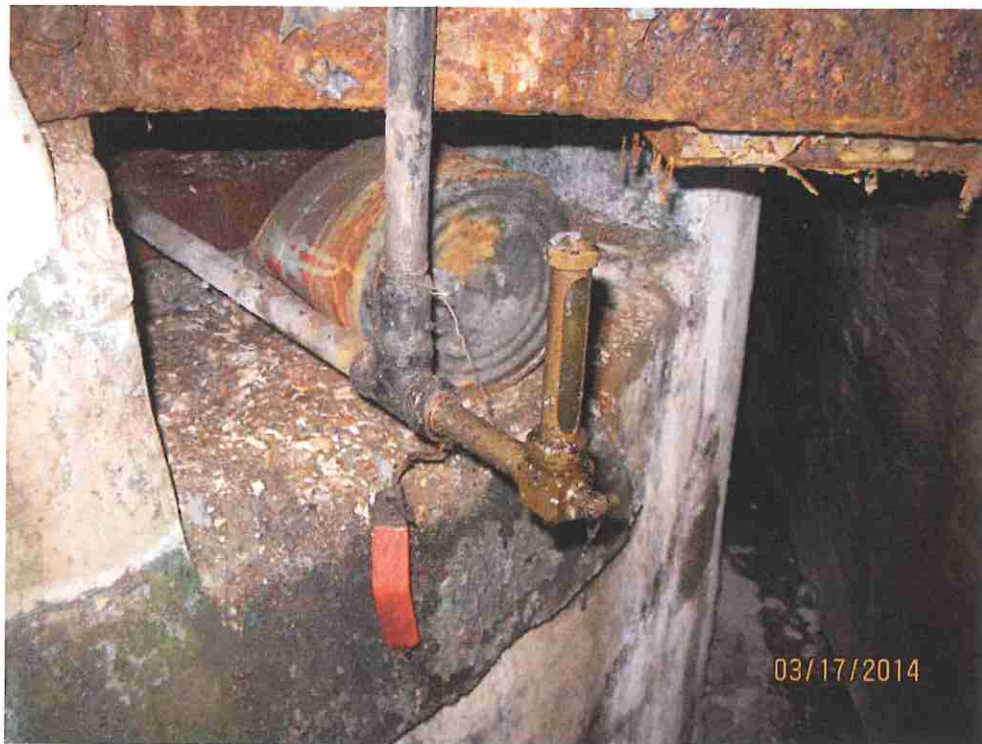
An oil sample was collected from the pan of the hydraulic pump and from a petcock valve on the side of the generator. Both oil samples were sent to an independent analytical laboratory for the analysis of PCBs. Both oil samples were found to be non-detect for PCBs.

Petcock valve on side of generator where oil sample was collected

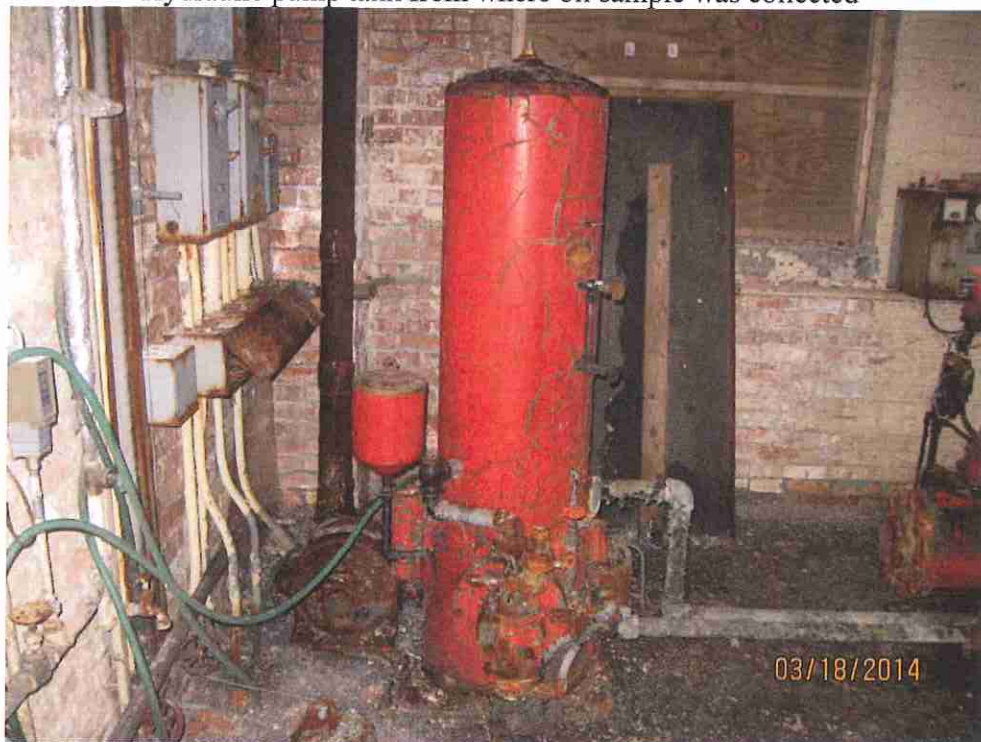
Hydraulic pump tank from where oil sample was collected
