Dowagiac River Restoration

Final Assessment Report

June 27, 2013

Inter-Fluve, Inc.
301 S. Livingston St., Suite 200
Madison, WI 53703
608-441-0342

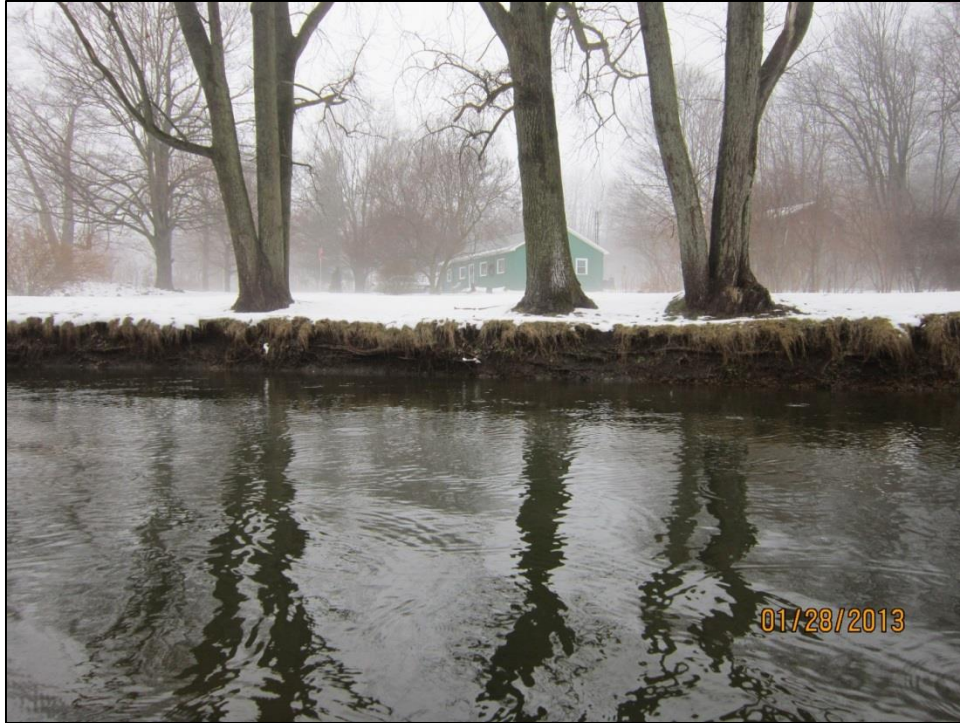
Figure 2. This house upstream of Peavine St. is sited very near the Dowagiac floodplain

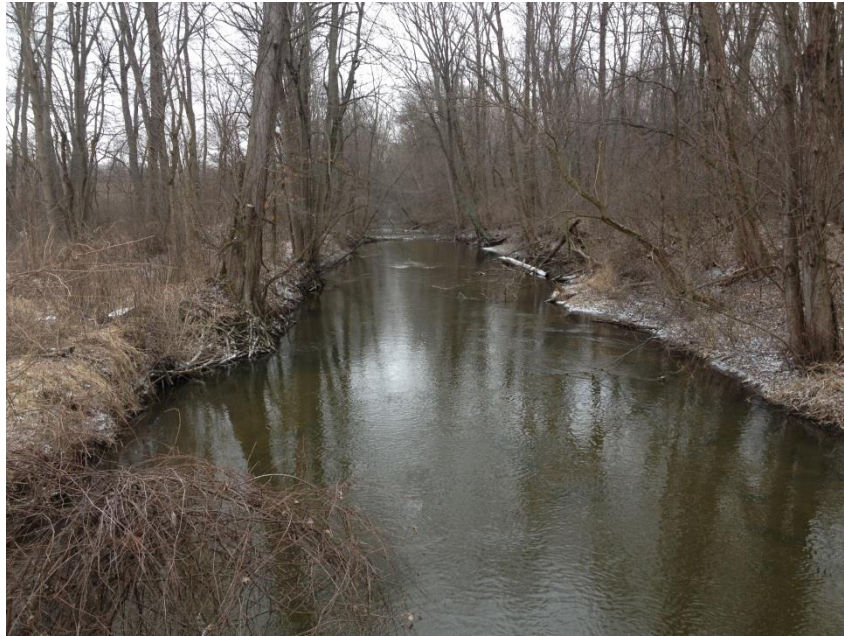
At Rudy Rd. – The river here begins to take the form noted within the project area with significant spoils piles on each side of the straight channel. Trees along the banks are leaning slightly and some exposed roots are evident, indicating some erosion is occurring but at very slow rates. The bed is composed of sands and fines here and some deposition is apparent in the photo below on the right bank.

Figure 20: Dowagiac River at Rudy Rd.

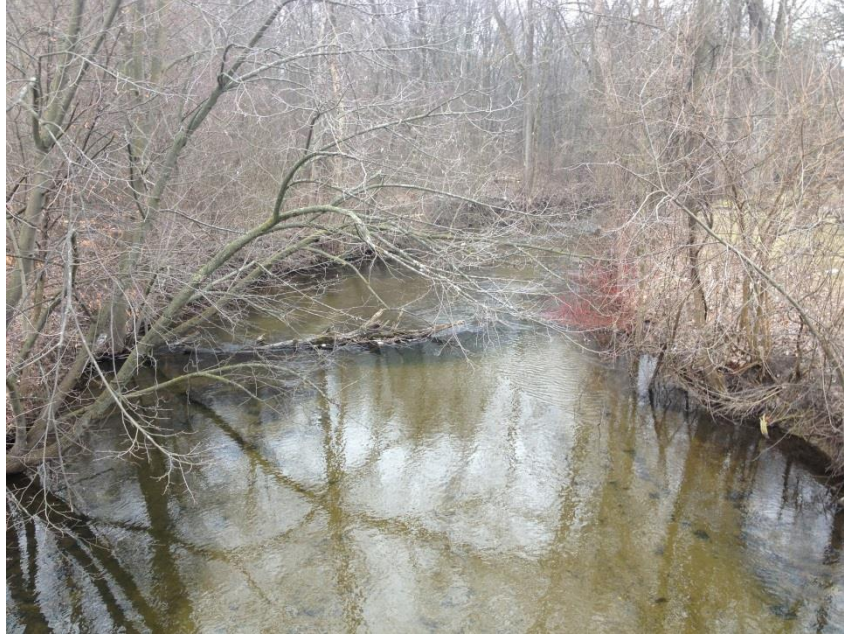
At M-62 – Very similar to upstream sections and to our project area. This is the last stop prior to the confluence with Dowagiac Creek, one of the larger tributaries to the Dowagiac. The creek includes a mill dam that arrests most sediment delivery its upper watershed before it can get to the mainstem Dowagiac. Sand is noted in the bed.

Figure 23: Dowagiac Creek at M-62. The sand bed is prevalent in the photo

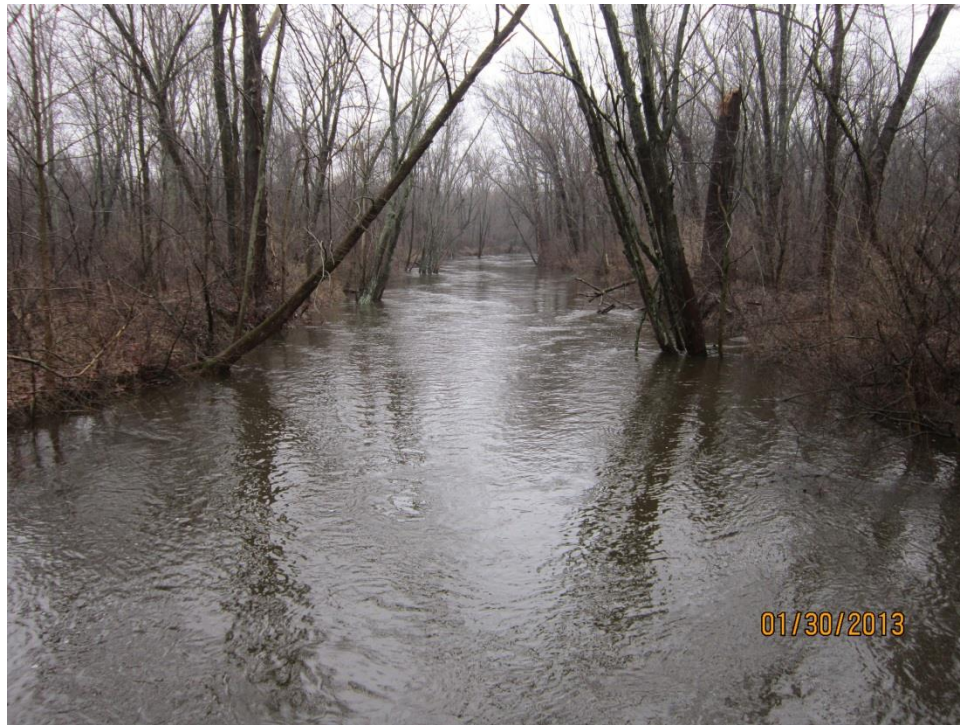
Figure 26. The Dowagiac River features long, straight, homogeneous channel reaches bordered by vegetated berms (dredge spoils).

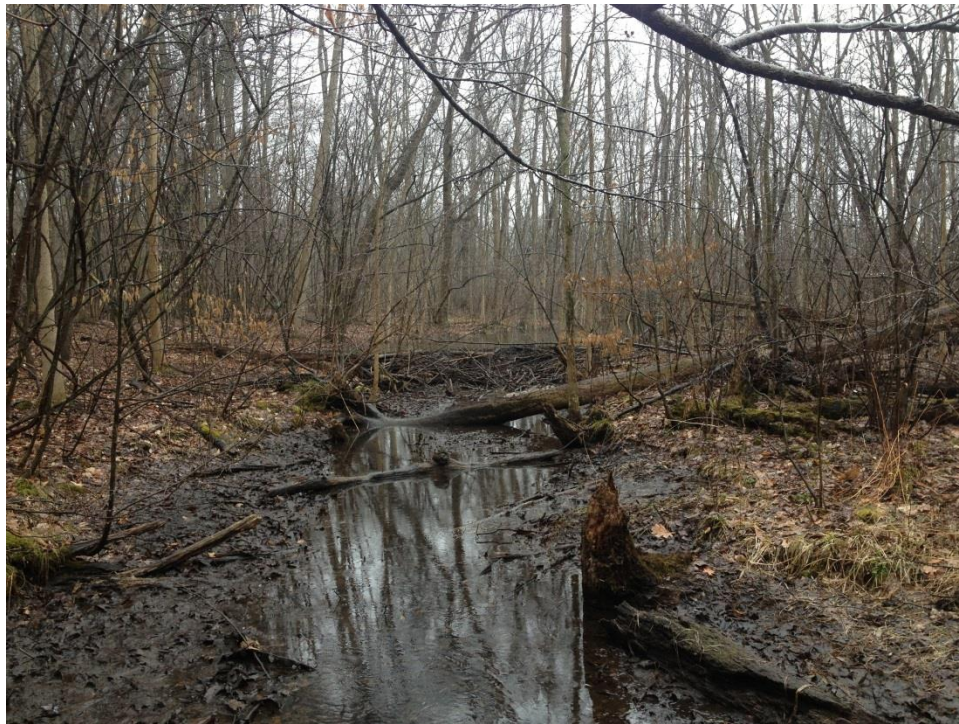
Figure 48. Beaver dam just below Rodgers Lake

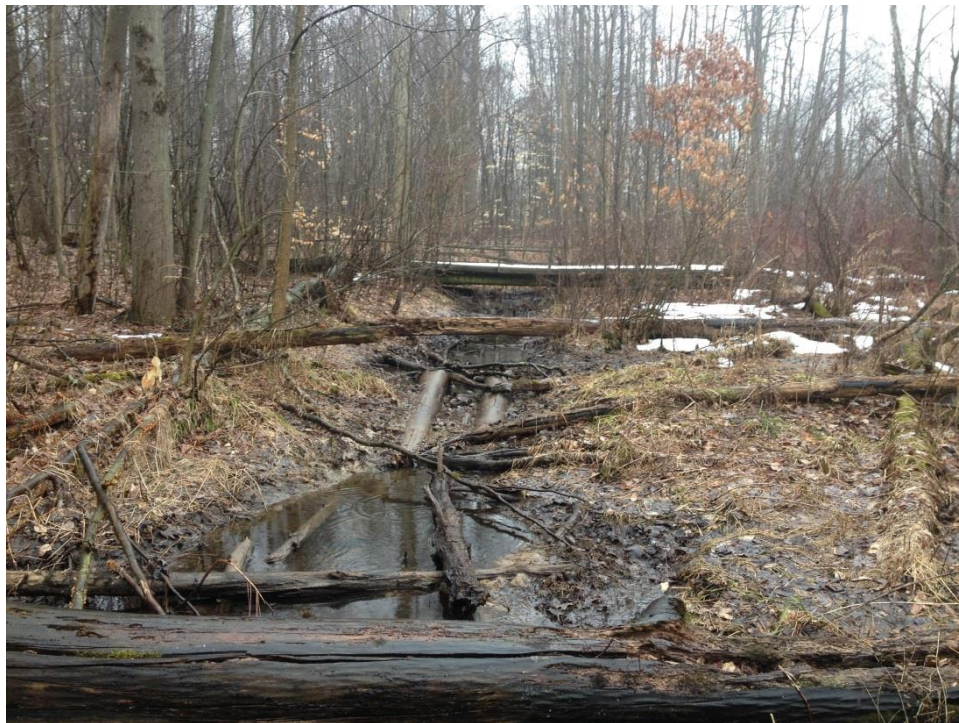
Figure 50. The old crossing above the pond - note the two old pipes in the bed

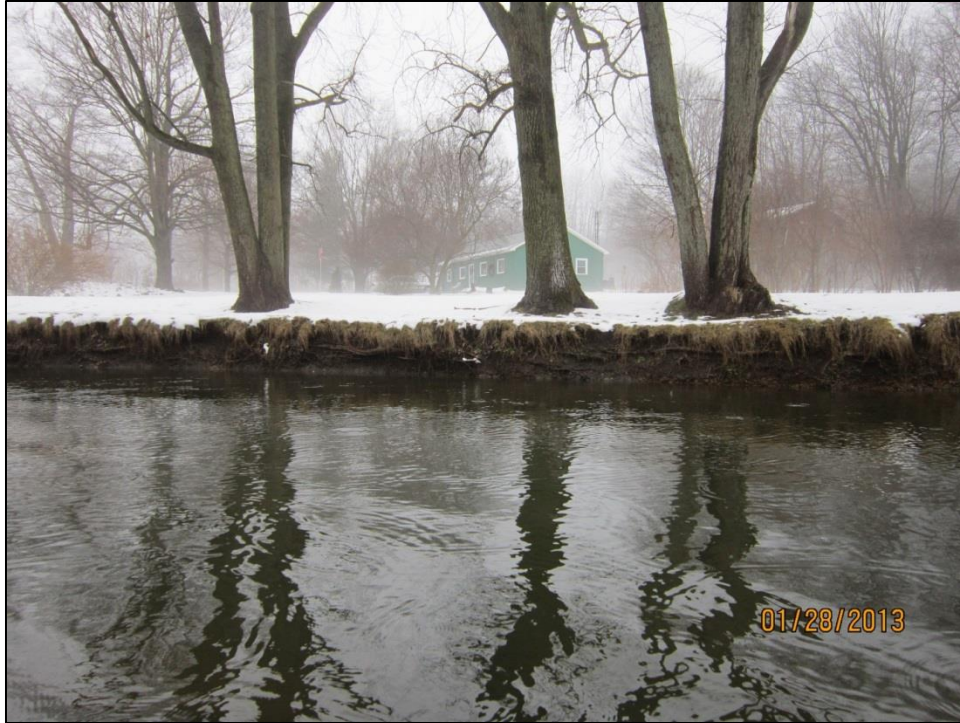
Figure 65. Photo looking west from the river at the home just upstream of Peavine St. There is little freeboard for the house in the background.
