## **Obstacle #4: Unpaved or Poorly Maintained Shoulders**

## **Obstacle #5: Difficult Road Crossings**

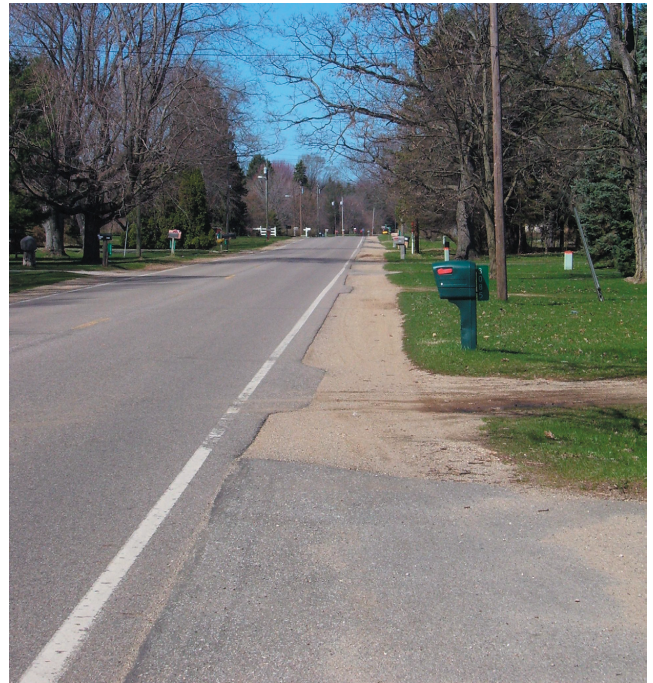
*Wide, unpaved should on north side of Pipestone Rd., between Nickerson Rd. and River Rd.*

- Shoulders with ample width for bike use but without paving
- Other problems pertaining to shoulder conditions not seen on this section of Pipestone Rd. include
  - Paved shoulders with excessive debris (rocks, tree limbs, trash, etc.)
  - Paved shoulders with advanced deterioration
  - Concrete seams and longitudinal grids that can catch bike tires and pose a severe risk to riders

Where sufficient right of way exists, at least four feet of paved shoulders should be provided in order to facilitate safe bike riding. These shoulders should be kept free of debris, should feature pavement maintained in rideable conditions, and should be designed to be free of potentially dangerous edges and seams.

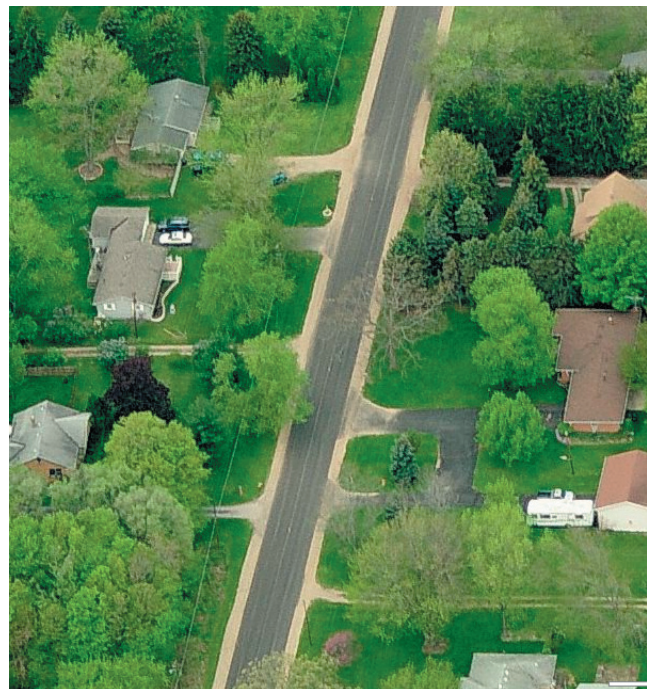
*Aerial view of wide, unpaved shoulders on both sides of Pipestone Rd., between Nickerson Rd. and River Rd. (photo from Bing Maps)*

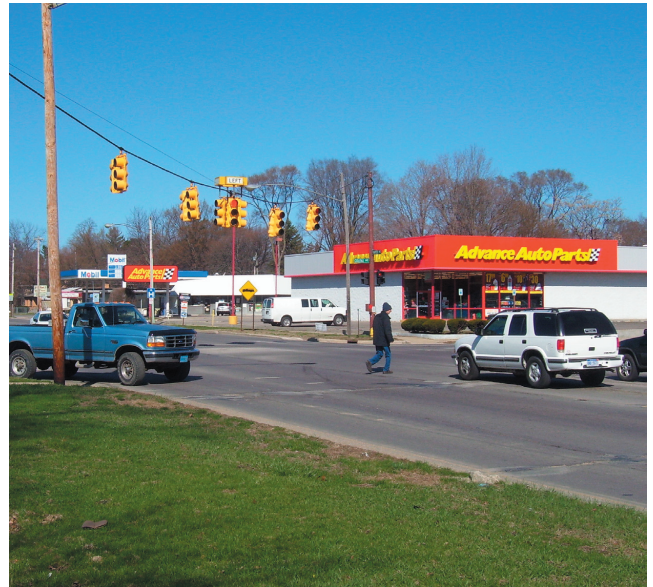
*Pedestrian crosses Napier Ave. on the east side of Colfax Ave.*

- A long crossing with no islands or other medians
- Public input reporting difficulty crossing and short signal times crossing Napier Ave.
- Pedestrian traffic generators, with several stores and a middle school directly adjacent to the intersection
- Other possible signs of problematic crossings
  - A history of serious crashes at or near the intersection
  - Intersections that are excessively complicated and difficult to navigate for bicyclists and pedestrians
  - Excessively wide turning radii, allowing for faster car speeds through the intersection and increasing the distances that pedestrians need to cross
  - Observations of pedestrians struggling with intersections or crossing mid-block in difficult circumstances

Ways of addressing intersection crossing width including shortening curb radii, extending curbs out into the intersection, installing traffic islands, or simply lengthening the signal time pedestrians have to cross (possibly through the use of pedestrian-activated signals). Other crossing design measures can include installing signs, signals, road markings, or protected medians at frequent midblock crossing sites or at previously unsignaled intersections, as well as making complicated intersections more navigable for pedestrians and cars.

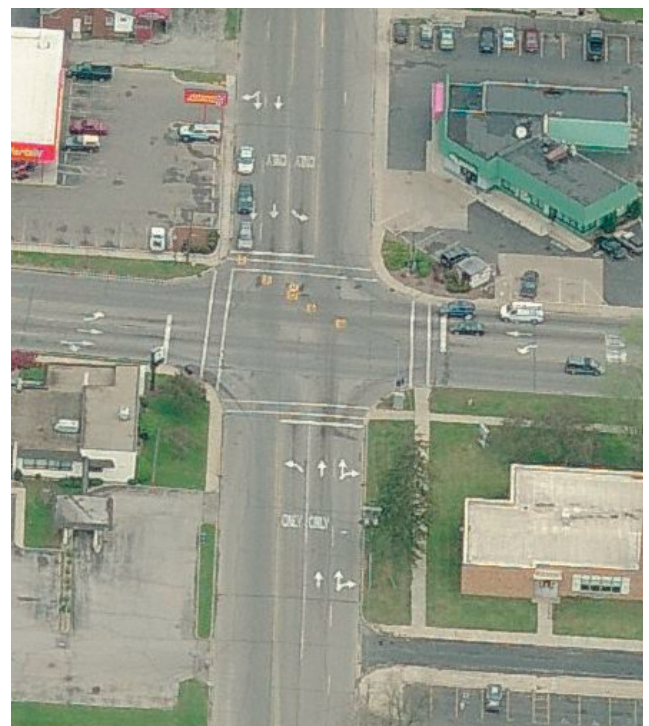
*Aerial view of the intersection of Napier Ave. (left-right) and Colfax Ave. (up-down), showing a crossing width of five lanes on each side of the intersection, with a school building shown to the lower right*
