# Galien River Watershed Management Plan

MDEQ Tracking Code #2000-0122

Prepared for  
**Berrien County Drain Commissioner**

**JULY 2003**  
**PROJECT NO. G01338**

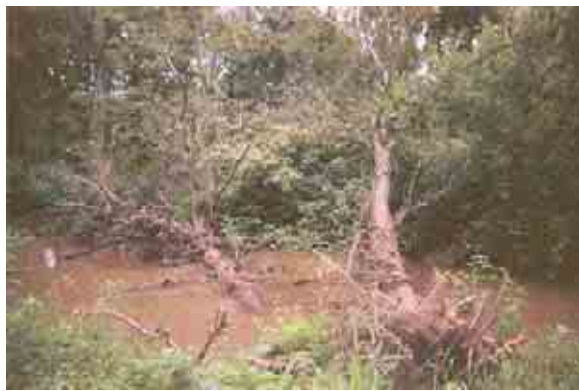
Photograph 1: Fallen Tree Diverting Flow

County drain information was made available by the BCDC. Frequent maintenance on a stream may indicate that the reach is unstable. It is not uncommon for trees to fall into the stream at the bank. The frequency of this occurrence varies widely, depending on soil type, topography, vegetation type, and flow rates. A fallen tree will cause the stream to change flow paths, but normally the stream will maintain the channel with slight alteration of the banks. It may scour the streambed below and the banks around the obstacle, creating an increased sediment load in the River (Photographs 1 and 2). This sediment load may be deposited downstream in the form of a sandbar. It may also alter a fast flowing channelized system into a slower meandering system with riffles, pools, and snags, which provide fish habitat. Major changes to flow paths and heavy sediment load are causes for concern.

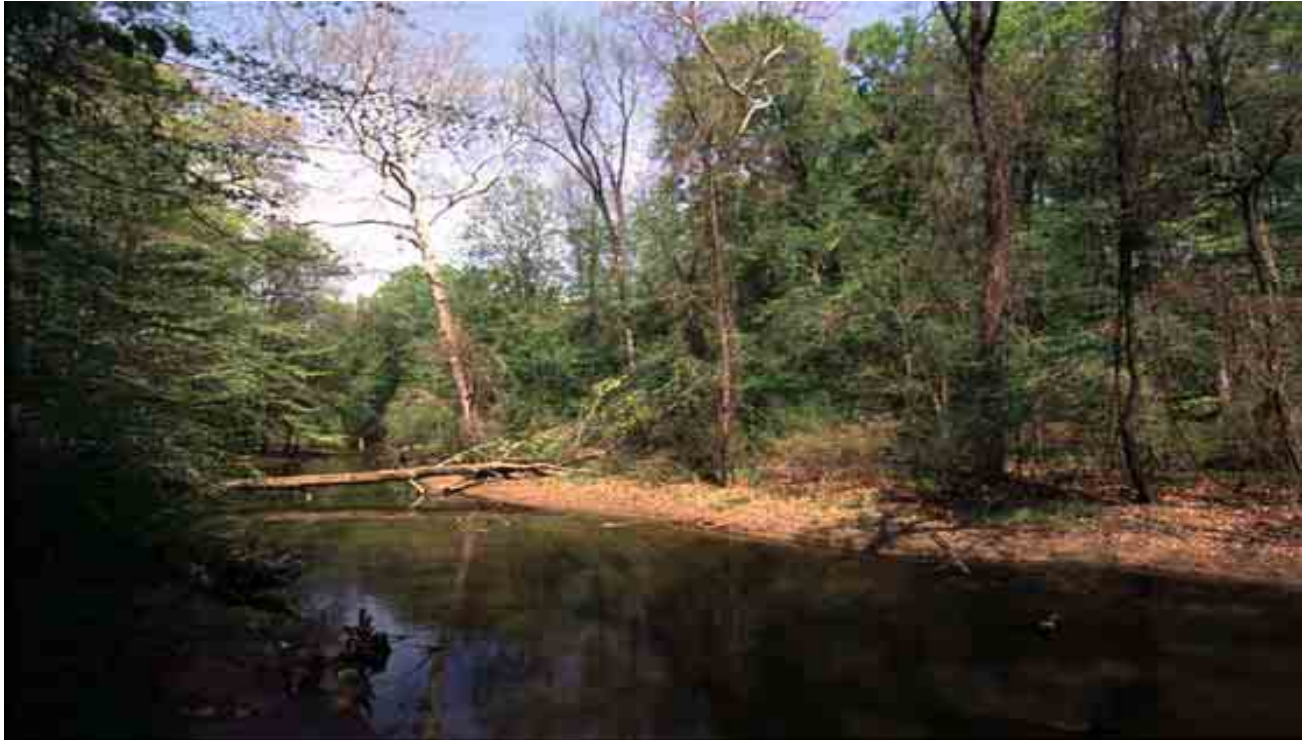
Photograph 3: Galien River Between Lake Michigan Channel and Red Arrow Highway

This reach of the River was classified as E6 (Photograph 3). An E classification represents the developmental “end-point” of channel stability and fluvial process efficiency for certain alluvial streams undergoing a natural dynamic sequence of system evolution (Rosgen, 1996). The E stream types are typically slightly entrenched ( $>2.2$ ), exhibit very low channel width/depth ratios ( $<12$ ), and display very high channel sinuosity ( $>1.5$ ). This reach is very slightly entrenched (22), since it is mostly a low marshy area and forested floodplain. The width/depth ratio is 9.6, indicating a wide, relatively deep river. The sinuosity is not as high as a typical type E stream, calculated at 1.3, but the number does indicate meandering, which is evident in the historical photographs. The slope (0.0012) and channel materials (Aquents and Histosols) identify the stream as E6. The relatively deep channels maintain a high resistance to change, resulting in channel stability. The stability can be compromised, however, when streambanks are disturbed or significant changes occur in the sediment loads or flows.

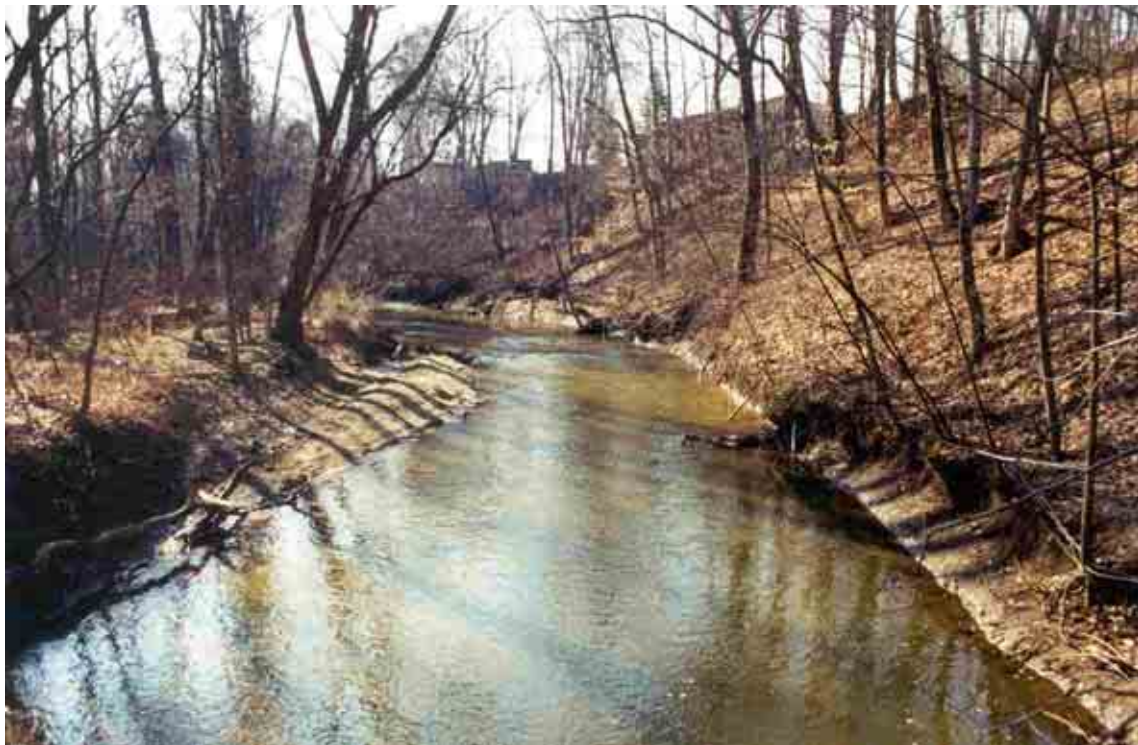
Photograph 4: Galien River at Minnich Road

This reach of the River was also classified as E6 (Photograph 7). The E stream types are typically slightly entrenched ( $>2.2$ ), exhibit very low channel width/depth ratios ( $<12$ ), and display very high channel sinuosity ( $>1.5$ ). The entrenchment ratio of 25 for a single stream indicates either a type C or E stream. The width/depth ratio of 8 indicates a wide, relatively deep river, resulting in an E classification. The sinuosity (1.4), slope, (0.0023) and channel material (Cohoctah sandy loam) yields a classification of E6. The relatively deep channels maintain a high resistance to change, resulting in channel stability. The stability can be compromised, however, when streambanks are disturbed or significant changes occur in the sediment loads or flows.

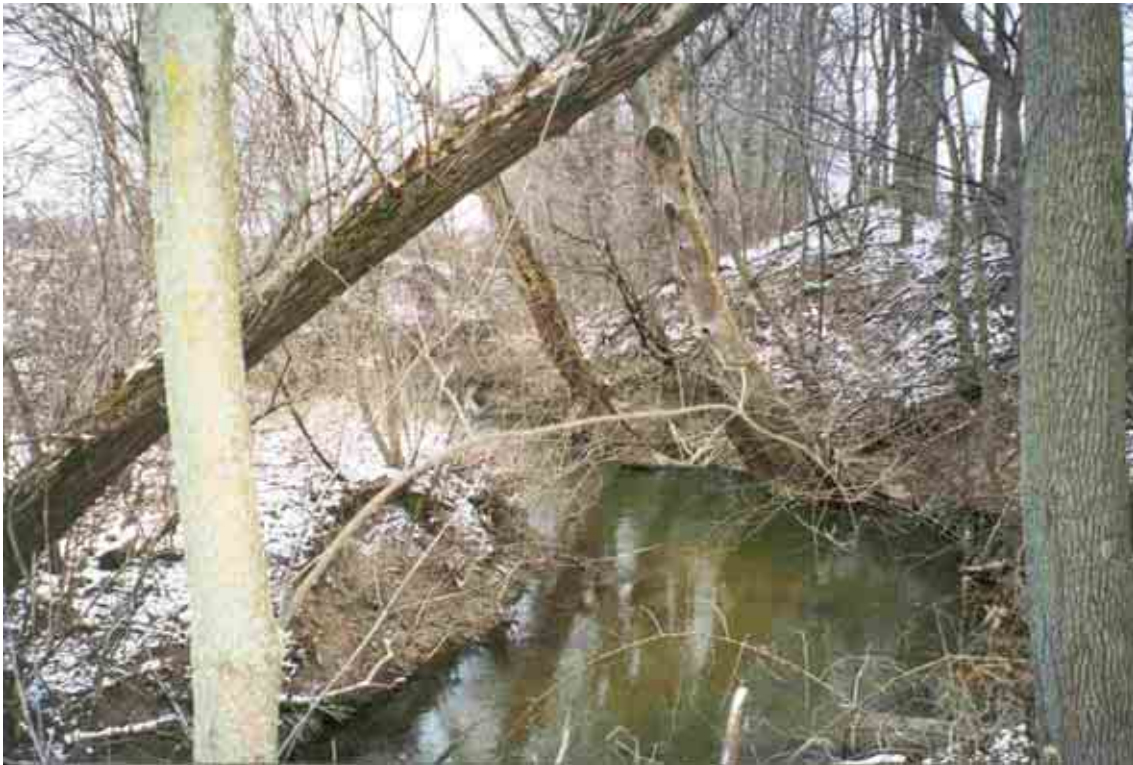
Photograph 5: Blue Jay Drain Between Holden and Pardee Roads

The Blue Jay Drain was classified as E6 (Photograph 5). An E classification represents the developmental “end-point” of channel stability and fluvial process efficiency for certain alluvial streams undergoing a natural dynamic sequence of system evolution (Rosgen, 1996). The E stream types are typically slightly entrenched ( $>2.2$ ), exhibit very low channel width/depth ratios ( $<12$ ), and display very high channel sinuosity ( $>1.5$ ). The entrenchment of this reach is slight (6), as it is located in an area that was a Black Ash swamp in presettlement days. The channel width/depth ratio is very low (5.8), indicating that the narrow and relatively deep channels maintain a high resistance to change, which results in channel stability, unless streambanks are disturbed and significant changes in the sediment loads or flows occur. A tributary to this reach had maintenance performed in 1996, which could have added a large sediment load and increased flows to the stream, thus creating an unstable condition. The reach has moderate sinuosity (1.2). The slope (0.0009) and channel materials (silt loam) are indicative of the E6 classification.

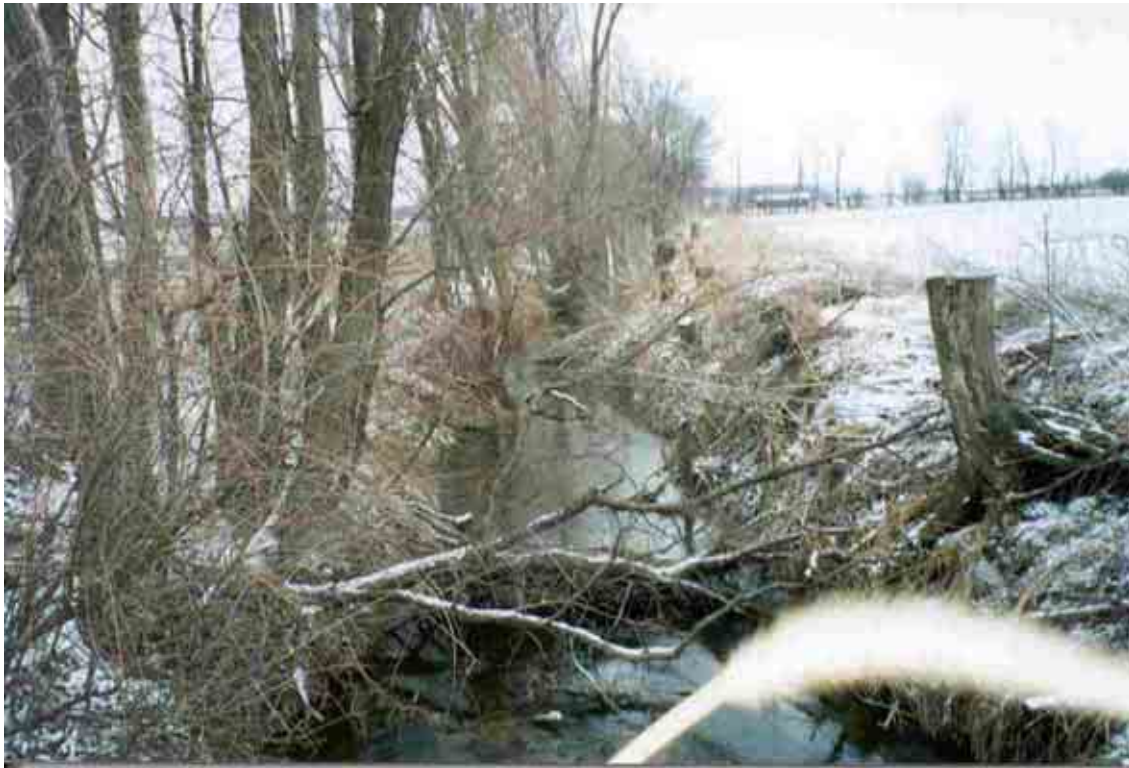
Photograph 6: Dowling Creek East of Hampton Road

Dowling Creek is classified as C5 (Photograph 6). The C stream types have a well developed floodplain, are relatively sinuous, and have a low relief channel (Rosgen, 1996). Channels of these types of streams can be significantly altered when the effects of changes in bank stability, watershed condition, or flow regime are combined to cause an exceedance of the channel stability threshold. Dowling Creek is very slightly entrenched (3.3), located in the Elm Valley area of glacial outwash in the Watershed. The channel has a moderately high width/depth ratio (14) and a high sinuosity (1.21), indicative of the depositional characteristics of the stream bed and the active meandering. The slope of the channel (0.0018) identifies the reach as C5. This stream type is susceptible to shifts of stability caused by direct channel disturbance and changes in the flow and sediment regimes of the contributing watershed, but is able to recover quickly if no further disturbances occur.

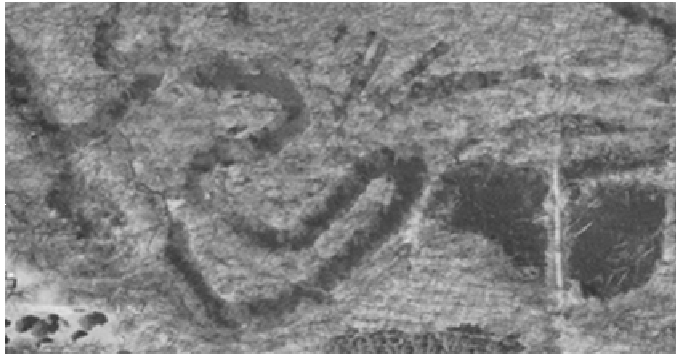
Photograph 8: Log Jams on the Galien River

The River in this lower area of the Watershed has a wide floodplain and the pattern of its sinuosity has shifted over time. It is a constantly changing river with meanders that slowly move as trees fall in at the banks. Its history can be seen in the convoluted meanders and oxbow lakes (Photograph 8).

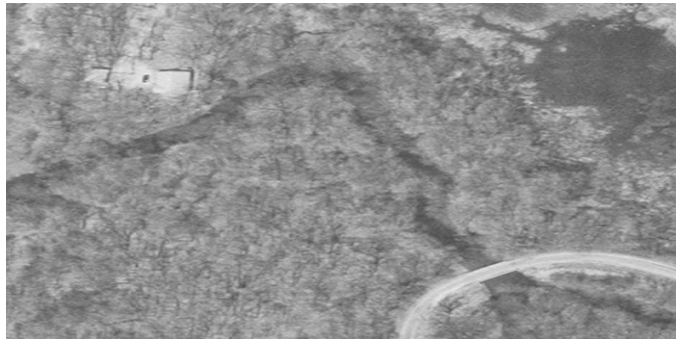
Photograph 9: Decreasing Meander of the Galien River

The meander in the southwest quarter of Section 13 in Chikaming Township appears to be moving toward Flynn Road. Meanders in the southwest quarter of Section 7 in Weesaw Township are decreasing (Photograph 9).

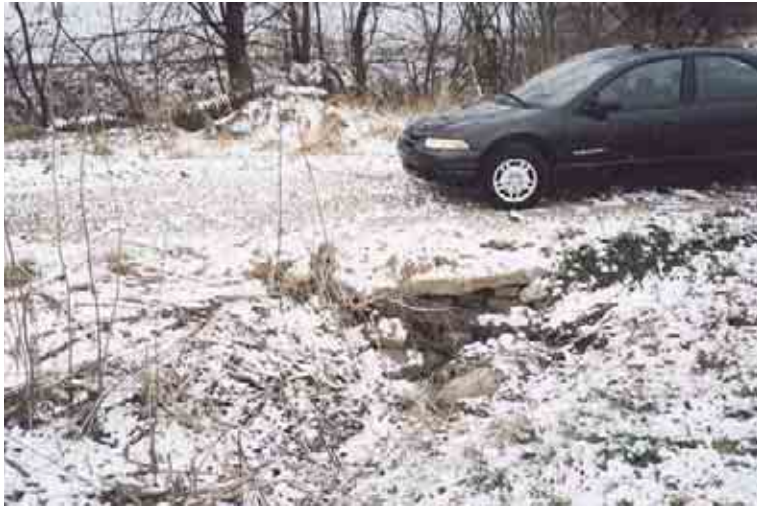
Photograph 11: Blocked Driveway Culvert

Much of the Elm Valley upstream from the confluence of the River and the East Branch of the River is farmed in the 2- to 5-year floodplain. Private drainage systems can be maintained to expedite the conveyance of water from the fields to the River once its level has gone down. Photograph 11 shows a blocked culvert that prevents drainage of water into the channel on the other side. Water will back up in the fields and overtop the driveway, causing both flooding conditions and erosion of the driveway.

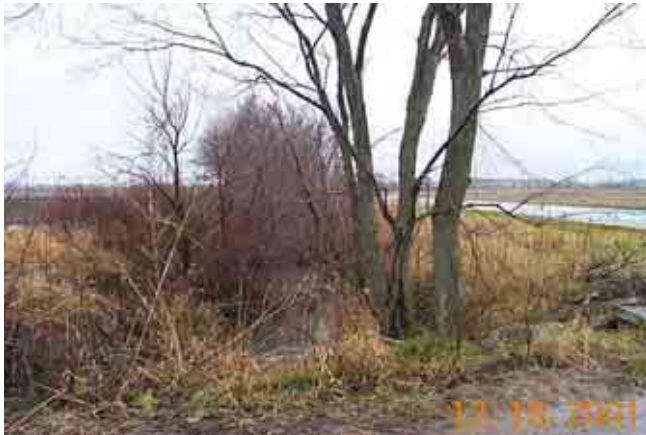
Photograph 12: Thick Brush on Banks

Flooding problems have been reported at Locations 18 and 24. Photographs of Location 18 show thick brush on the channel banks (Photograph 12). Channel conveyance will approach the 10-year storm event at this location with selective brush removal. Replacing the crossing and excavating additional channel will increase this location's conveyance capacity to the 25-year event. A channel's flow capacity is related to the channel roughness. Decreasing channel roughness often results in an increase of the channel's capacity. Selective brush removal within the channel can reduce a channel's roughness and increase the channel's capacity. Proper selective brush removal can also maintain the streambank vegetative cover, which benefits the stream by both shading the stream to maintain temperatures and stabilizing the streambank from possible erosion.

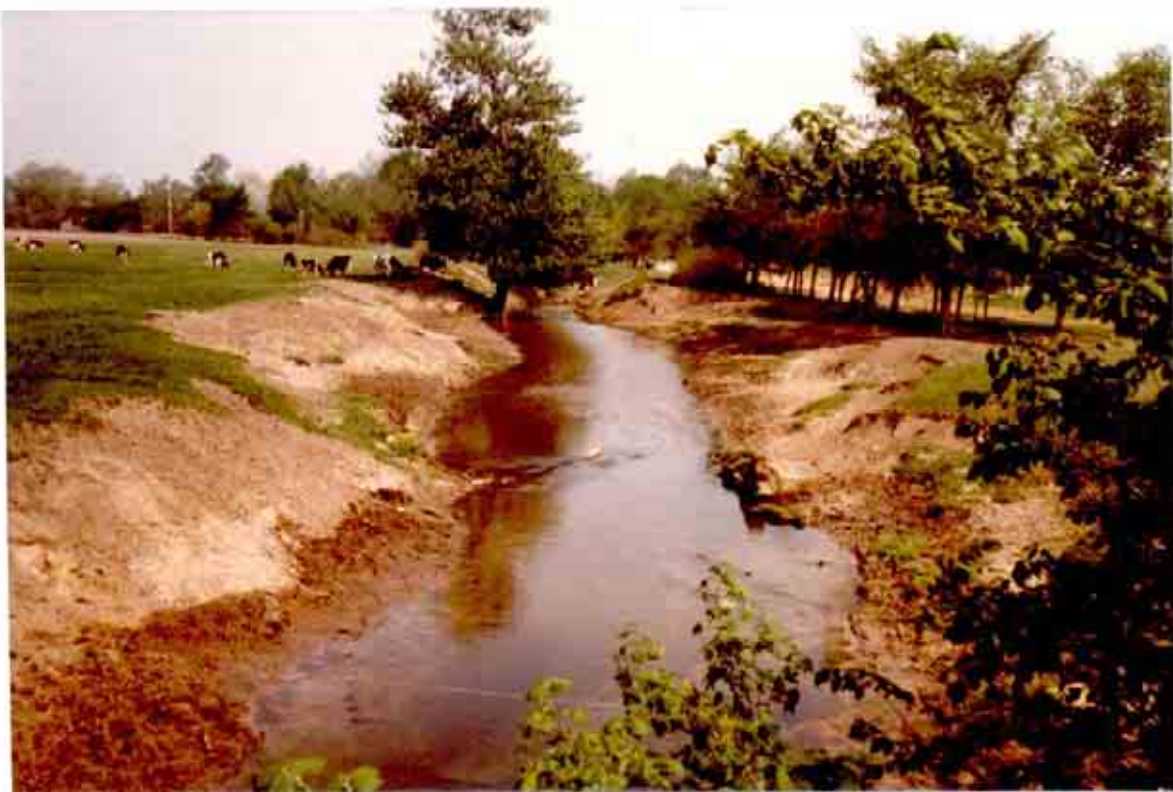
Picture 7: Unlimited Livestock Access (May 1982).

The effects of livestock access to streams can be severe. There is a twofold problem: waste elimination into the water and destruction of streambanks. *E. coli* and excessive nutrients pollute the streams from livestock waste. Even if livestock are allowed near the bank, their waste can wash directly into a water body. As livestock climb the banks of the river, the integrity of the banks suffers. Pictures 7 and 8 show the devastation that the weight of the cattle cause to streambanks. Livestock should be excluded from streams by use of fencing. Cattle crossings can be constructed of materials that will not erode under their weight. There should be substantial sized buffers, preferably 100 feet, between the fencing and the stream, especially on a slope. If gullies form, livestock should also be kept away from this region with fencing.
