MICHIGAN DEPARTMENT OF ENVIRONMENTAL QUALITY
WATER BUREAU
JANUARY 2009

STAFF REPORT

A BIOLOGICAL SURVEY OF SITES IN THE GALIEN RIVER WATERSHED
BERRIEN COUNTY, MICHIGAN
SEPTEMBER 2007

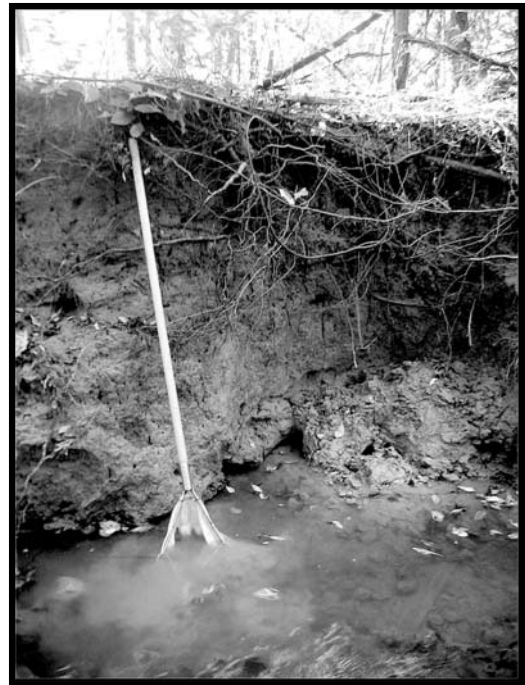
Visual reconnaissance at three other locations (Table 1) found conditions similar to those described above. A great deal of the watershed is used for agriculture and, as such, much of the large woody debris has been removed from the straightened channels. The riparian zone of these channelized stretches of the Galien River is extremely narrow, frequently less than 20 feet wide. The channel is deeply incised with the substrate consisting mostly of loose sand. The banks were generally bare and failing in many spots with exposed root mats of surrounding small trees (see photo on page 4).

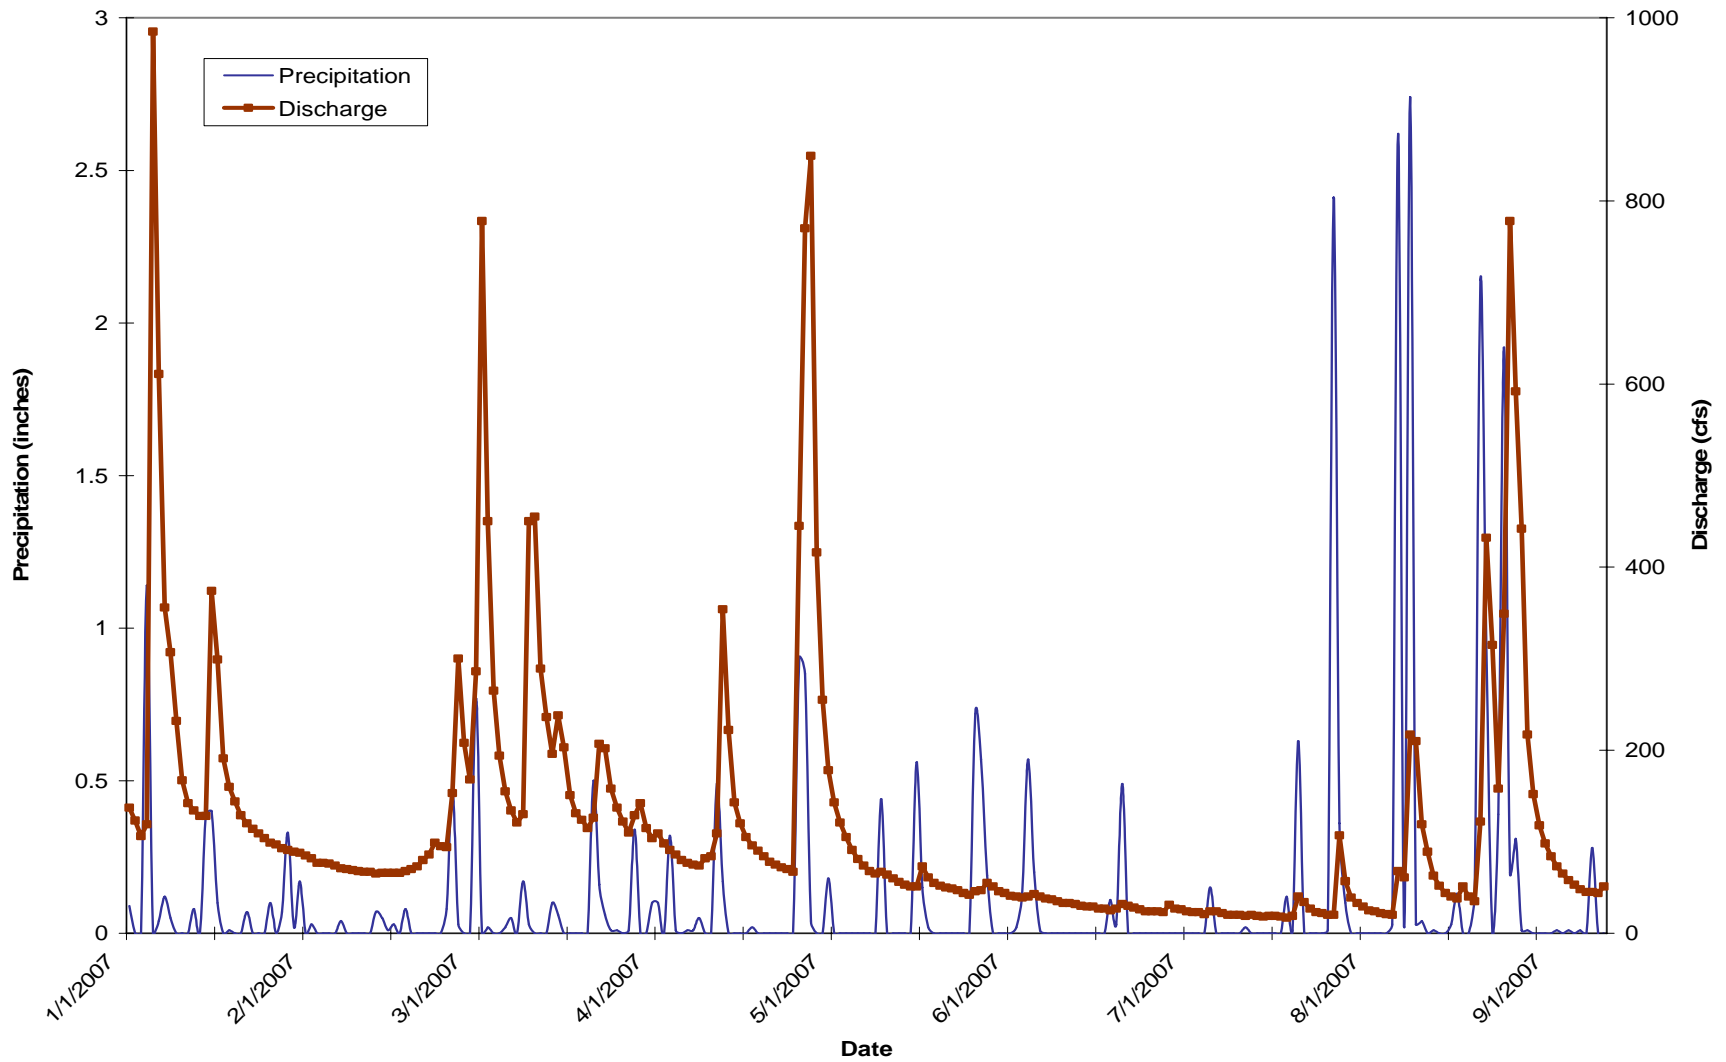
It is important to note that the 2007 biosurveys were conducted two weeks after rains had caused the discharge to increase from an average flow of 40 cubic feet per second (cfs) to flows exceeding 700 cfs (Figure 2). High, flashy flows, such as those found in the Galien River watershed, have been found to destroy habitat (Lamberti *et al.*, 1991) and decrease the total density and taxonomic richness of stream macroinvertebrates (Fisher *et al.*, 1982; Palmer *et al.*, 1996). Negishi *et al.* (2002) found that flood events in channelized stream reaches have an even greater impact on macroinvertebrate communities because habitat homogeneity in these reaches reduces the availability of flow refugia critical for the recolonization of the stream. Conversely, low summer flows (Figure 3) may have caused some smaller tributaries to stop flowing or to dry up completely; negatively impacting macroinvertebrate communities and the resultant Procedure 51 assessment scores. Low flows have been found to impact aquatic communities by reducing total useable habitat area, increasing stream temperature, and causing shifts in functional feeding group and habitat guild proportions (Wills *et al.*, 2005).

FIGURE 2. USGS discharge measurements and precipitation data for the Galien River near Sawyer, MI. January -September 2007.

acceptable at both sites. Habitat was rated marginal at both Flynn Road (100) and Pardee Road (88). The habitat was scored with glide/pool metrics because of the absence of riffle habitat. The greatest impairment of in-stream habitat is due to the flashy flow regime found in the Galien River watershed (see Figures 2 and 3). Our surveys took place only two weeks after water levels had risen five to six feet and discharge had increased from around 50 cfs to over 700 cfs.

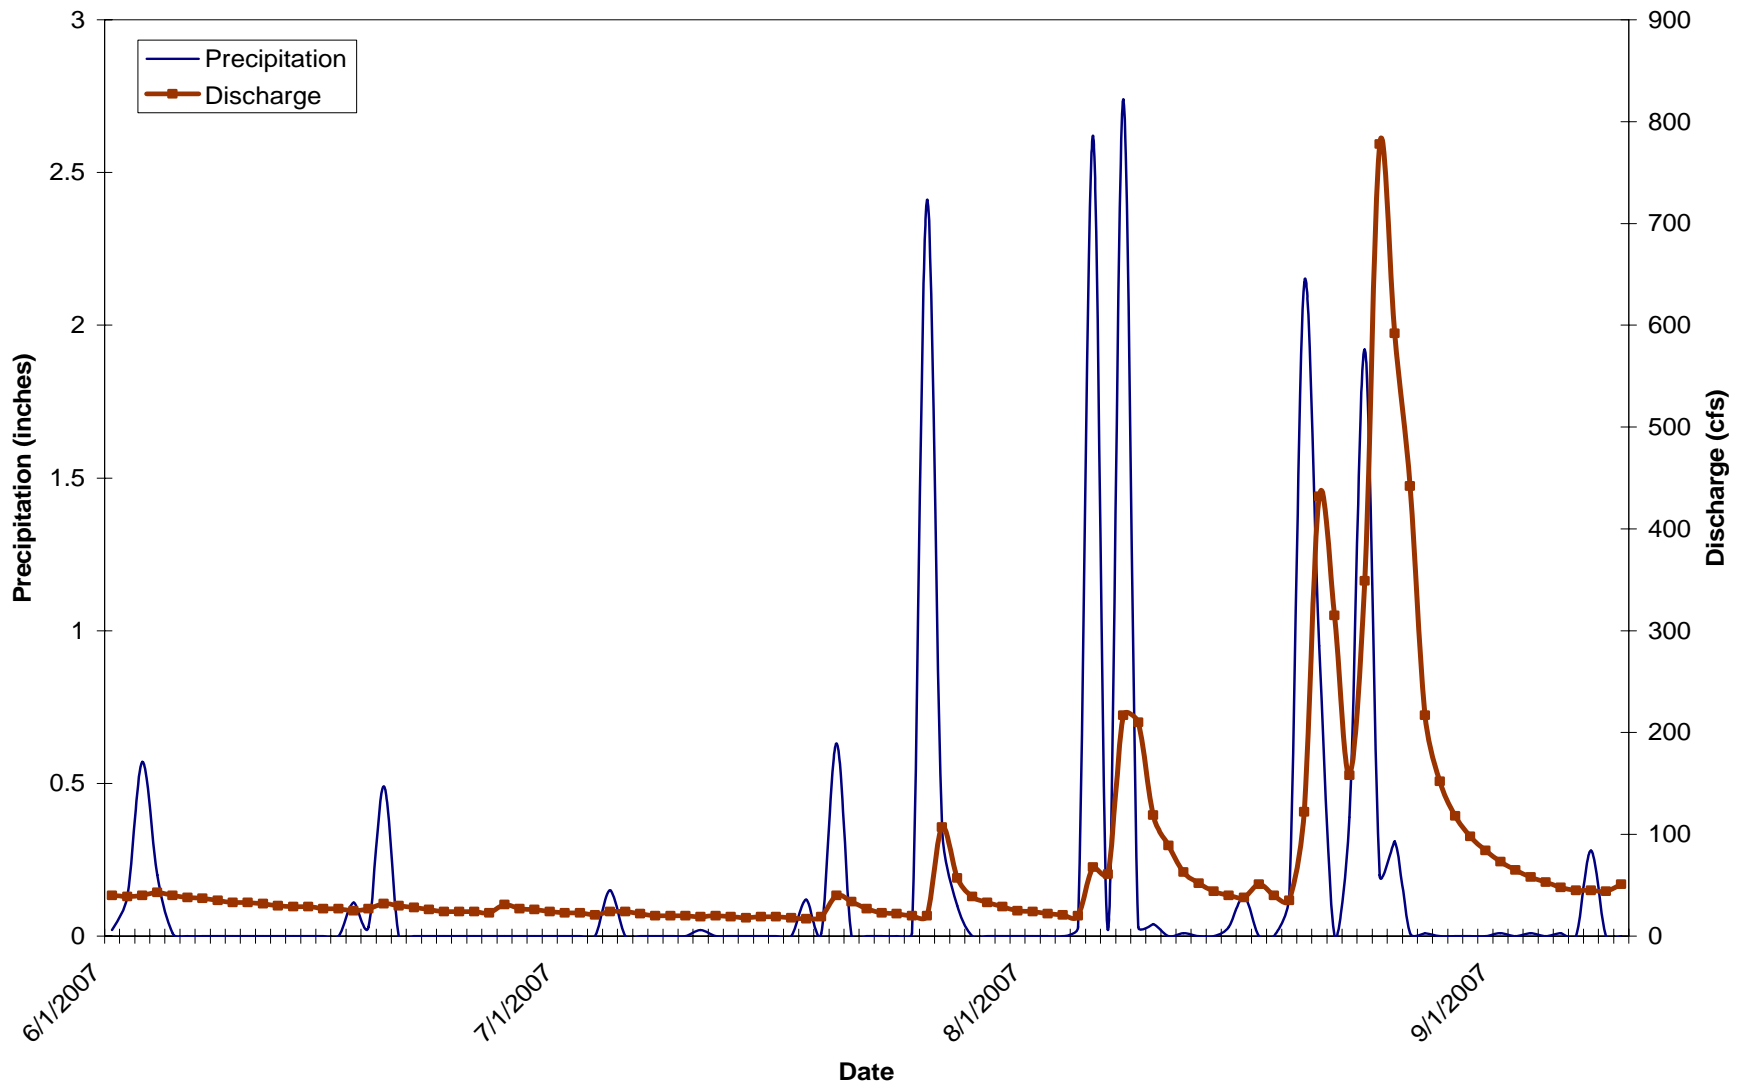
Habitat conditions throughout the watershed are highly influenced by flashy flows attributable to channel modification and agricultural land use practices (i.e., field tiling, riparian vegetation removal, etc.). Stream discharge during this assessment cycle was estimated to range between 20 to 55 cfs on the Galien River. A high flow event two weeks prior to our surveys calculated stream flows up to 778 cfs (Figure 3).

FIGURE 3. USGS discharge measurements and precipitation data for the Galien River near Sawyer, MI. June-September 2007.
