*Ox Creek TMDL Development --
Watershed Characterization and Source
Assessment Report*

March 24, 2010

Prepared for
U.S. Environmental Protection Agency -- Region 5
Michigan Department of Natural Resources and Environment

Tetra Tech, Inc.
1468 West Ninth Street, Suite 620
Cleveland, OH 44113

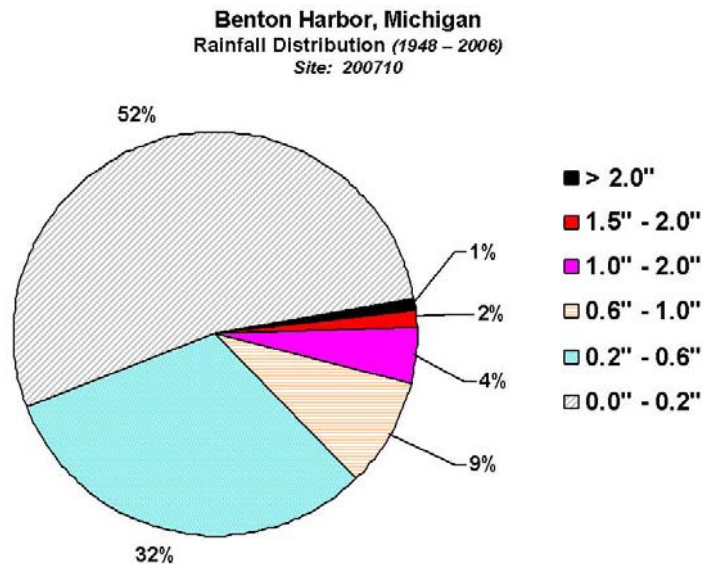
Figure 2-4. Precipitation intensity – Benton Harbor airport gage.

Examination of precipitation patterns is a key part of watershed characterization. In particular, rainfall intensity and timing affect watershed response to precipitation. This information is important in evaluating the effects of storm water on Ox Creek. Figure 2-4 presents one way to show rainfall intensity. Using Benton Harbor airport data from 1948 to 2006, 52 percent of the precipitation events were very low intensity (i.e., less than 0.2 inches). On the other hand, seven percent of the measurable precipitation events were greater than one inch.

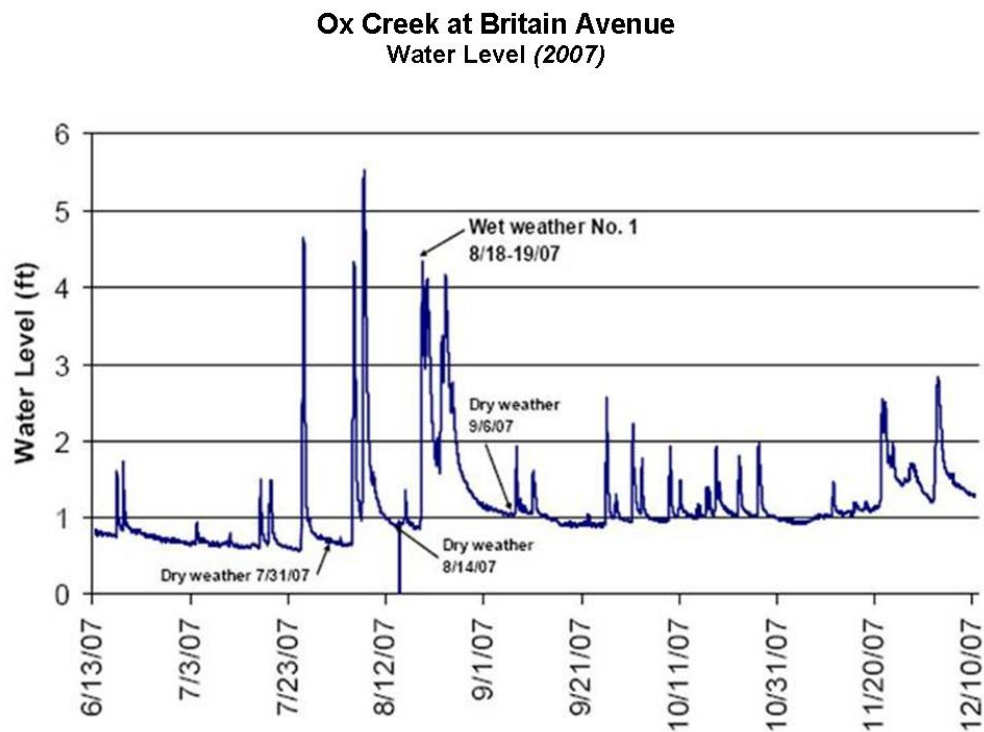
Figure 2-7. Level logger data collected in Ox Creek at Britain Avenue -- 2007.

Recorders that report water levels at short time intervals (i.e., 15 minutes) can be used to examine the flashiness of a stream. These devices, often referred to as level loggers, were deployed on Ox Creek at Britain Avenue in 2007 by the Michigan Department of Natural Resources and Environment (DNRE) (*Figure 2-7*). This information shows that during storm events over the Ox Creek watershed, water levels can rise over four feet in a very short period of time. Similar patterns were also observed in 2008 (*Figure 2-8*). In addition to water volume excesses due to storm water and flooding, natural dry weather periods (e.g., the lack of sufficient water) can make water quantity a factor that affects water quality.

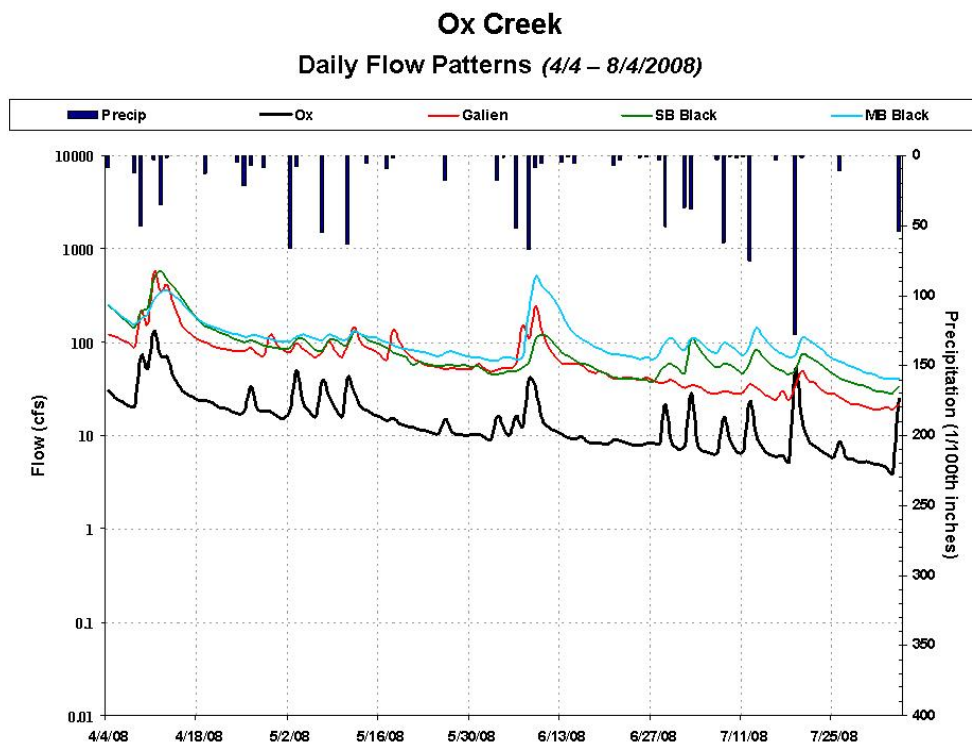
Figure 2-11. Ox Creek flows compared to several USGS sites -- 2008.

Figure 2-10 and Figure 2-11 illustrate that temporal flow patterns in Ox Creek are similar to several sites identified in Table 2-3. For this reason, it is useful to develop a quantitative comparison of flows at these sites to the limited flow data available for Ox Creek. A screening analysis, which correlates flows between sites, is one way to identify a gage that could be used for comparisons. The purpose of this analysis is to identify a site that provides a longer term view of the range of hydrologic conditions that may occur in the Ox Creek watershed. Figure 2-12 shows an example analysis using the Galien River site. Results of the correlation analysis for all of the gages are summarized in Table 2-4.

Flow data collected for Ox Creek (Figure 2-10 and Figure 2-11) does not account for variability over an entire year. Galien River flows were more closely correlated with Ox Creek than the other gages (*Table 2-4*). For this reason, information at this site can be used to show patterns during the missing periods. Figure 2-13 illustrates the degree to which daily average Galien River flows fluctuated over the course of the two-year Ox Creek level logger study period.

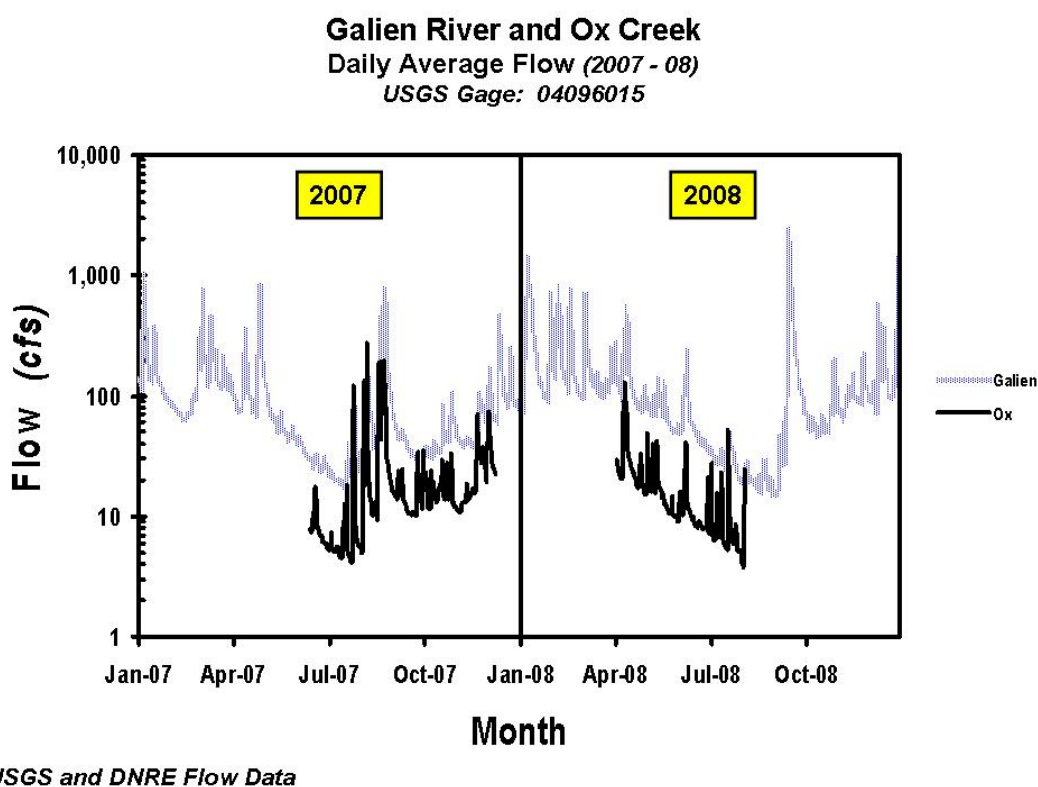
Figure 2-13. Daily average flows in 2007-08 for Galien River.

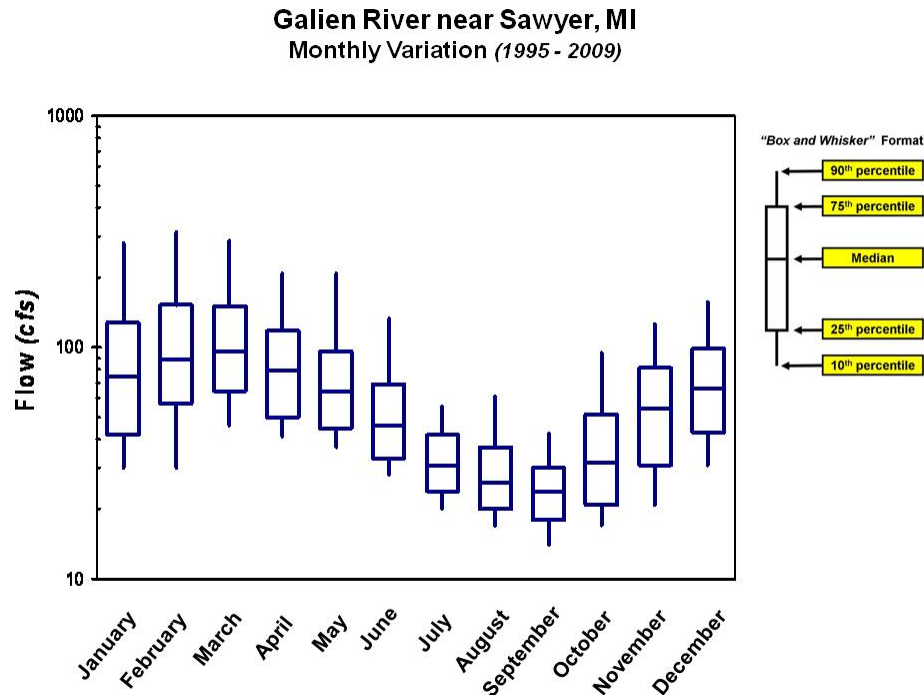
Figure 2-14. Seasonal variation of Galien River flows.

Figure 2-14 shows the seasonal variation of flow for the Galien River site using the entire period of record (1995 – 2009). In addition to showing general patterns, the “Box and Whisker” format used in Figure 2-14 highlights the variability of flows from month to month. For example, the highest flows typically occur between January and March. Flows during these months also tend to vary, reflecting the significant effect that air temperatures exert on hydrology. Periods of heavy snow followed by warmer temperatures can result in major runoff events. Conversely, lower winter flows may coincide with extended periods of below freezing temperatures.

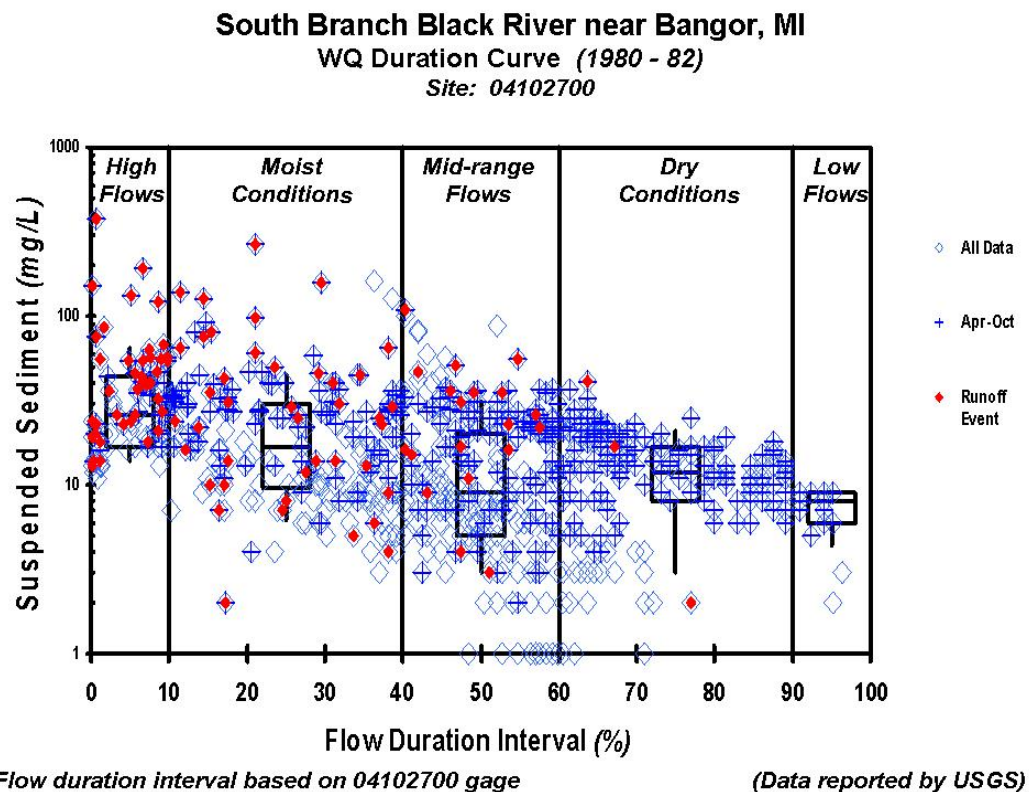
Figure 2-17. Relationship between flow and sediment using duration curve framework.

The use of duration curves in water quality assessment creates a framework that enables data to be characterized by flow conditions. The method provides a visual display of the relationship between stream flow and water quality. This concept is illustrated by using sediment data collected at one of the gages identified in Table 2-3: the South Branch Black River near Bangor. In the case of Figure 2-17, sediment concentrations are the greatest under high flow conditions. In addition, the display also shows that the highest levels are generally associated with runoff events (as indicated by the shaded diamonds). A similar analysis to the one shown in Figure 2-17 can be completed using Ox Creek data during development of the TMDL.
