# Pucker Street Dam Removal and River Restoration

## DRAFT Design Report

April 7, 2016

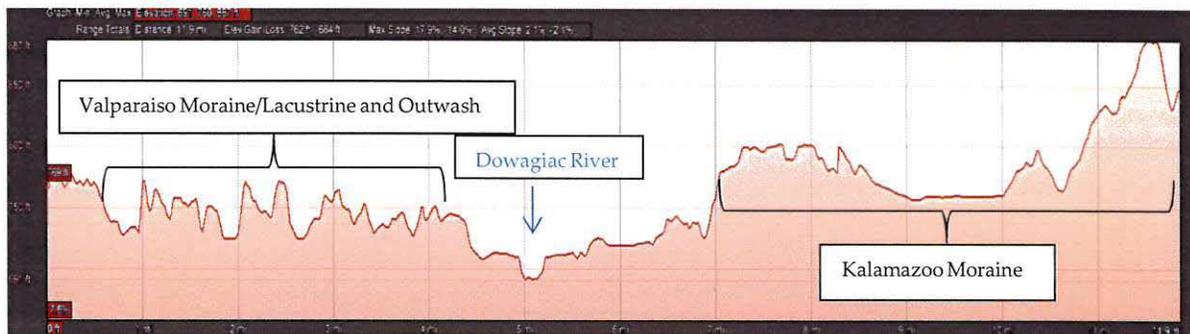
Figure 5. Generalized cross section of the Dowagiac River valley at the upstream end of the project reach. The overall valley is defined by the Valparaiso Moraine to the west (left) and the Kalamazoo Moraine to the east (right).

The Dowagiac River runs along the former Glacial Lake Dowagiac bed between the Kalamazoo and Valparaiso Moraines (Figure 5). The lake formed when ice and sediment blocked spillway outlets to the south (Figure 4). The flat lake bed is expressed in the low gradients of the upper Dowagiac River and the river's associated wetlands upstream of Sumnerville, MI (Figure 6). The glacial lake spillway is largely filled with gravelly, sandy delta deposits from upstream (north) and from the adjacent moraines. These sands and gravels are now the dominant material in the modern channel and floodplain (Stone et al., 2003; Kincare, 2010). They also make up the sandy and loamy soils found in the region (e.g. Ockley/Kalamazoo Loams, Oshtemo Sandy Loam, Cohoctah Sandy Loam). The sands and silts stored behind Pucker Street Dam are derived from these materials.

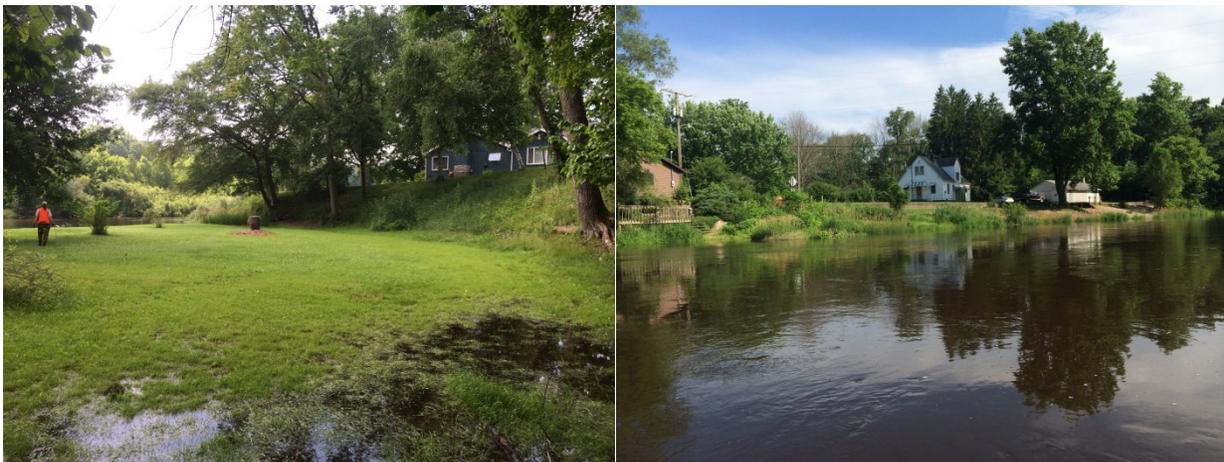
**Figure 7. Houses and yards set within 50 feet of the Dowagiac River impoundment.**

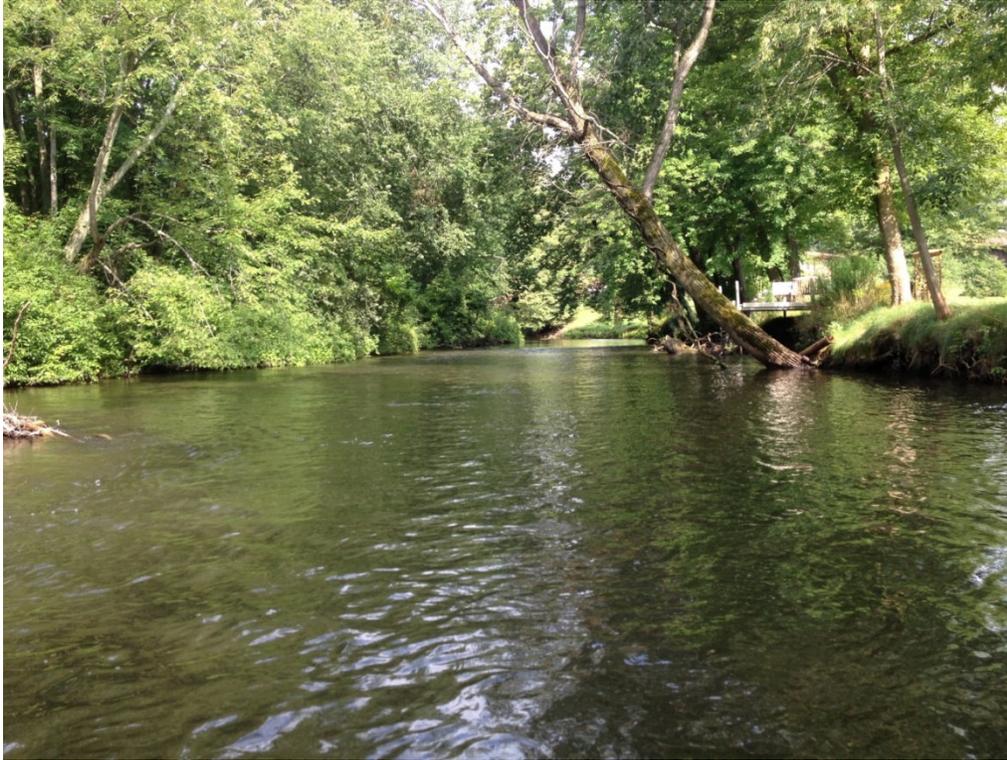
**Figure 8. Upstream section of Dowagiac River, below Kinzie Road.**

Below Kinzie Road, the valley along the *upstream reach* (i.e., upstream of the former impoundment; Figure 11) includes more woodland and narrower valley widths relative to the lower two-thirds of the study area (Figure 8). The channel is relatively sinuous, steep, and gravelly, and large wood is present in the stream. At the downstream end of this section, the channel turns to the west and transitions to the lower gradient, formerly impounded section of the channel.

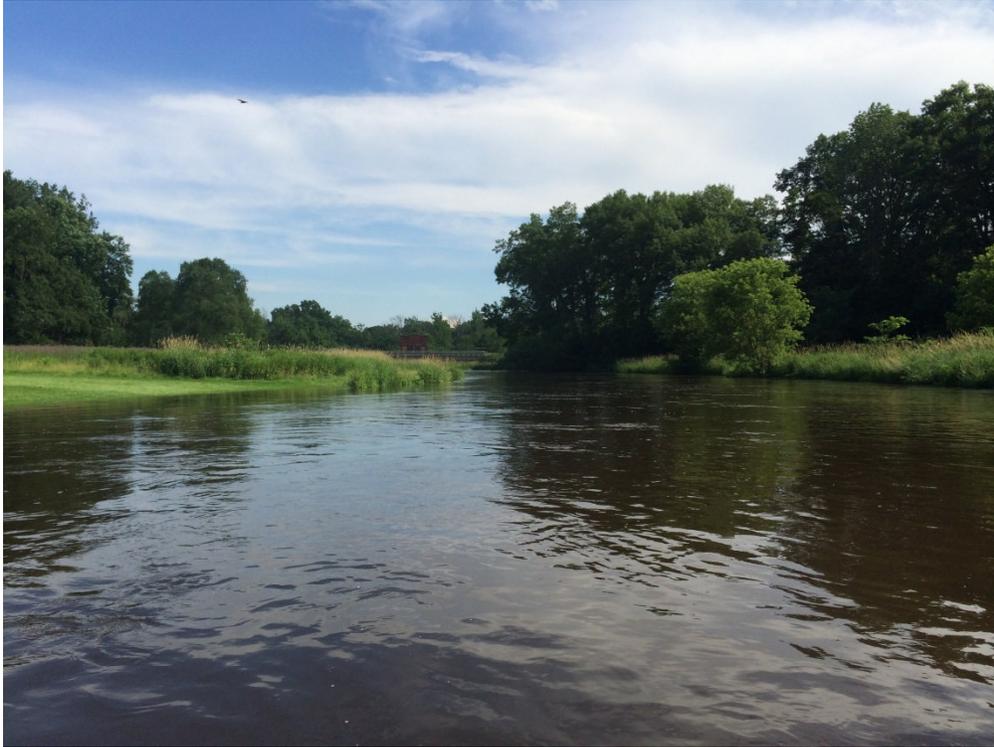
**Figure 9. Downstream section of Dowagiac River, within the impoundment.**

The *downstream*, impoundment section (Stations 1150 – 7200) is inset into glacial material, leaving high, steep, wooded, valley walls demarcating the flat floodplain of the former reservoir (Figure 12 and Figure 9). In this lower section, the channel is straighter than upstream, despite the wide flat valley. Cross section surveys along the channel show variable channel widths, ranging from around 70 feet to 100 feet wide at estimated bankfull conditions within the impounded section (Figure 12), and channel depths (i.e., impounded sediment surface to channel bed) varied from around 4 feet to around 8 feet, with an average of approximately 6 feet (see Data Collection section of this report). Wetlands and small side channels are common where groundwater seeps from the adjacent slopes and where side channels were abandoned after the dam was opened in 1999 (Figure 10). Much of the floodplain remains vegetated in native and non-native plants, with occasional thick copses of willows and small stands of cottonwood, ash, and alder (Figure 9 and Figure 10).

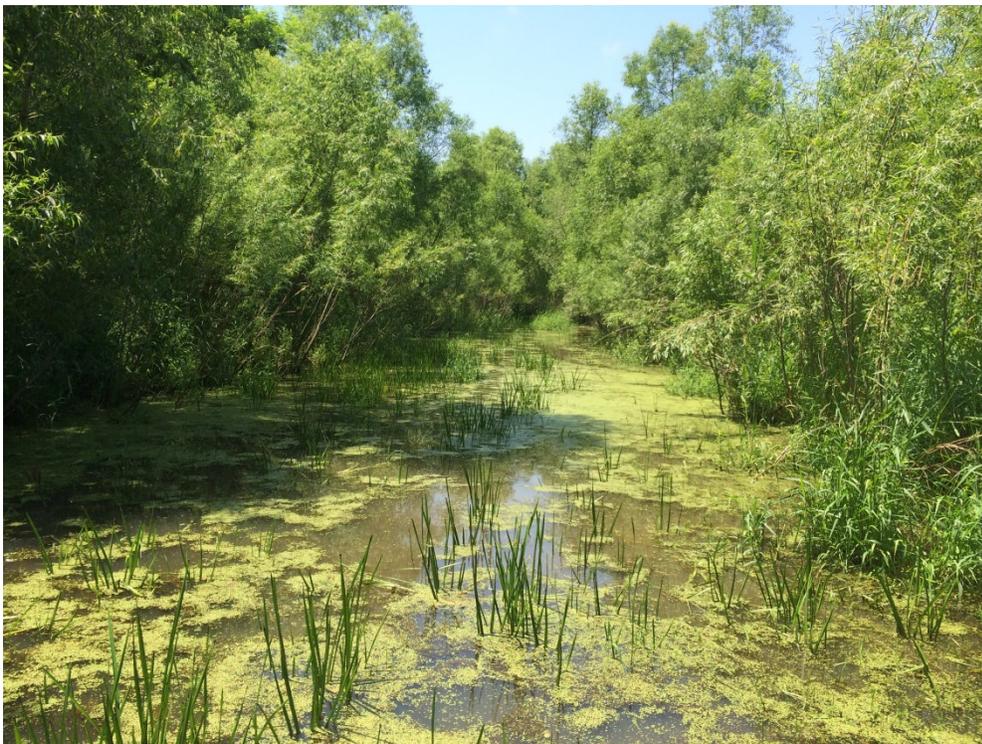
**Figure 10. Floodplain wetland along the valley wall within the impoundment reach.**

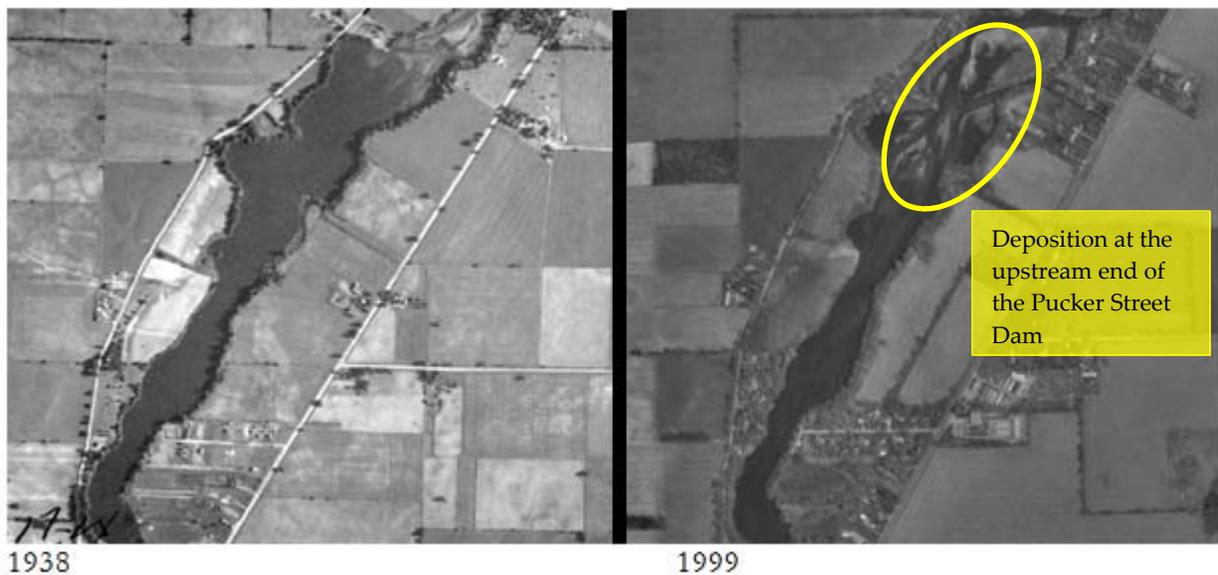
**Figure 133. Comparison of the 1999 air photo and 1938 air photo at the Pucker Street Dam impoundment. A sizeable delta formed over the northern (top of 1999 photo) third of the reach.**

The 1938 aerial photographs of the dam impoundment (Figure 13) depict delta formation at the upstream end of the impoundment, indicating continued filling through that time. By 1999, a significant delta had formed over the upper third of the reservoir, leaving low lying vegetated islands and bars of fine material (Figure 13). The wedge of sediment formed despite at least one dredging event (1940) and multiple accidental and maintenance related sediment releases (Wesley, 2008). The reservoir was drawn down in 1999, and the corresponding air photos (Figure 14) show exposed deposition throughout the former pond. Currently, the dam is dormant with three gates permanently left open.

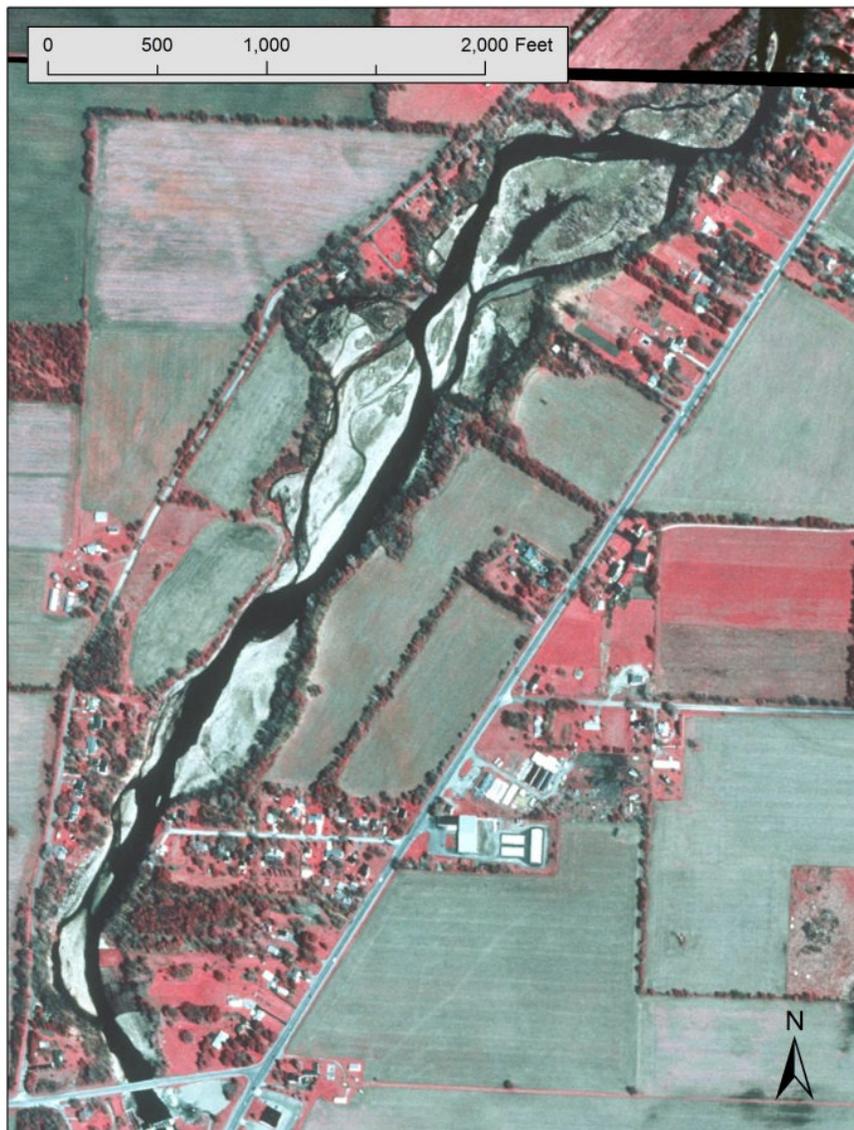
**Figure 144. Sediment exposed within Pucker Street Dam impoundment after the 5 foot draw down event in 1999. Light colored areas adjacent to the channel are exposed reservoir sediment.**

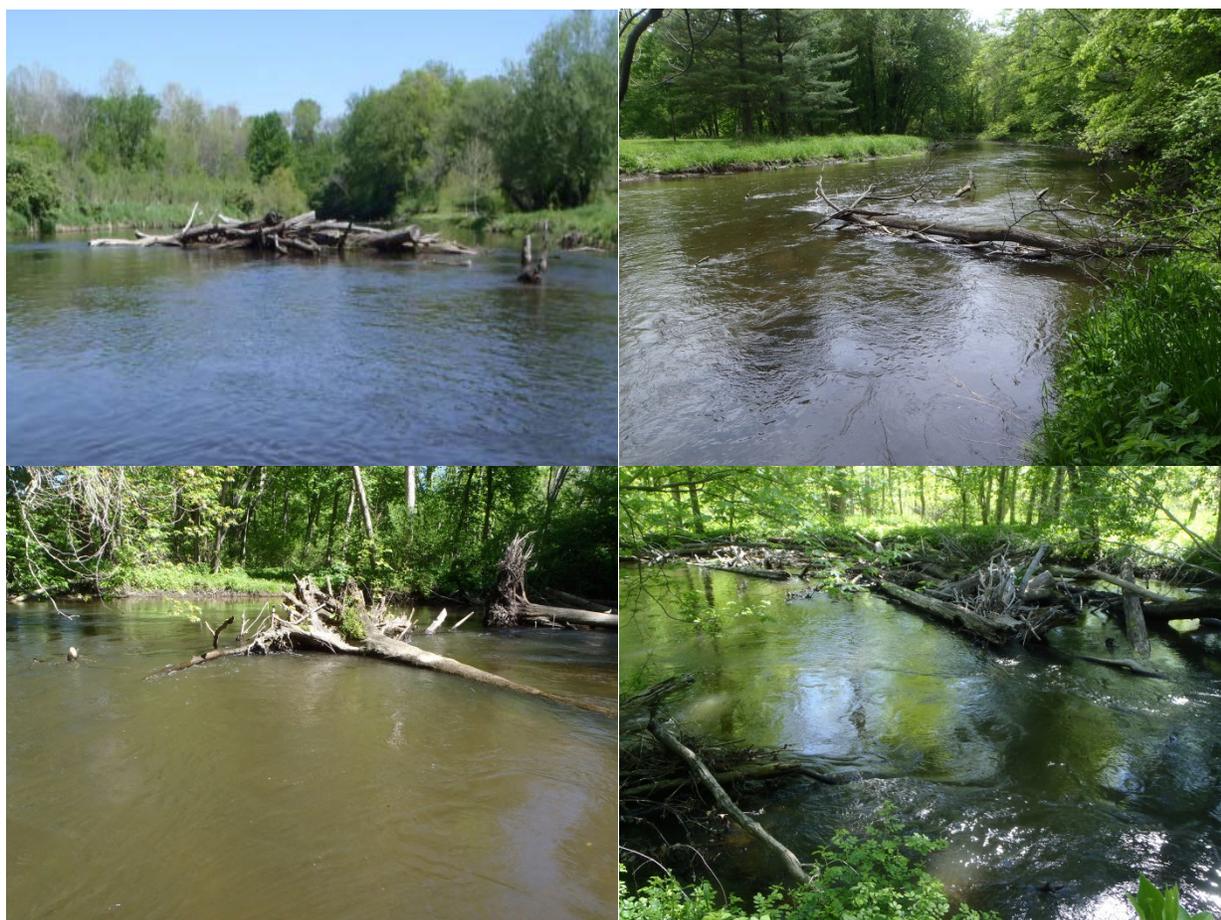
**Figure 22. Examples of single log and wood accumulations along the Dowagiac River.**

Habitat within the newly excavated channel will be augmented by the construction of wood complexes and single log pieces. Analogs of these exist within the current channel, both upstream and downstream of the project reach (Figure 22). A complex of large wood provides important habitat for adult and young of the year fish. In-channel wood also induces scour and deposition within the channel, creating bed variability and habitat heterogeneity. Installation of large wood remains an option in the proposed design and will be dependent on the final budget and contractor bid prices. If installation of large wood is completed as part of this project, wood will not span the channel, and will be compatible with paddler use of the river. Placed wood may require periodic maintenance to ensure captured debris from upstream does not completely block the channel.

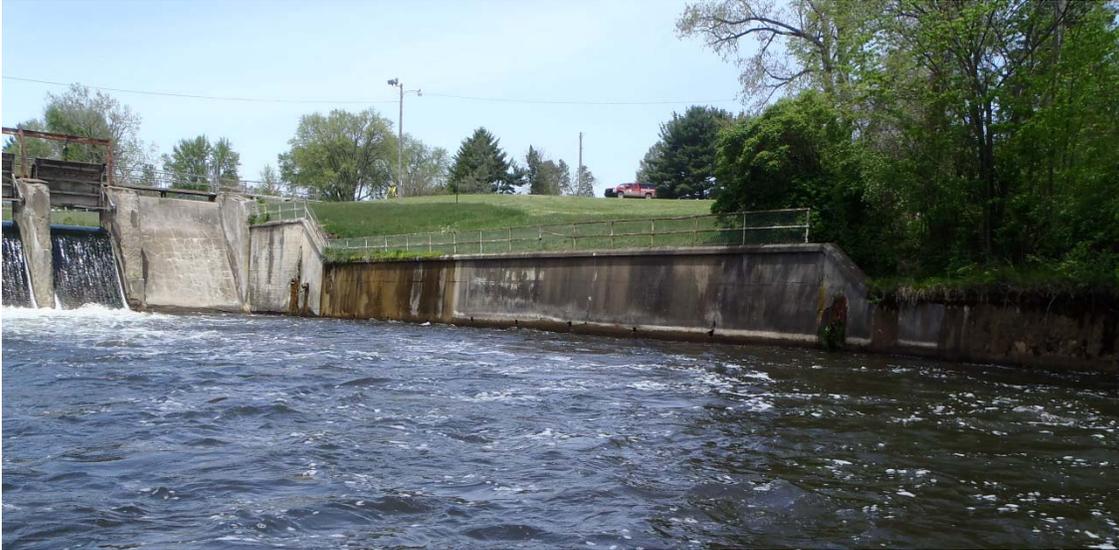
**Figure 24. Concrete wall along the east bank below Pucker Street Dam.**
