**Berrien County
Drain Commissioner**

Galien River Watershed

Hydrologic and Hydraulic Study

**JULY 2003
PROJECT NO. G01338**

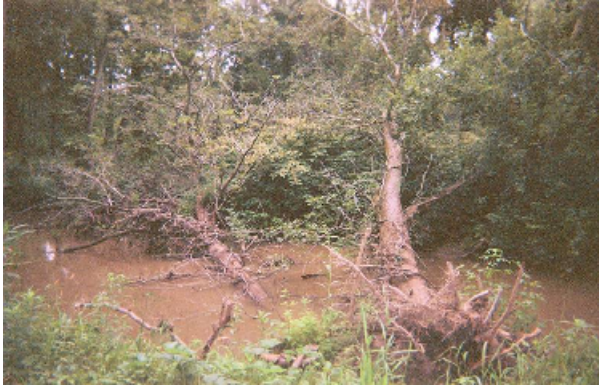
Photograph 1: Fallen Tree Diverting Flow

County drain information was made available by the BCDC (Appendix 2). Frequent maintenance on a stream may indicate that the reach is unstable. It is not uncommon for trees to fall into the stream at the bank. The frequency of this occurrence varies widely, depending on soil type, topography, vegetation type, and flow rates. A fallen tree will cause the stream to change flow paths, but normally the stream will maintain the channel with slight alteration of the banks. It may scour the streambed below and the banks around the obstacle, creating an increased sediment load in the River (Photographs 1 and 2). This sediment load may be deposited downstream in the form of a sandbar. It may also alter a fast flowing channelized system into a slower meandering system with riffles, pools, and snags, which provide fish habitat. Major changes to flow paths and heavy sediment load are causes for concern.

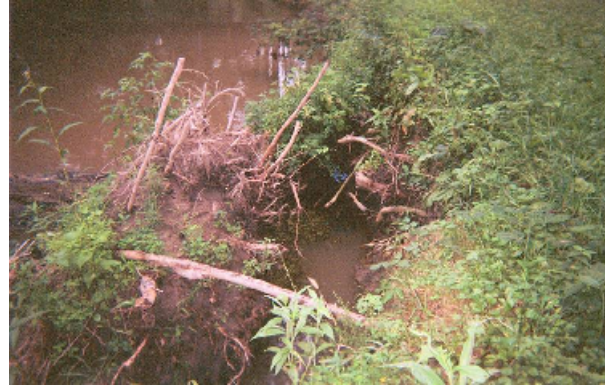
Photograph 2: Erosion from Diverted Flow at Root Mass

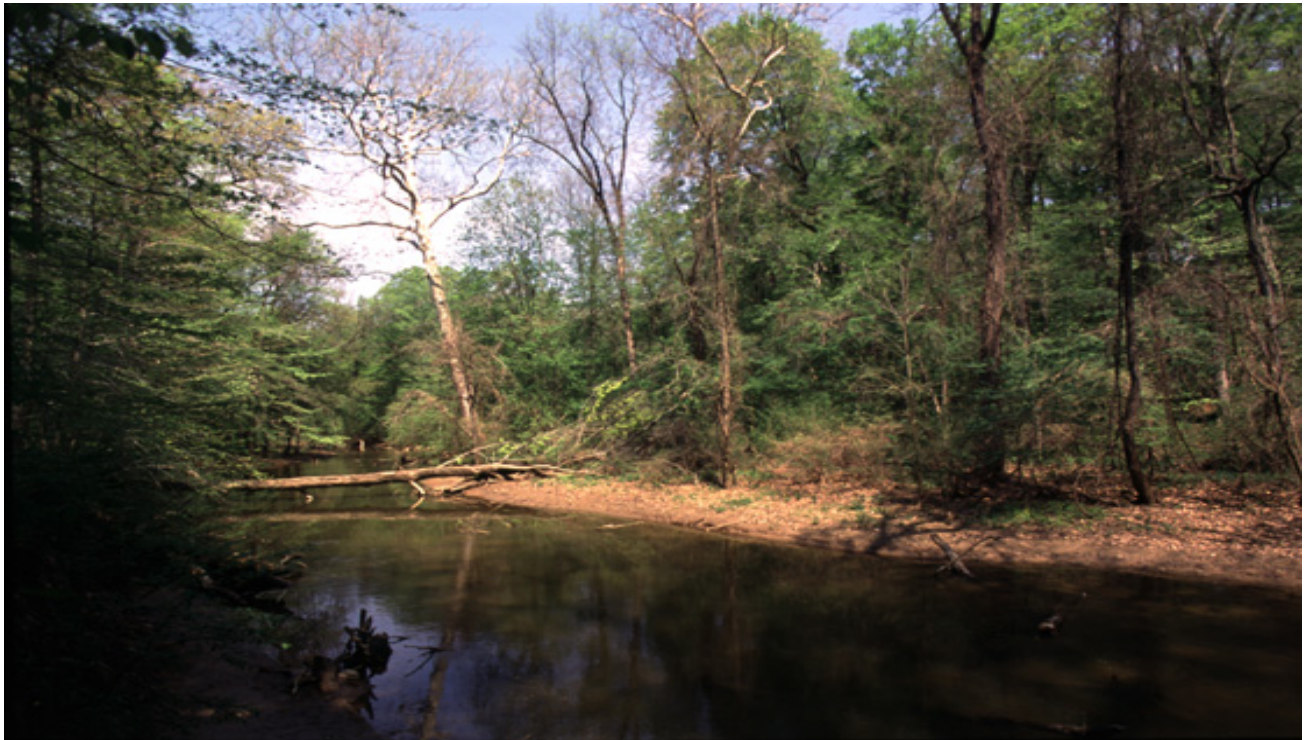
Photograph 3: Galien River Between Lake Michigan Channel and Red Arrow Highway

This reach of the River was classified as E6 (Photograph 3). An E classification represents the developmental “end-point” of channel stability and fluvial process efficiency for certain alluvial streams undergoing a natural dynamic sequence of system evolution (Rosgen, 1996). The E stream types are typically slightly entrenched (>2.2), exhibit very low channel width/depth ratios (<12), and display very high channel sinuosity (>1.5). This reach is very slightly entrenched (22), since it is mostly a low marshy area and forested floodplain. The width/depth ratio is 9.6, indicating a wide, relatively deep river. The sinuosity is not as high as a typical type E stream, calculated at 1.3, but the number does indicate meandering, which is evident in the historical photographs. The slope (0.0012) and channel materials (Aquents and Histosols) identify the stream as E6. The relatively deep channels maintain a high resistance to change, resulting in channel stability. The stability can be compromised, however, when streambanks are disturbed or significant changes occur in the sediment loads or flows.

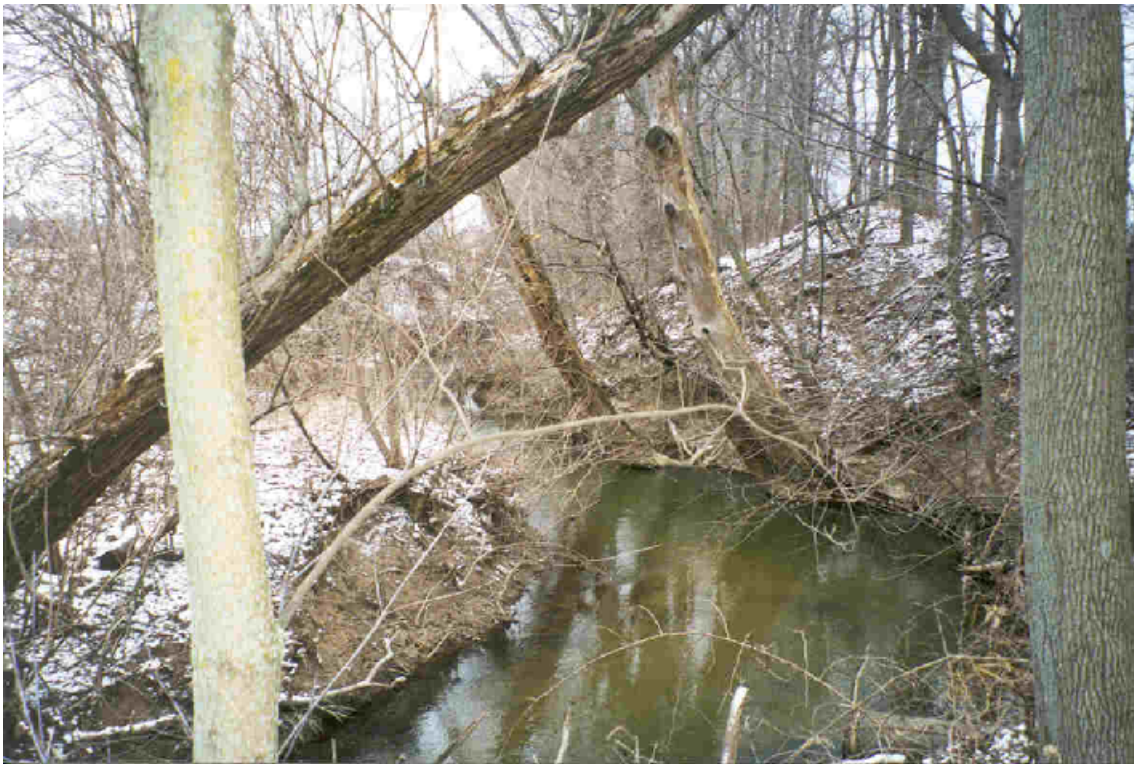
Photograph 5: Blue Jay Drain Between Holden and Pardee Roads

The Blue Jay Drain was also classified as E6 (Photograph 5). The E stream types are typically slightly entrenched (>2.2), exhibit very low channel width/depth ratios (<12), and display very high channel sinuosity (>1.5). The entrenchment of this reach is slight (6), as it is located in an area that was a Black Ash swamp in presettlement days. The channel width/depth ratio is very low (5.8), indicating that the narrow and relatively deep channels maintain a high resistance to change, which results in channel stability, unless streambanks are disturbed and significant changes in the sediment loads or flows occur. A tributary to this reach had maintenance performed in 1996, which could have added a large sediment load and increased flows to the stream, thus creating an unstable condition. The reach has moderate sinuosity (1.2). The slope (0.0009) and channel materials (silt loam) are indicative of the E6 classification.

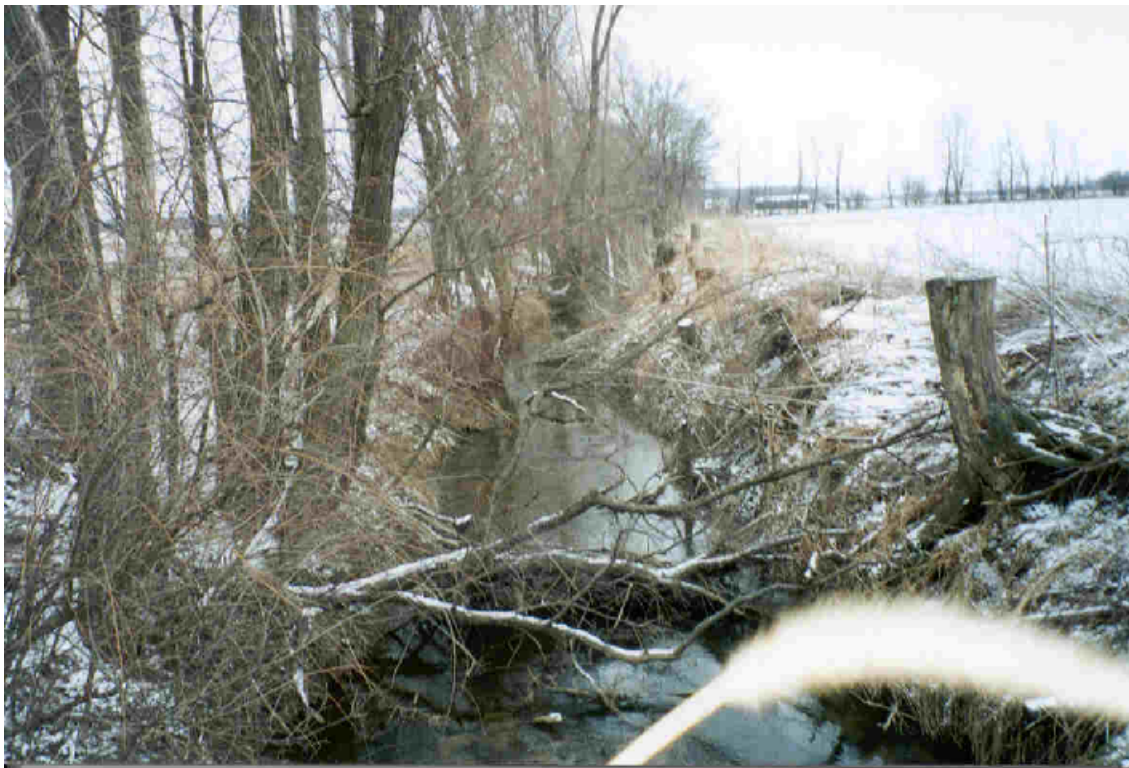
Photograph 6: Dowling Creek East of Hampton Road

Dowling Creek is classified as C5 (Photograph 6). The C stream types have a well developed floodplain, are relatively sinuous, and have a low relief channel (Rosgen, 1996). Channels of these types of streams can be significantly altered when the effects of changes in bank stability, watershed condition, or flow regime are combined to cause an exceedance of the channel stability threshold. Dowling Creek is very slightly entrenched (3.3), located in the Elm Valley area of glacial outwash in the Watershed. The channel has a moderately high width/depth ratio (14) and a high sinuosity (1.21), indicative of the depositional characteristics of the stream bed and the active meandering. The slope of the channel (0.0018) identifies the reach as C5. This stream type is susceptible to shifts of stability caused by direct channel disturbance and changes in the flow and sediment regimes of the contributing watershed, but is able to recover quickly if no further disturbances occur.

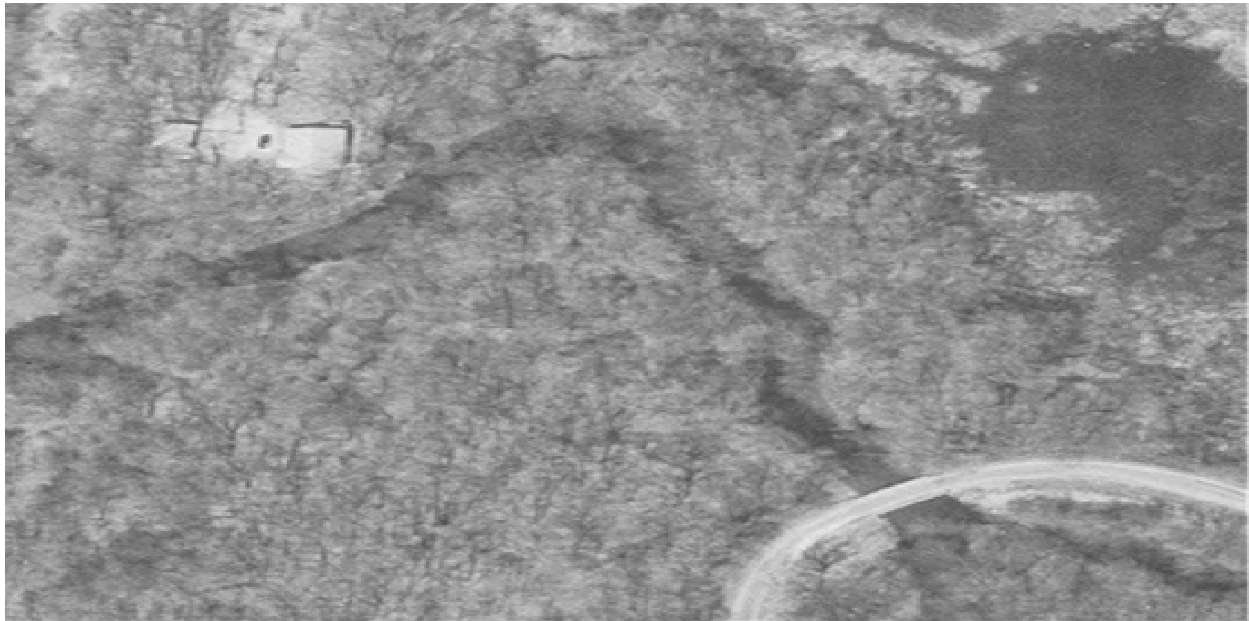
Photograph 9: Decreasing Meander of the Galien River

Some movement of meanders appears to be occurring at a slow rate, barely visible over the 15-year period. The meander in the southwest quarter of Section 13 in Chikaming Township appears to be moving toward Flynn Road. Meanders in the southwest quarter of Section 7 in Weesaw Township are decreasing (Photograph 9).

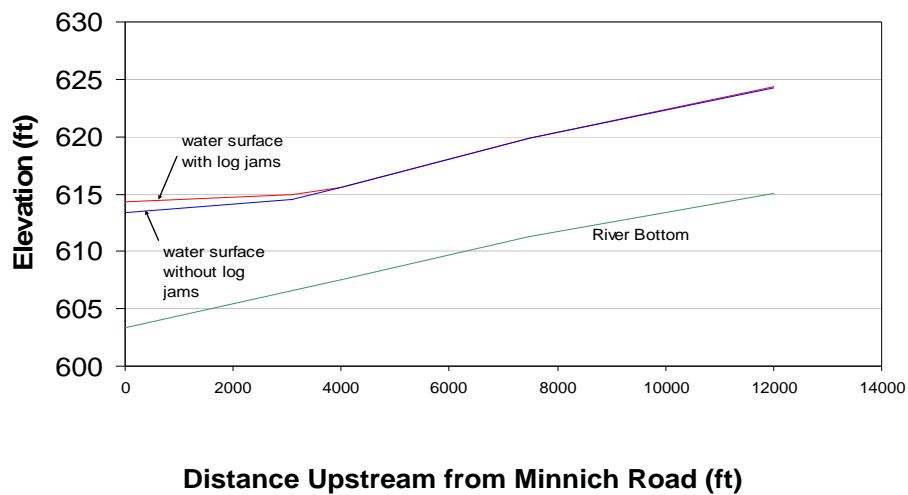
Graph 1 - Effects of Log Jam Removal
on the 10 year rainfall event

The backwater effects of removing log jams downstream from Minnich Road reduced water surface elevations for about 4,000 feet upstream of Carpenter Road for the 2-, 5-, 10-, 50-, and 100-year precipitation events. Graph 1 shows the backwater impacts of log jam removal in the profile view for the 10-year storm event. The floodplain east of Minnich Road, however, is undeveloped forest, where structural or crop flooding damage is not a concern. These results agree with the conclusions in the ACOE analysis conclusions.

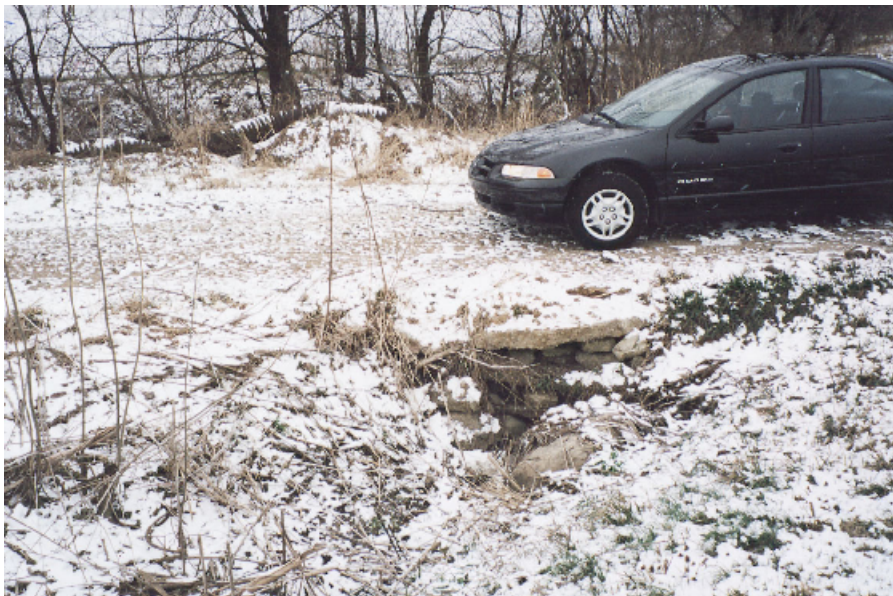
Photograph 11: Blocked Driveway Culvert

A channel cross section of the River at Kaiser Road (Location 3) shows the water surface elevation for various storm events (Graph 2). Much of the Elm Valley upstream from the confluence of the River and the East Branch of the River is farmed in the 2- to 5-year floodplain. Private drainage systems can be maintained to expedite the conveyance of water from the fields to the River once its level has gone down. Photograph 11 shows a blocked culvert that prevents drainage of water into the channel on the other side. Water will back up in the fields and overtop the driveway, causing both flooding conditions and erosion of the driveway.

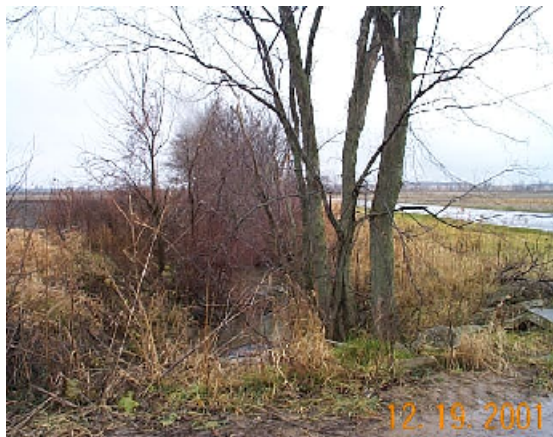
Photograph 12: Thick Brush on Banks

Flooding problems have been reported at Locations 18 and 24. Photographs of Location 18 show thick brush on the channel banks (Photograph 12). Graph 3 shows the effects on flow capacity from different channel modifications at Location 18. Channel conveyance will approach the 10-year storm event at this location with selective brush removal. Replacing the crossing and excavating additional channel will increase this location's conveyance capacity to the 25-year event. A channel's flow capacity is related to the channel roughness.
