# Black and Paw Paw River Watersheds

## Pathogen Monitoring Project

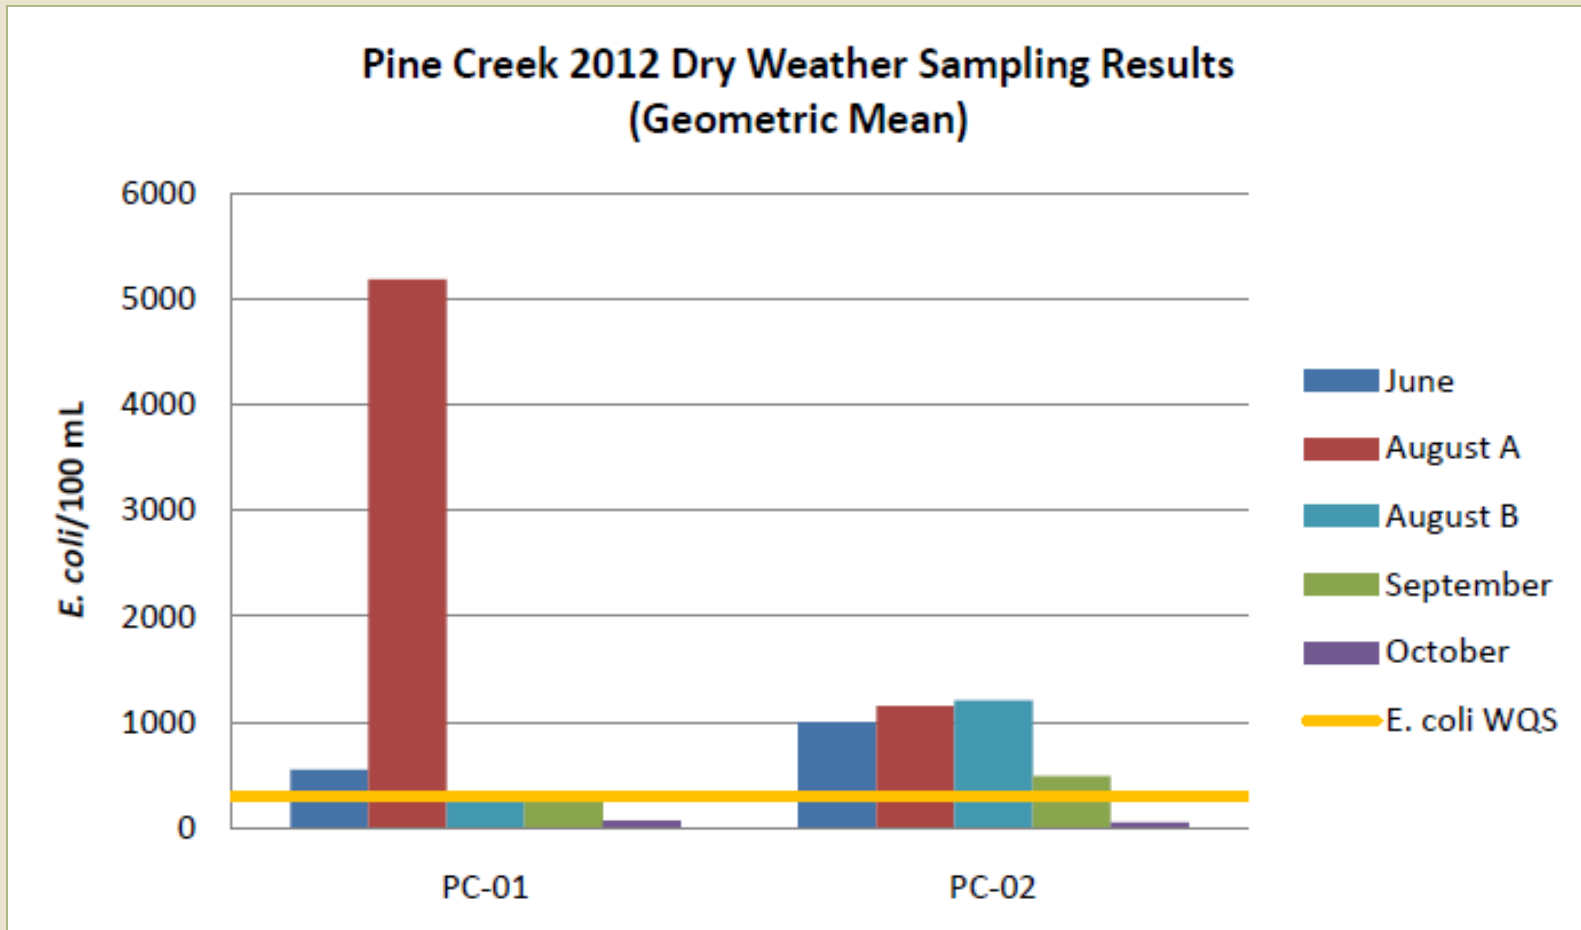
# Dry Weather Sampling

- Dry Weather
  - Pine Creek (2 sites) Pathogens
- Wet Weather
  - Pine Creek (4 sites) - Pathogens
  - Black River (7 sites) - Pathogens
  - Mill Creek (1 site) - Pathogens and Flow
