**Pucker Street Dam Removal and Dowagiac River
Restoration**

Environmental Assessment

Berrien County, Michigan

December 2018

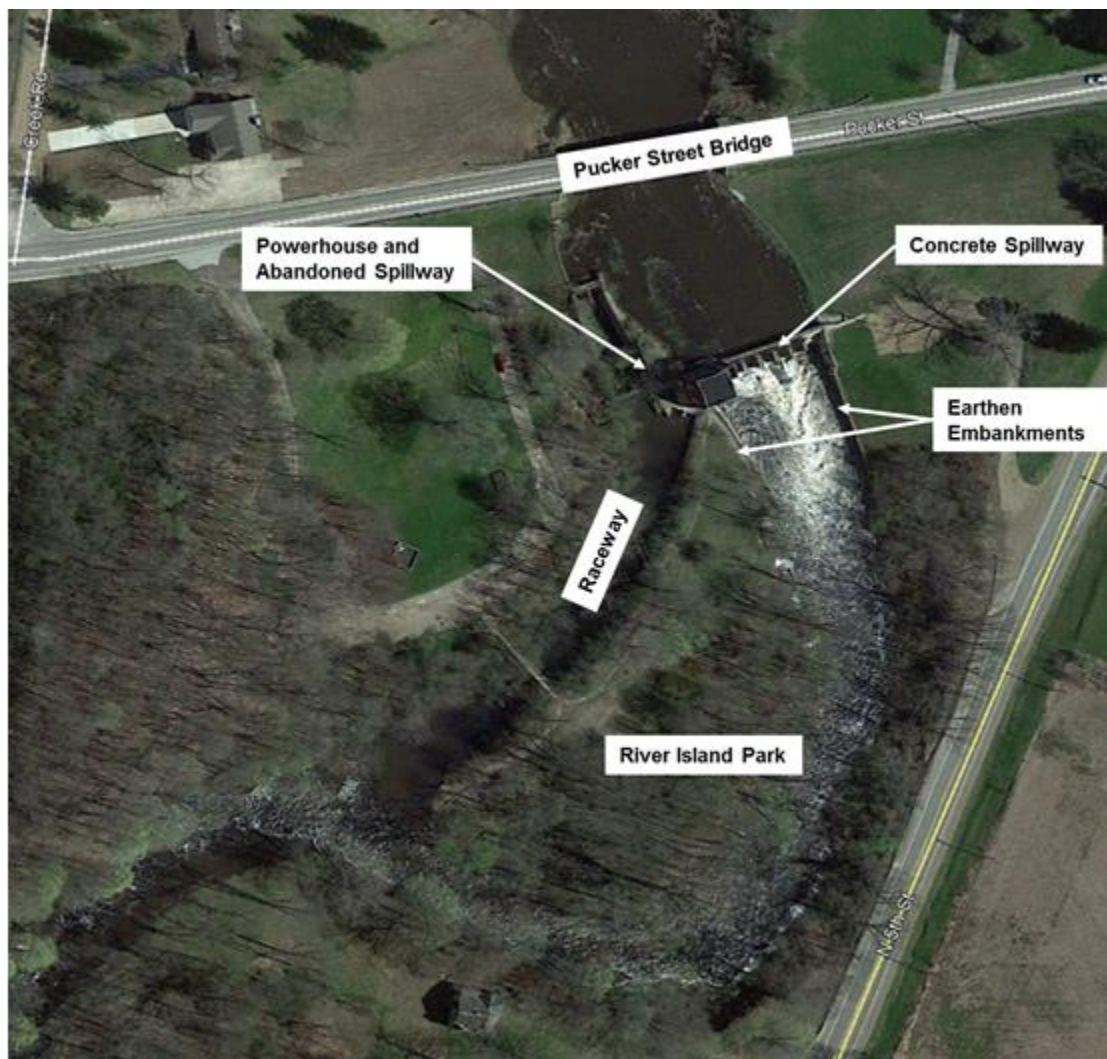
Figure 1-2. Pucker Street Dam Elements

The Pucker Street Dam consists of a short left earthen embankment, a gated concrete principal spillway, a powerhouse section, a concrete and earth fill needle section, an abandoned millrace/spillway and a short right earthen embankment (Figure 1-2). The dam is about 100 feet long and has a structural height of 38 feet. The abandoned spillway consists of two approximately 12-foot wide gated concrete spillway bays and a severely deteriorated concrete-lined channel. The powerhouse has a concrete substructure and a brick masonry superstructure and is 28 feet wide along the axis of the dam.

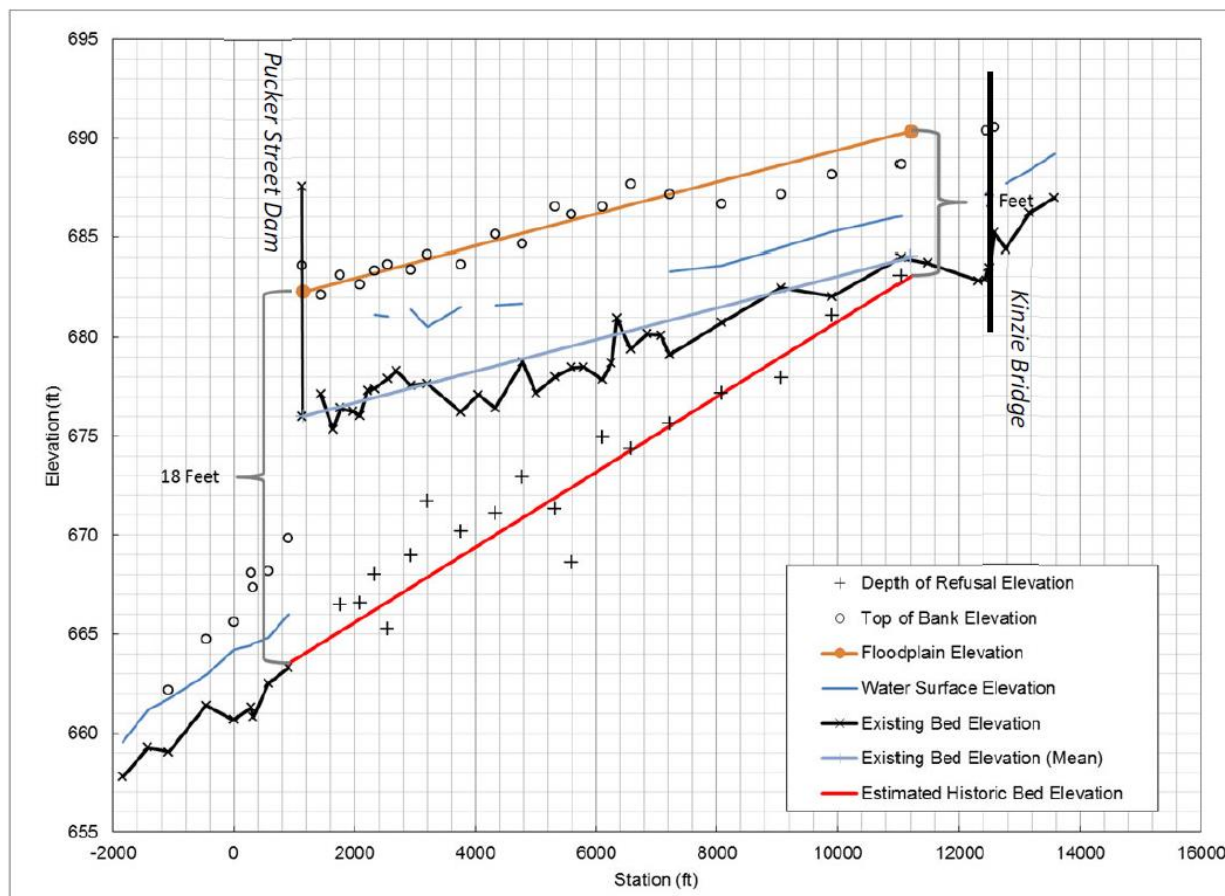
Figure 3-3. Floodplain Longitudinal profile of the Dowagiac River from Kinzie Road to Pucker Street Dam

The downstream end of the Dowagiac River is characterized as having a steeper gradient as compared to the upper reaches. Pucker Street Dam is located within the upper section of the reach containing this steeper gradient (see Figure 1-4). Survey data suggests the steeper slope extends under the Pucker Street impoundment sediments to near Kinzie Road.
