# Syndicate Park Dunes Stabilization and Monitoring Plan

Syndicate Park Sub division, Van Buren  
County, MI

February 16, 2016

Cardno Project No. J151517400

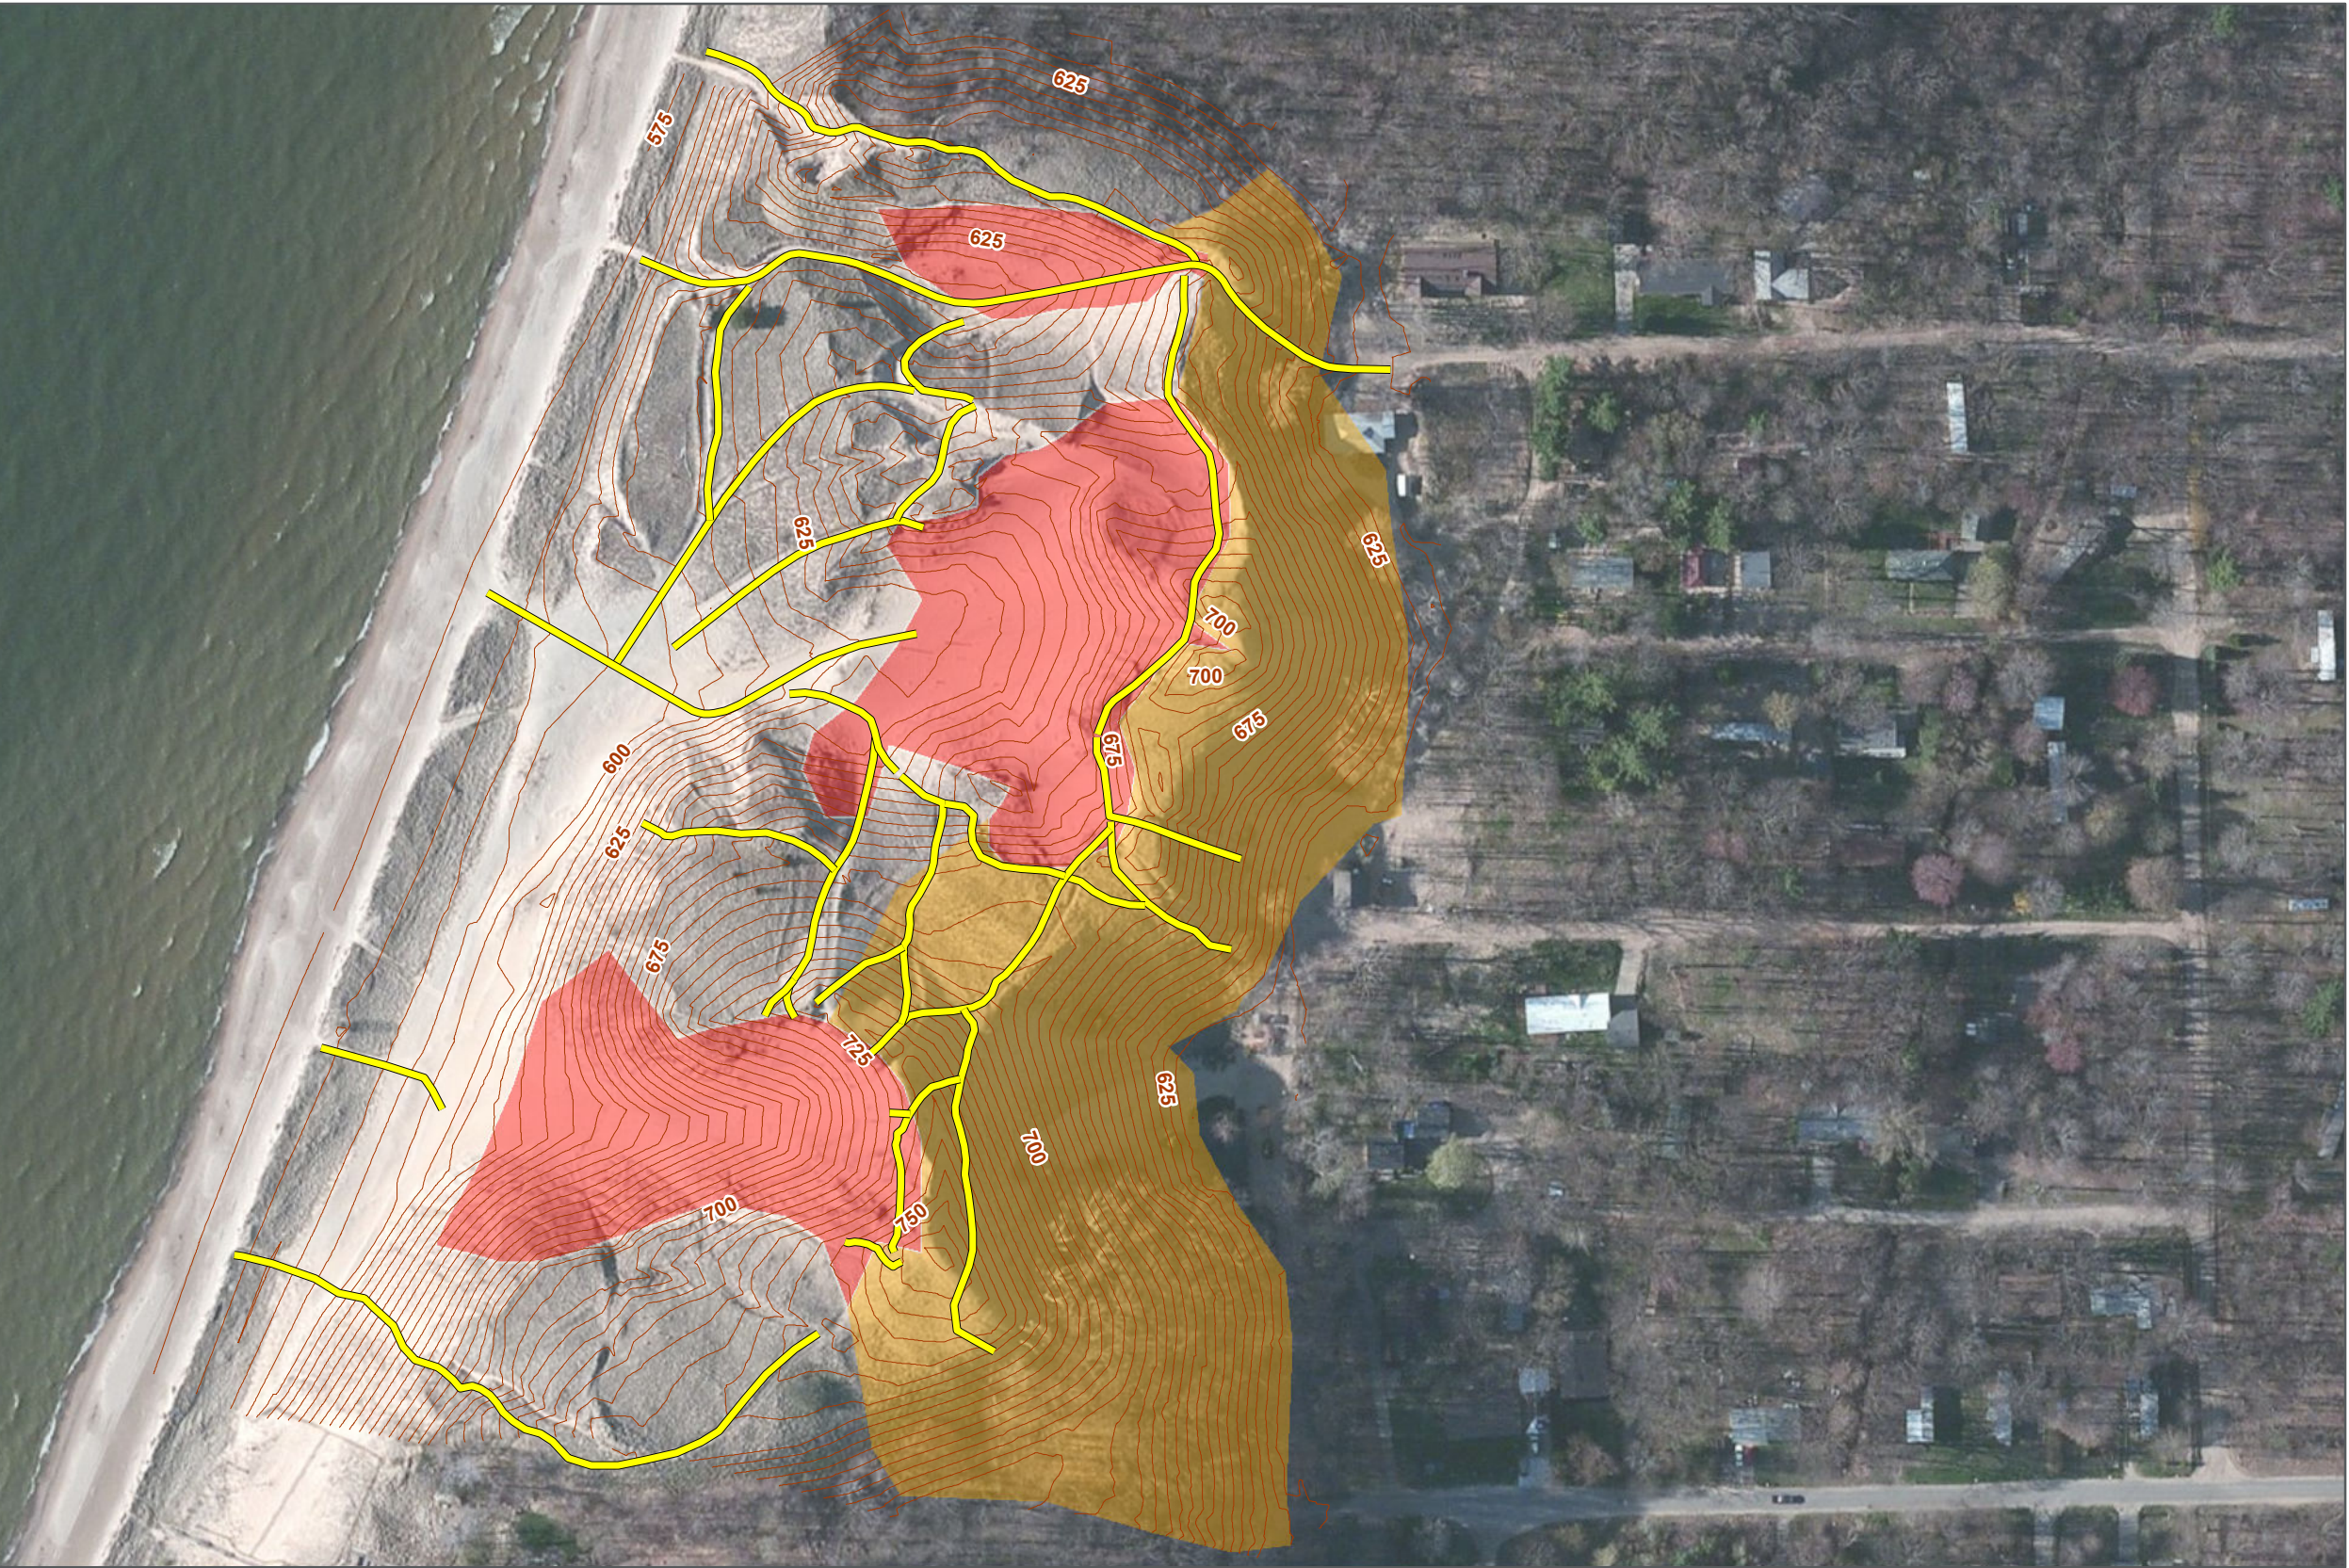
**Figure 1: Existing Conditions**  
**Syndicate Dunes Park**  
**Abonmarche**  
**Van Buren County, MI**

The Syndicate Park Dunes area has been a popular destination for summer recreational activities since at least the early twentieth century. Uncontrolled access to the lakeshore by walking or driving over the dunes through the years has resulted in an extensive network of well-worn and erosive trails (Figure 1). These bare sand trails cut across and along contours contributing significantly to site erosion and degradation by supplying transient materials as well as creating blow-outs and deflation areas. It is critical to the dune stabilization effort to decommission a large portion of these trails and maintain a limited access policy to allow vegetation establishment and inhibit the erosion process.

Three blow-out areas have developed on the west facing side of the dune with corresponding slip faces on the eastern toe of slope. The prevailing wind along the lake shore comes predominantly from the west leaving significant deflation areas where bare sand is currently present along the western aspect. These areas of bare sand without vegetation are a significant source of the material depositing on the slip face and advancing the dune. Additional bare sand areas are the result of access trails where vegetation has been disturbed by foot traffic and ORV passage. These areas are interspersed throughout the site along contours and across contours contributing heavily to the erosion process.

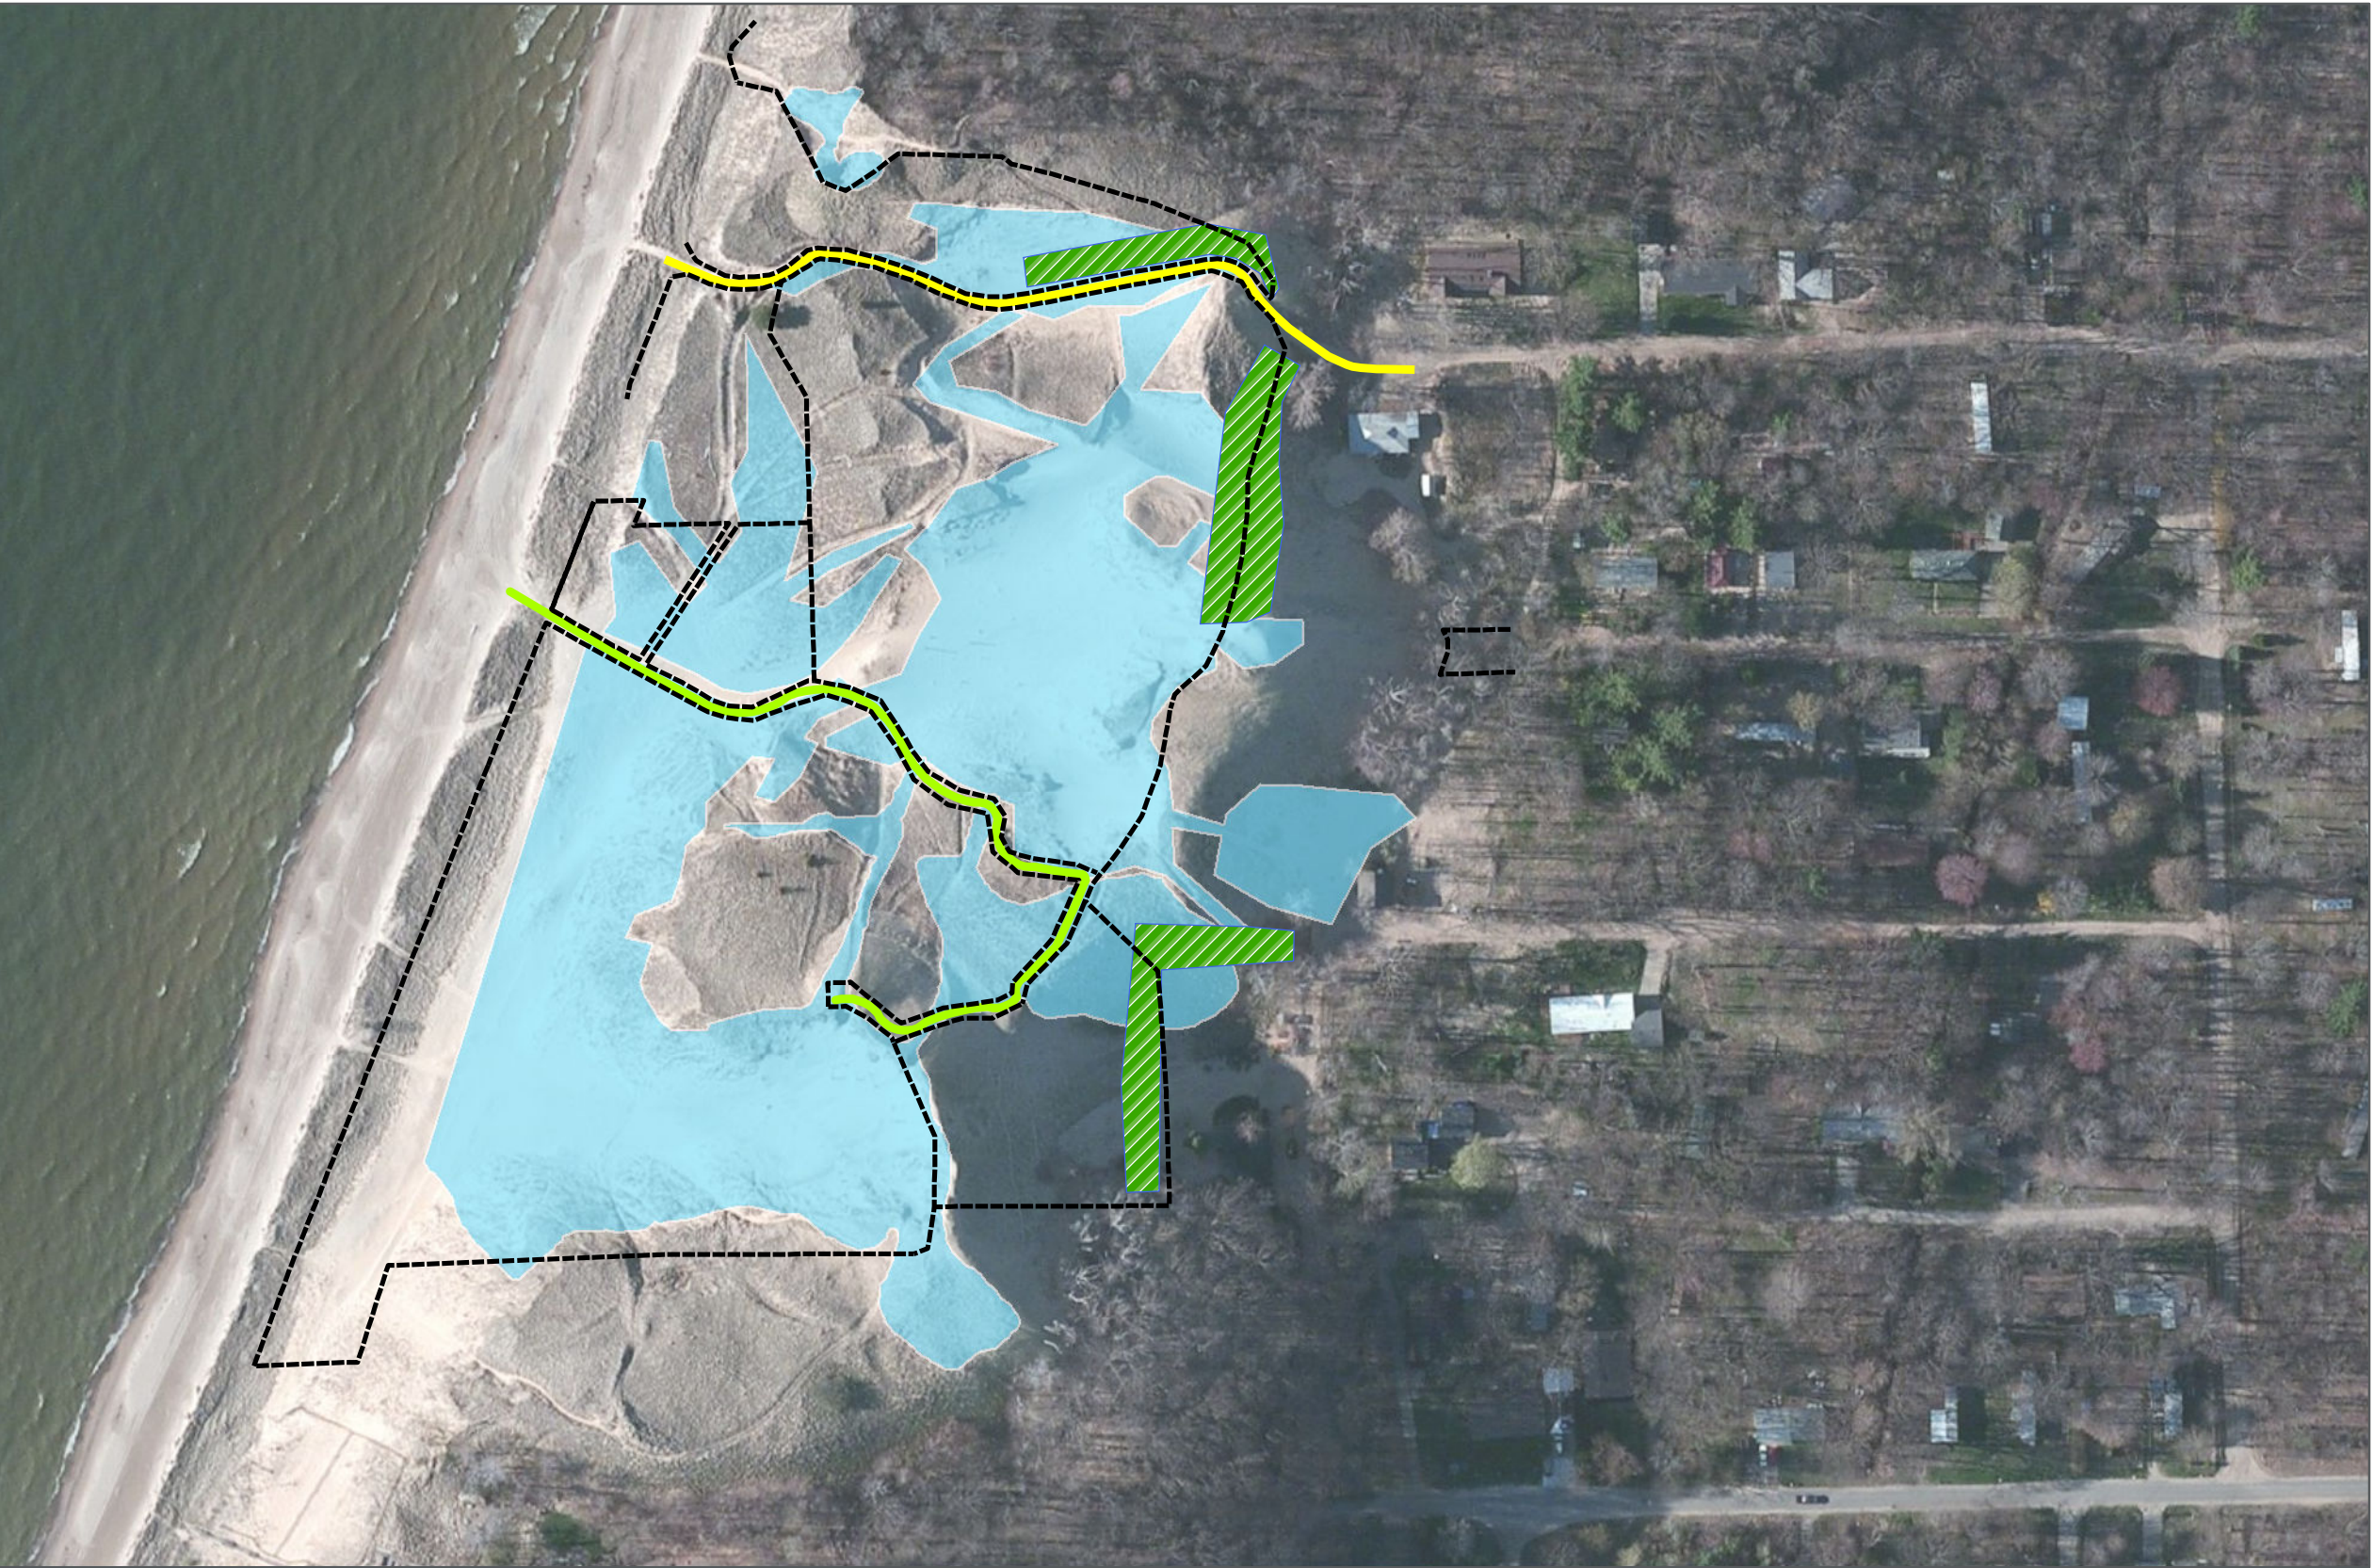
**Figure 2: Planting Plan**  
Syndicate Dunes Park  
Abonmarche  
Van Buren County, MI

Vegetation establishment is the most effective and sustainable method of stabilization in an active dune landscape. Well established root mat structures hold fast sand and soil particles while the above surface structure of the plant attenuates the erosive energy of the wind against once bare surfaces. Fencing or permanent structures may be erected to manipulate wind currents and material deposition. These structures will eventually be covered over by deposition or may require repeated maintenance and upkeep. Physical structures serve best as a supplement to vegetative restoration and carefully managed access trails. Refer to section 4 (Planting Plan) of this report for details regarding the installation location and species list.

The continuation of public access to the resource is however a key project objective and therefore necessitates the continued use of a portion of the trail network. Two existing trails will be retained and improved (Figure 3) and these will represent the only public access to the active dune areas. The remaining trails will be fenced at entrance and exit points excluding access to allow vegetation establishment. Recreational access and activities in The Syndicate Park Dunes area has not been historically excluded from the slopes of the dune. Exclusionary fencing will be erected to limit access to the dune slopes (Figure 2, 3, 4) to similarly allow vegetation to establish and stabilize the dune.
