PROJECT COMPLETION FINAL REPORT

WATERVLIET DAMS REMOVAL PAW PAW RIVER, MICHIGAN

March 5, 2014

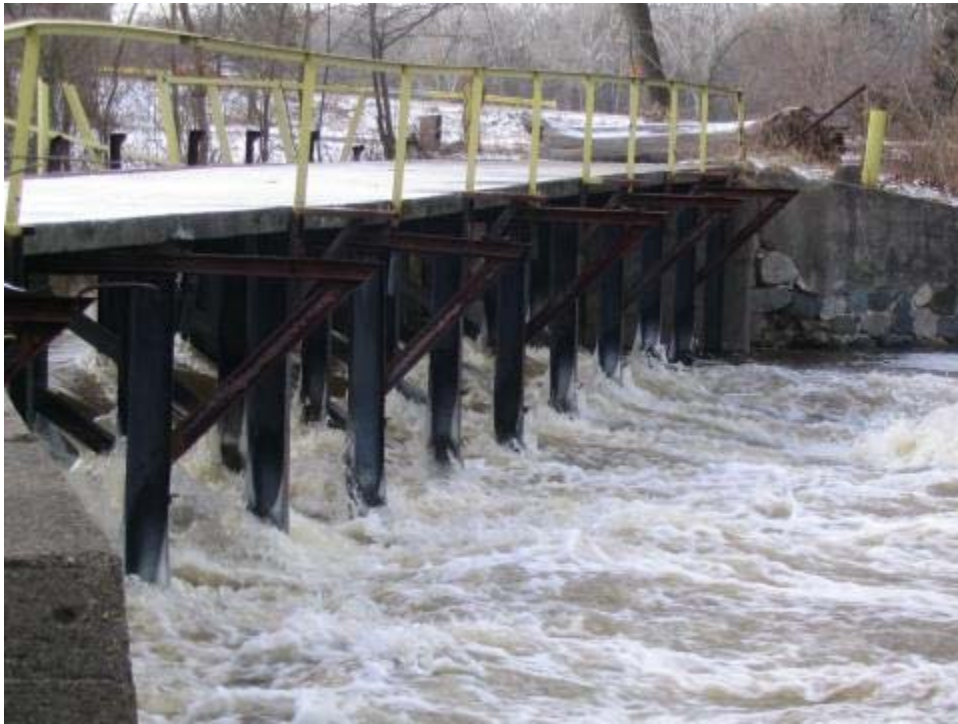
Figure 4-1. Spillway dam prior to acquisition by Berrien County in 2000 showing infrastructure that was removed prior to dam removal.

At the time of project conception and funding in 2010, the dams and related infrastructure had been substantially altered to address public safety concerns and conduct brownfield remediation activities. The spillway dam supported a road deck and utilities above the concrete spillway in addition to supporting stop logs (Figure 4-1). The steel super structure and utilities were removed in 2002. The remaining structural components in 2010 included the concrete spillway, concrete abutments, and cobble-stone/concrete wing walls (Figure 4-2). Portions of the steel super structure embedded in the concrete abutments and spillway were still present and protruded from the concrete. The former power house and mill race located west of the spillway dam had been demolished and the mill race filled with soil. The spillway

dam could not be used for impounding water above the spillway elevation at the start of the project in 2010.

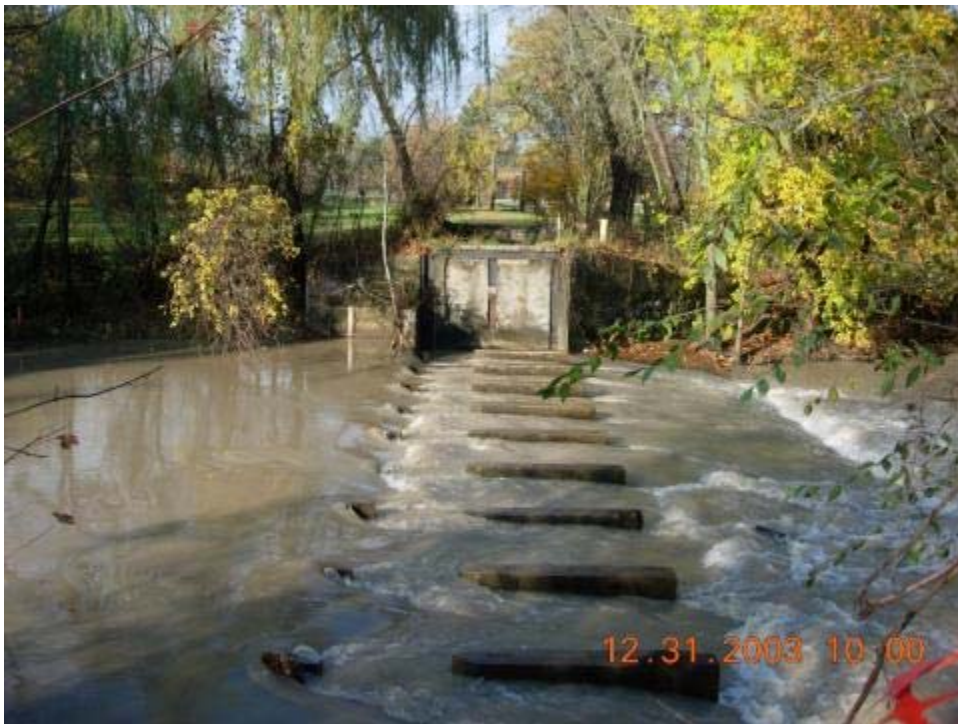
Figure 4-2. Spillway dam at initiation of dam removal design/funding.

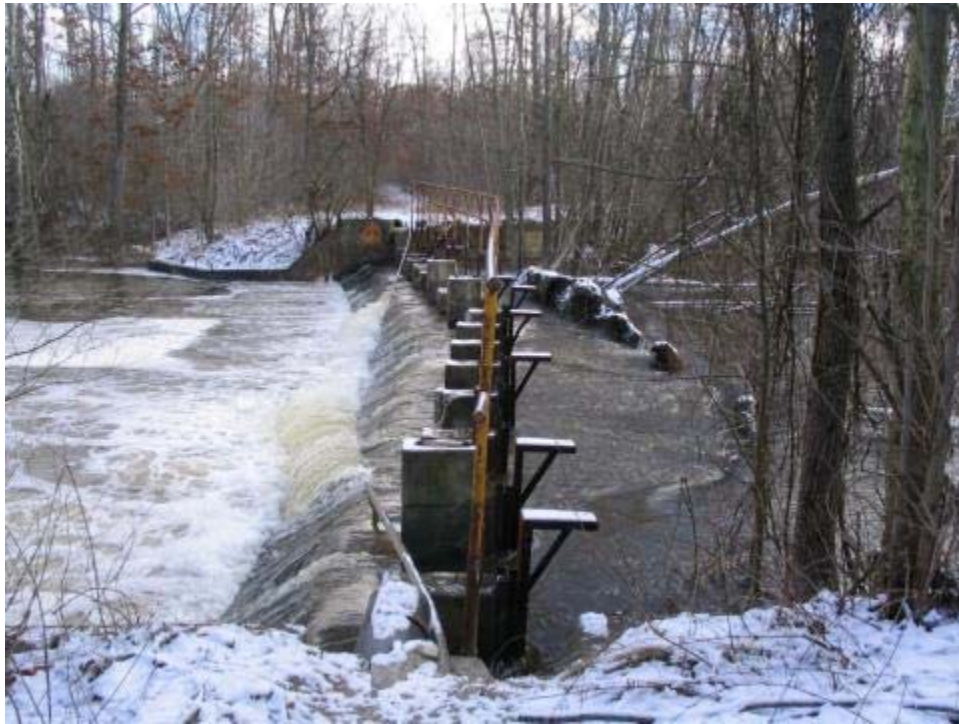
Figure 5-1. Diversion dam prior to acquisition by Berrien County in 2000 showing utilities that had been removed prior to dam removal.

The diversion dam also supported a steel super structure and utilities, although the structure appears to have only supported a catwalk for foot traffic (Figure 5-1). By 2010 the utilities and catwalk had been removed. The remaining structural components present in 2010 included the concrete spillway, concrete abutments, concrete wing walls, catwalk support framing, and guardrail (Figure 5-2). The diversion dam was not used for impounding water; therefore, it did not contain a steel superstructure for support gates or stoplogs.

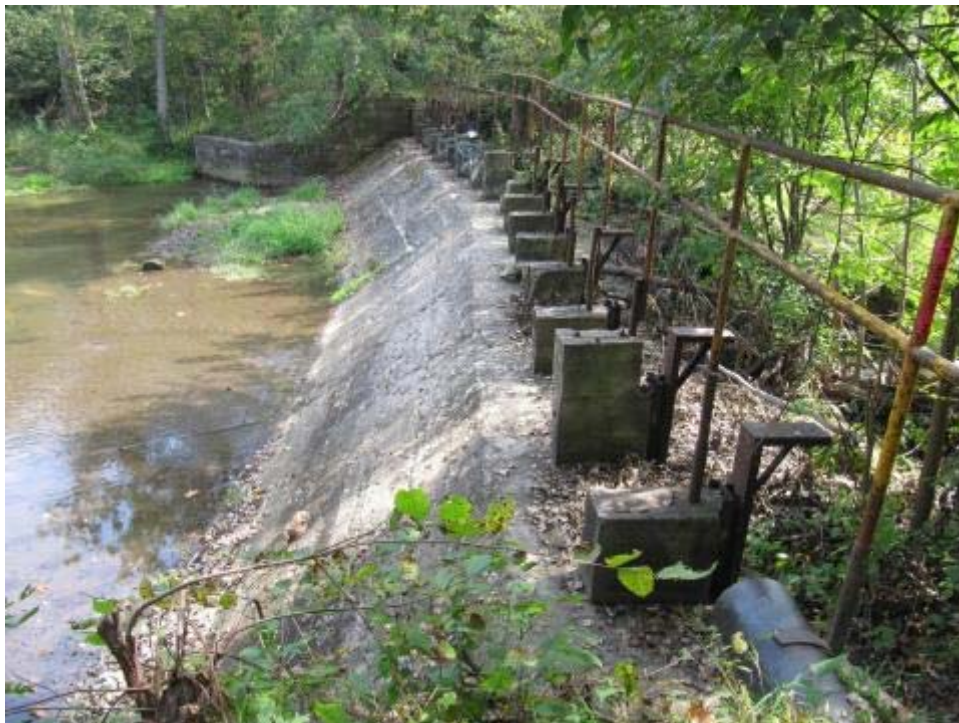
Figure 5-2. Diversion dam at initiation of dam removal design/funding.

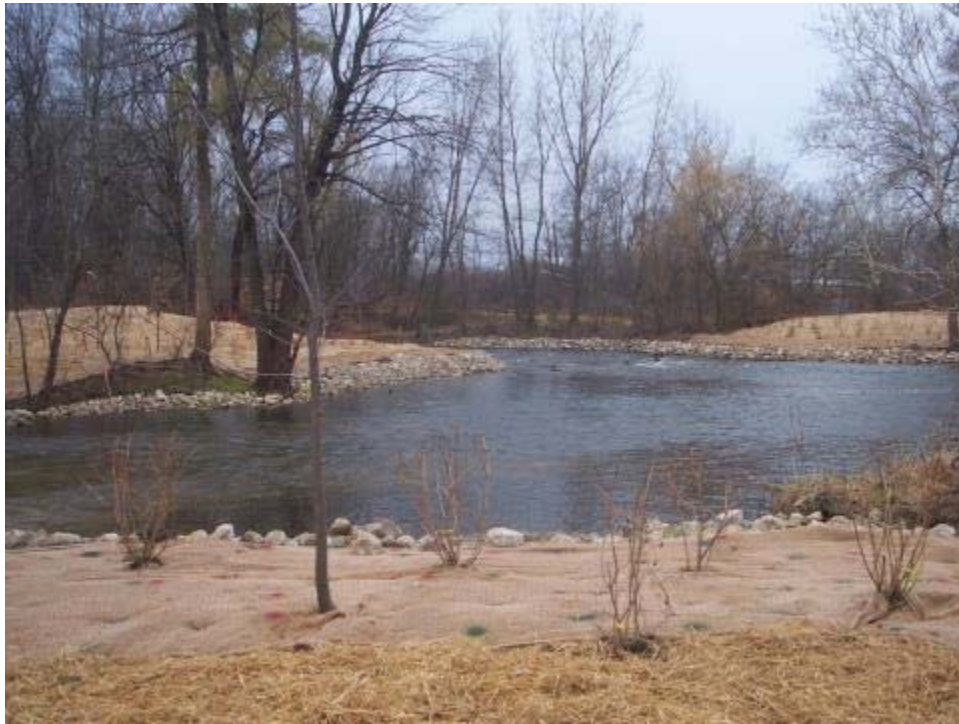
Figure 6-1. Historic channel (left) and spillway dam (center) constructed riffles and bankfull benches after dam removal.

The Watervliet dams removal and restoration project included complete removal of both dam structures below the streambed, concrete abutments, and concrete/cobble stone wing walls (Figures 6-1 and 6-2). Streambanks, constructed bankfull benches, and disturbed areas were planted with native grasses, forbs, shrubs, and trees. Due to removal of the diversion dam, continuous flow under all flow regimes was restored to the historic channel. Three constructed riffles and armored bankfull benches were used to fix the bed elevations and channel dimensions at the two former dam locations and at the downstream end of the historic channel. The width of the channel at the two former dam sites was greater than the bankfull width of the Paw Paw River in the vicinity of the project. The riffles and armored bankfull benches fixed the dimensions (i.e. width and depth) of the channels and the amount of flow that would naturally split between the two channels. The design channel dimensions and bed elevations were based on a flow split of 20% to the historic channel and 80% to the southern channel under the bankfull discharge. However, the flow split will vary with total stream discharge and stage. Based on design, target fish species should be able to freely swim through all three riffles, the historic channel, and the mill race. Monitoring was conducted to confirm successful restoration of fish passage. Monitoring results are document in a separate monitoring report.

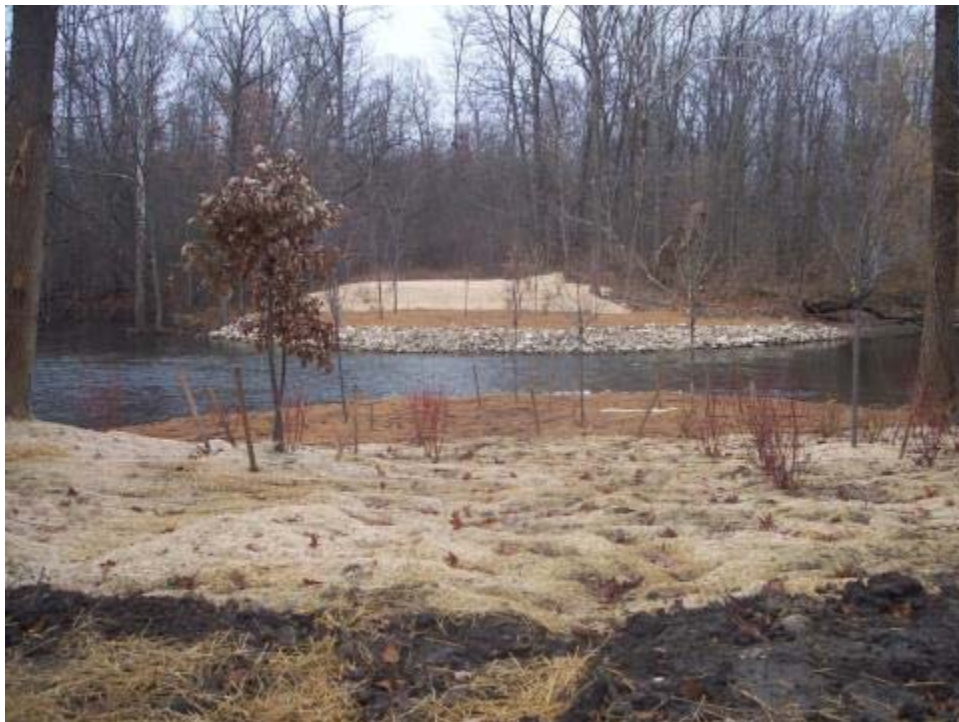
Figure 6-2. Diversion dam (center) constructed riffle and bankfull benches after dam removal.

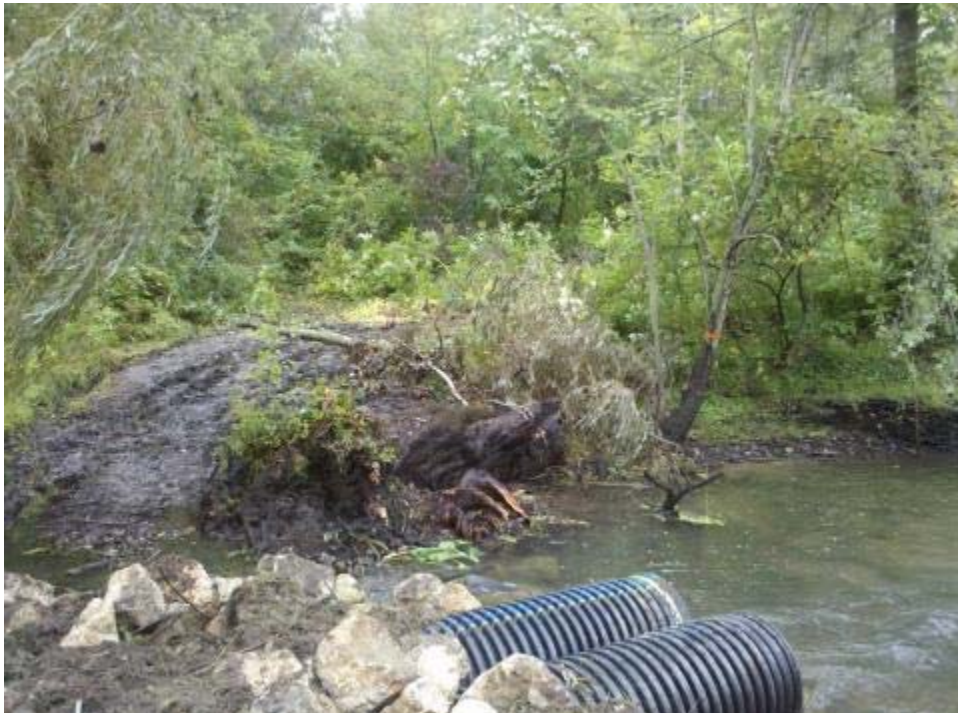
Historic channel crossing preparation - culvert installation.

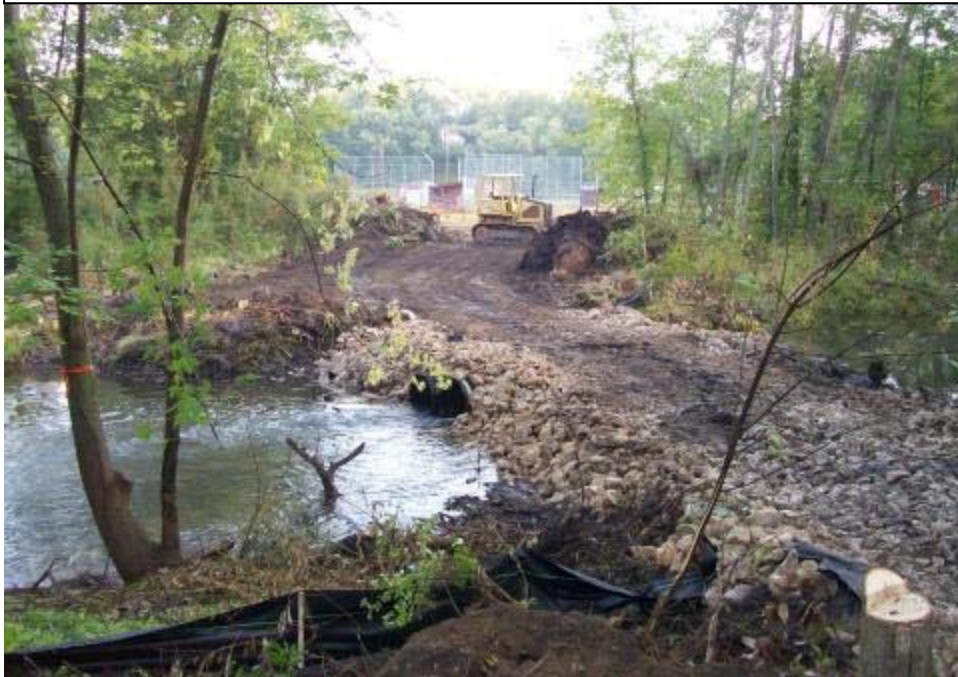
Historic channel crossing.

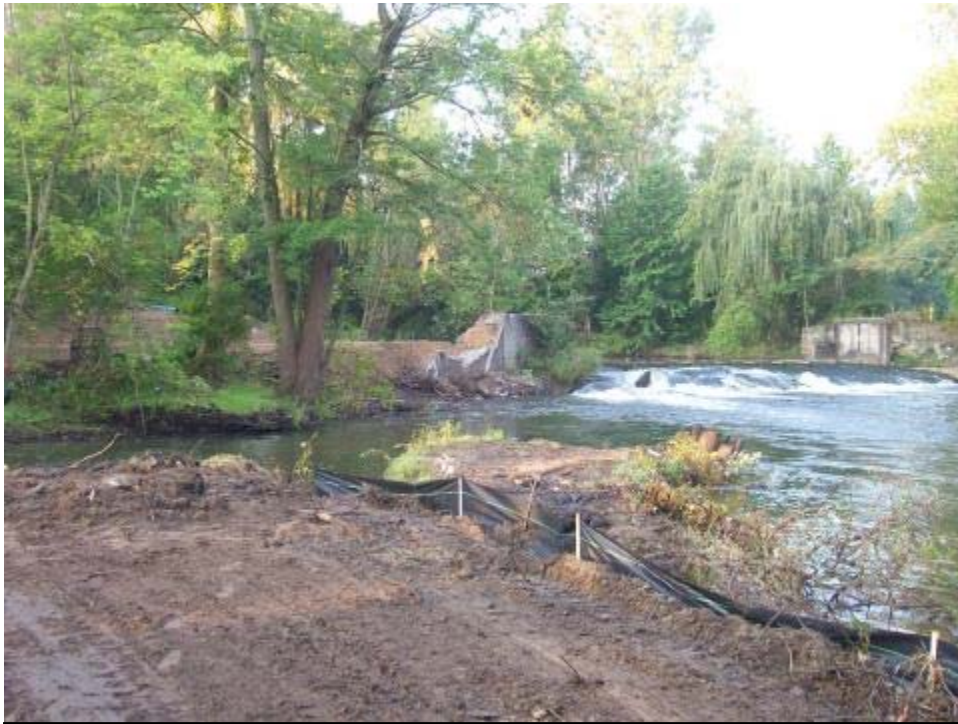
Start of spillway dam east wingwall and abutment demolition.

Dam demolition work began at the east end of the spillway dam on September 21 with excavation of the earthen dike and demolition of the wing walls and headwall to the elevation of the concrete spillway.

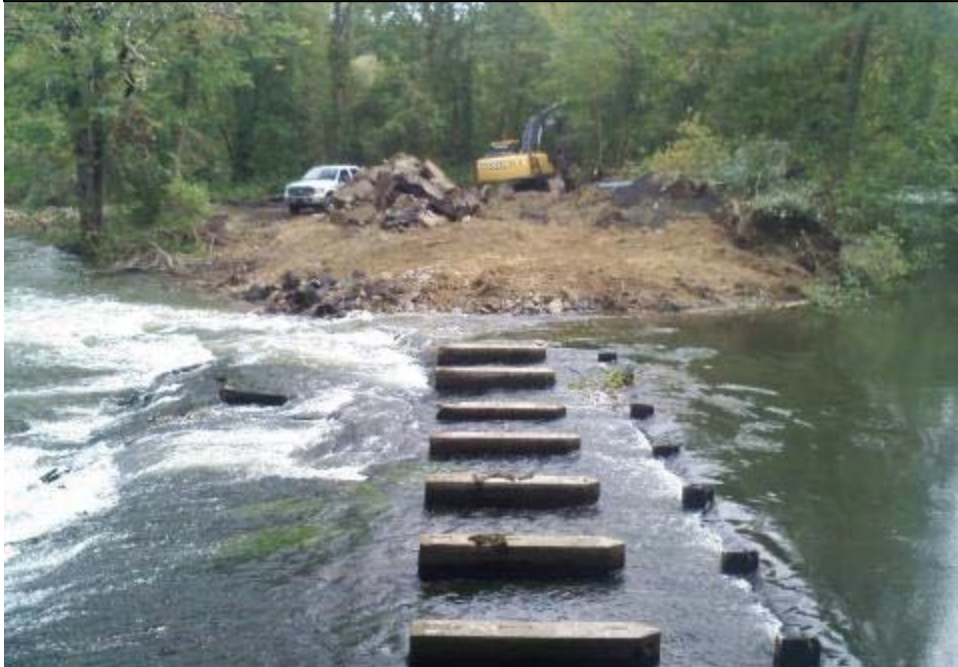
Spillway dam east wingwall and abutment demolition to sill.

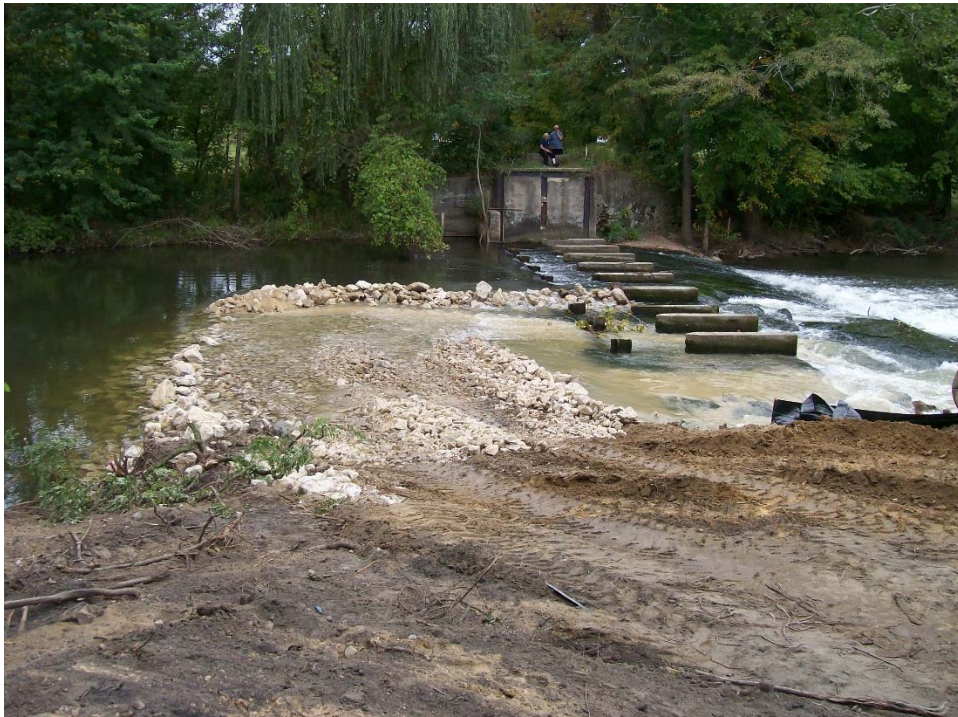
Installation of upstream and downstream rock cofferdams at spillway dam.

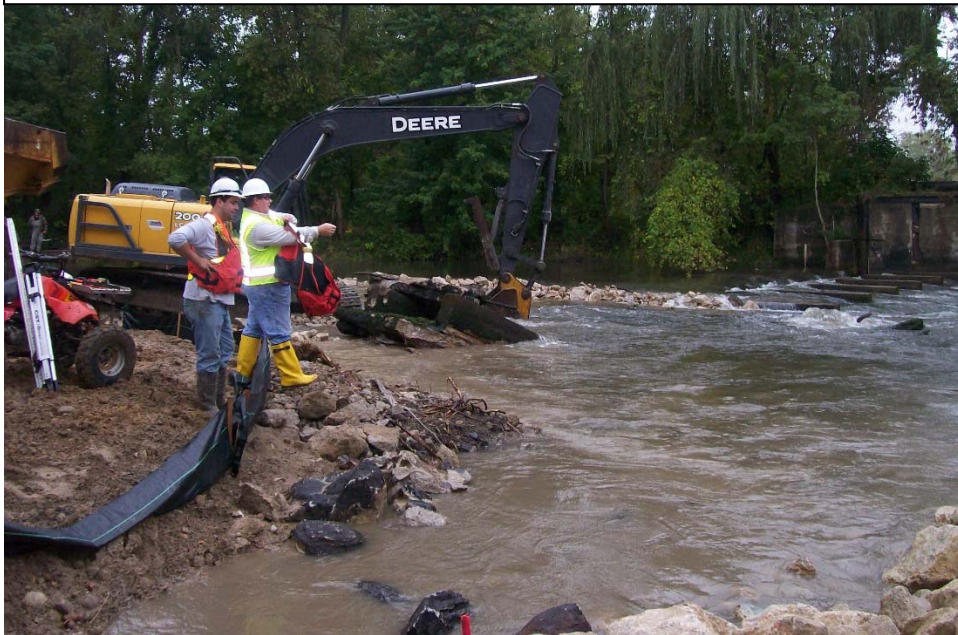
Start of spillway dam removal, east half - 9/28/2011.

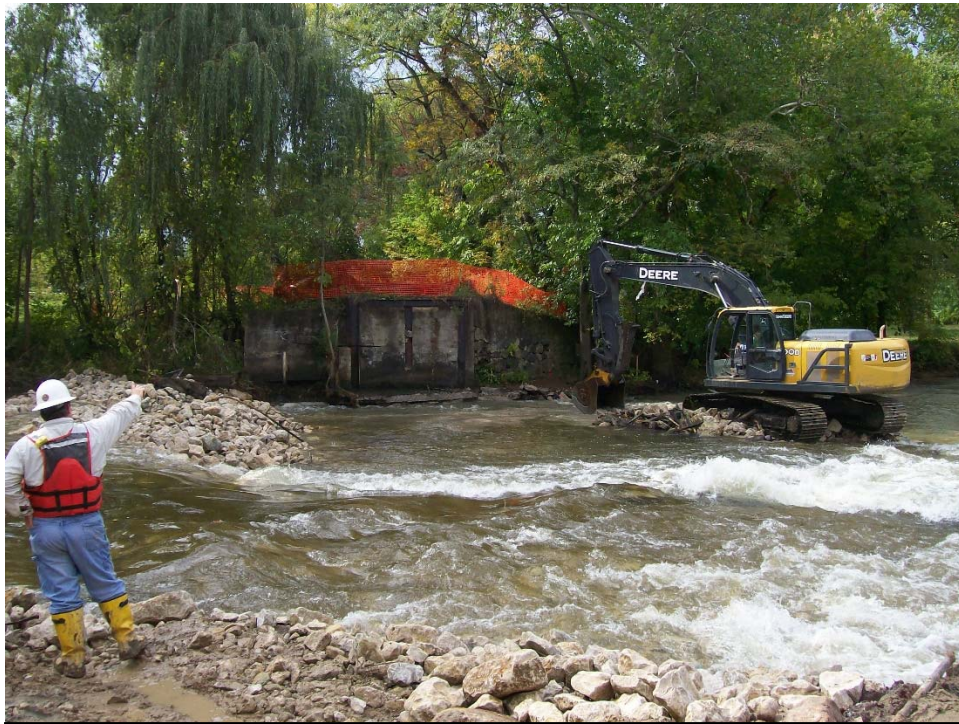
Removal of spillway dam, west half - 9/28/2011.

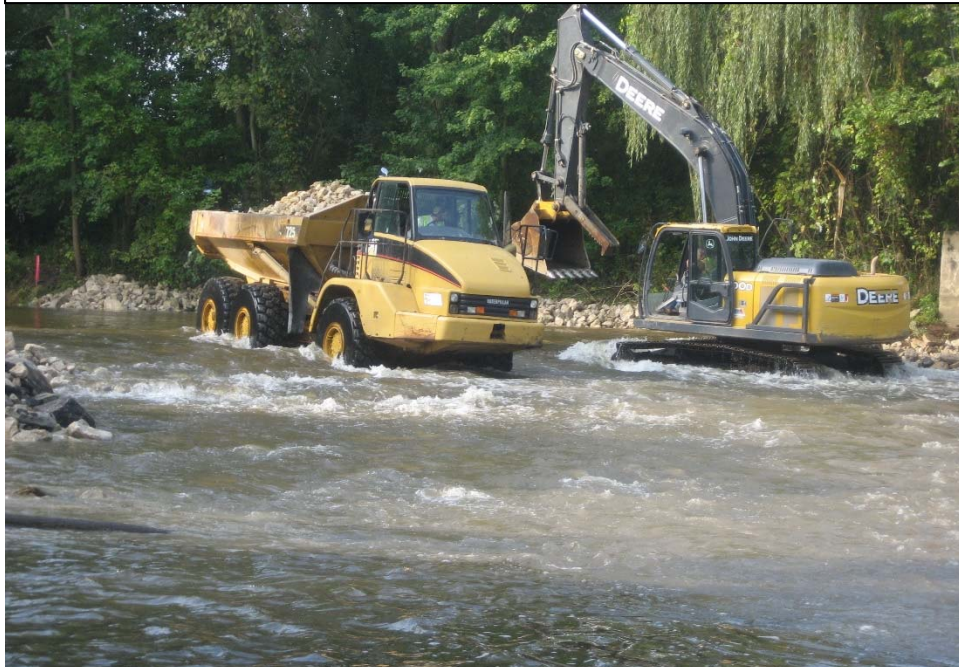
Installation of spillway dam riffle.

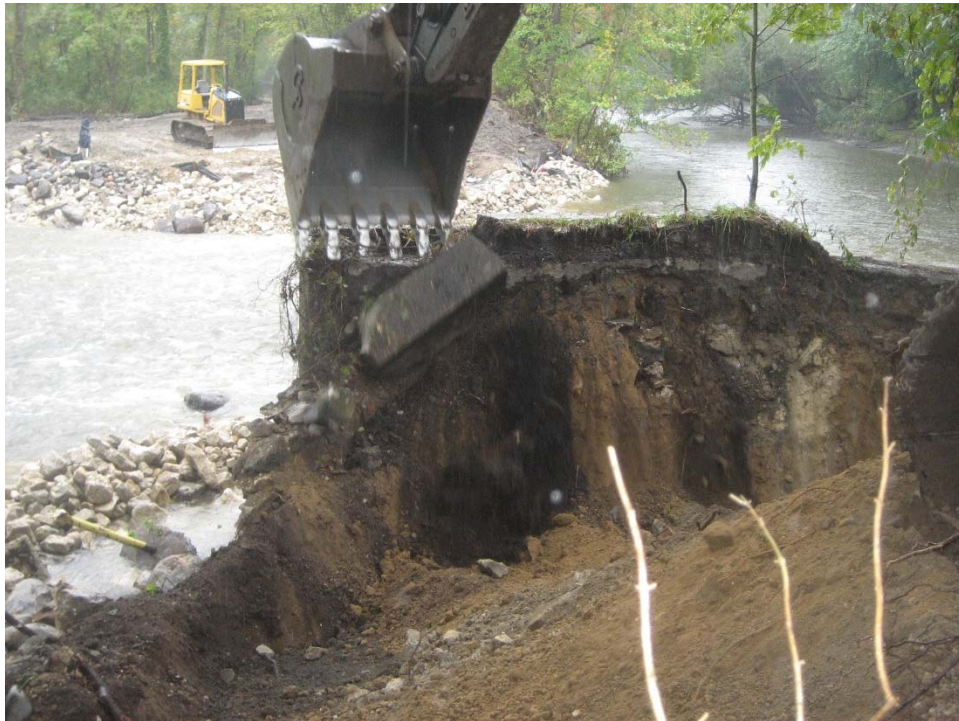
Removal of east wingwalls and abutment at spillway dam.

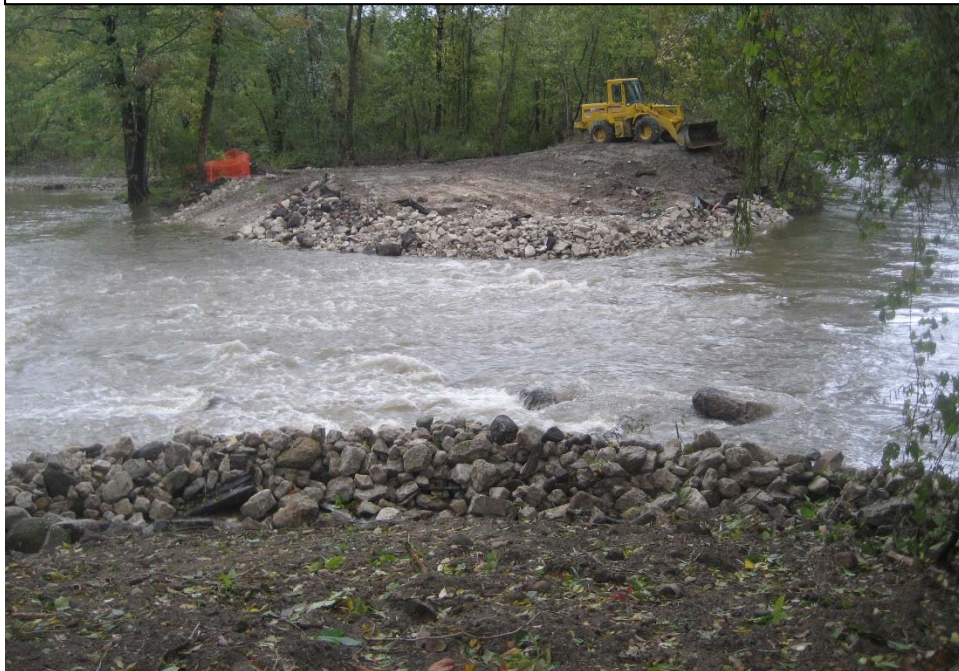
Completed spillway dam cross-section after removal - 9/30/2011.

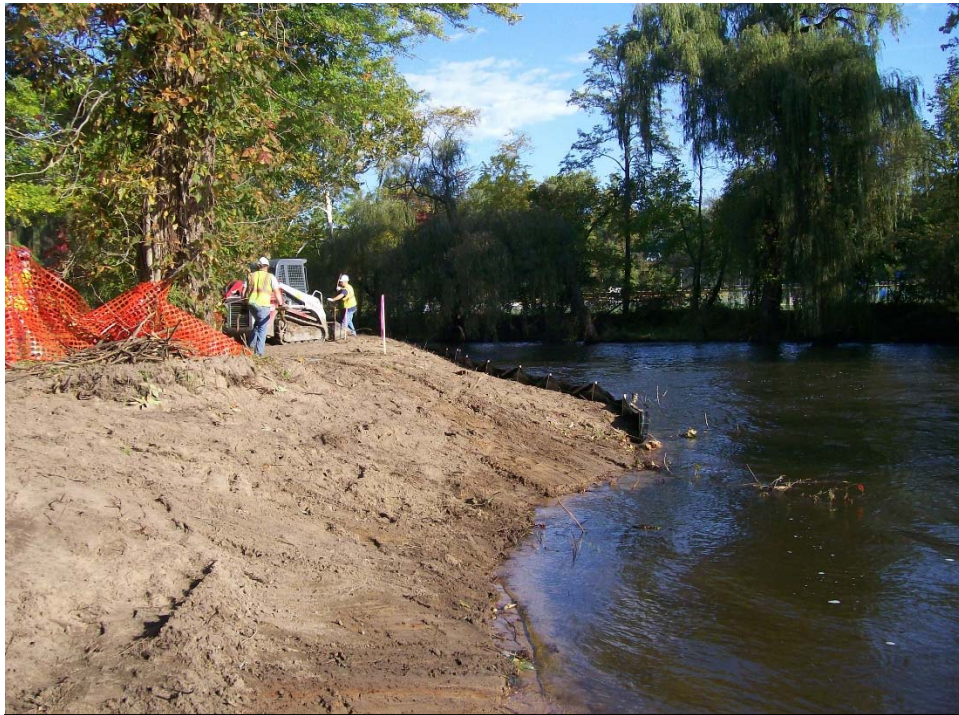
Spillway dam start of streambank grading and stabilization.

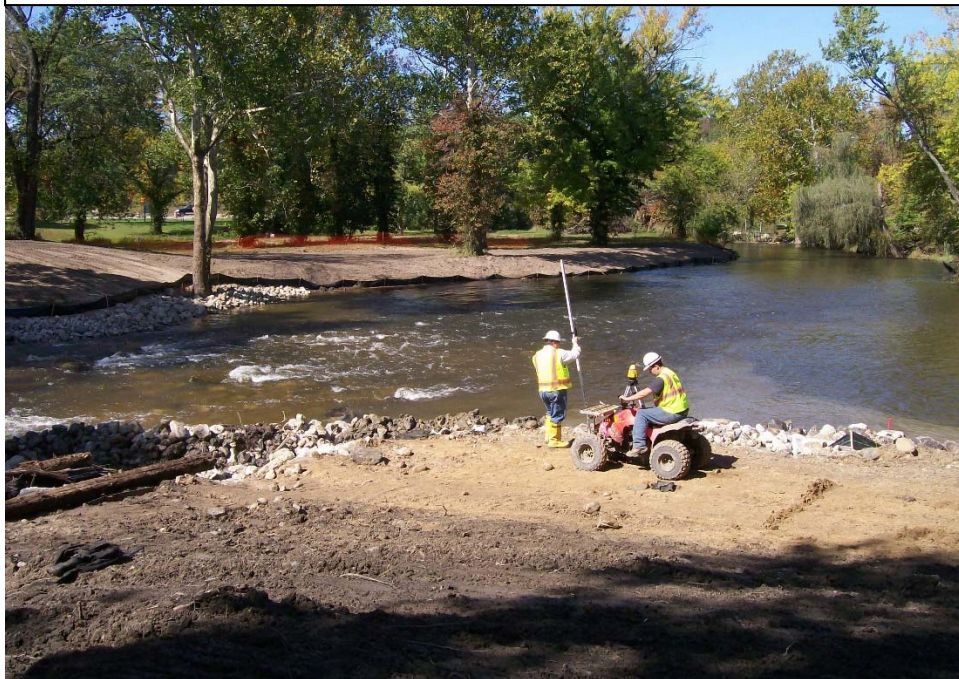
Spillway dam bankfull bench grading can construction.

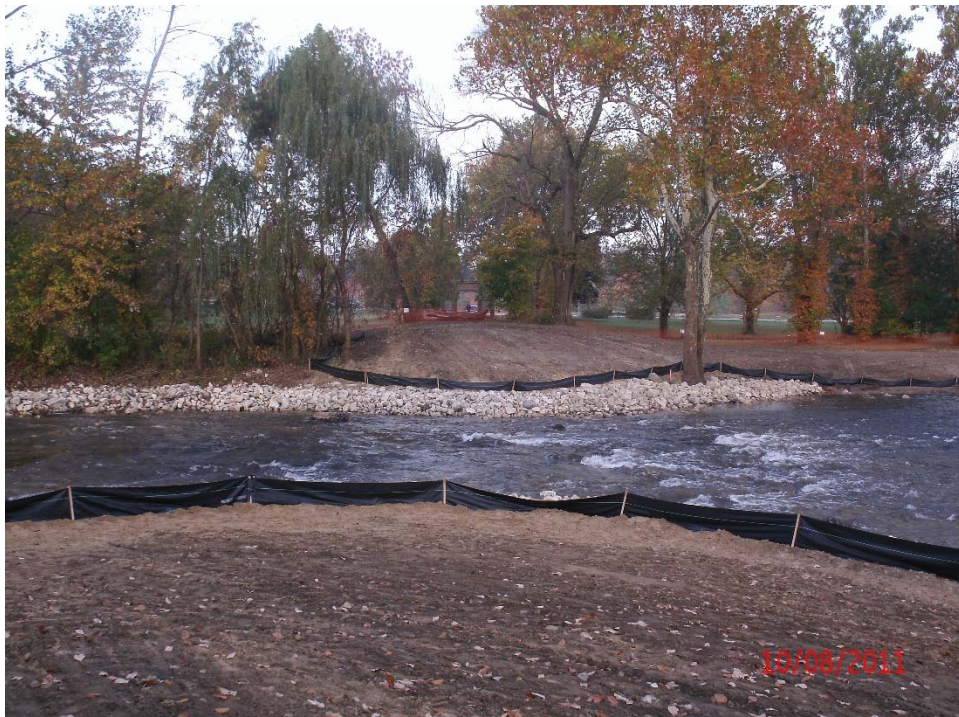
Spillway dam restoration completed, prior to landscaping.

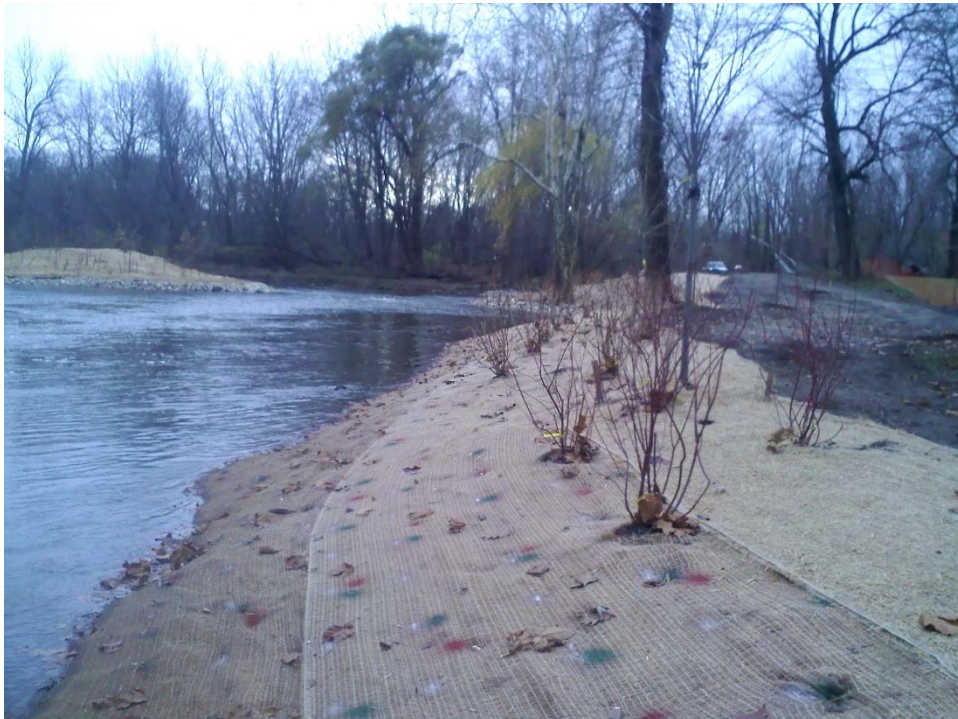
Completed streambank stabilization and landscaping - 11/18/11.

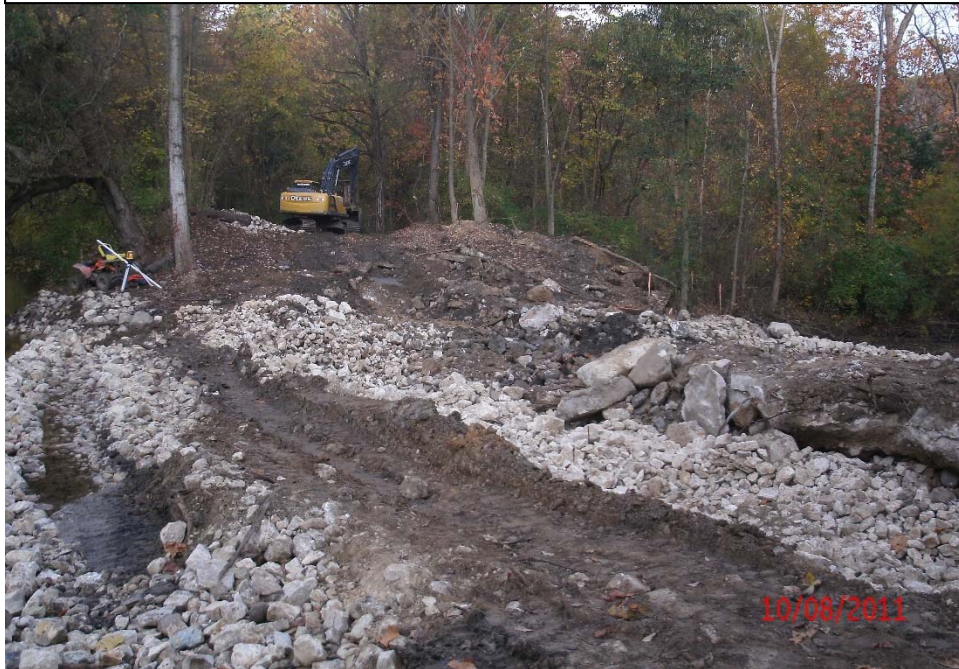
Diversion dam upstream rock cofferdam installation - 10/8/11.

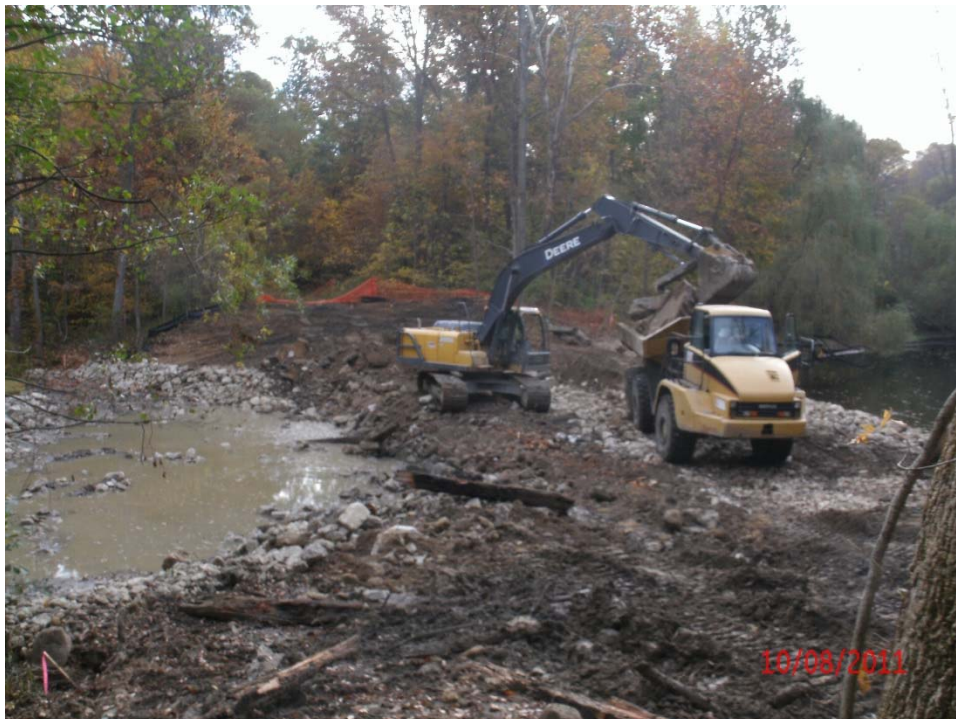
Start of diversion dam removal - 10/8/11.

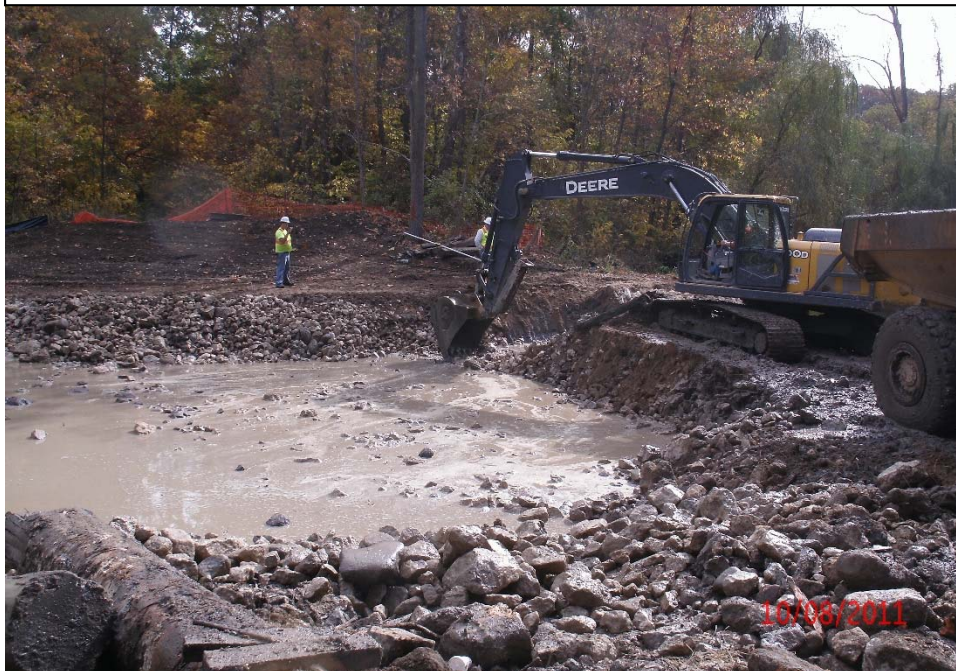
Start of diversion dam cofferdam breach - 10/8/11.

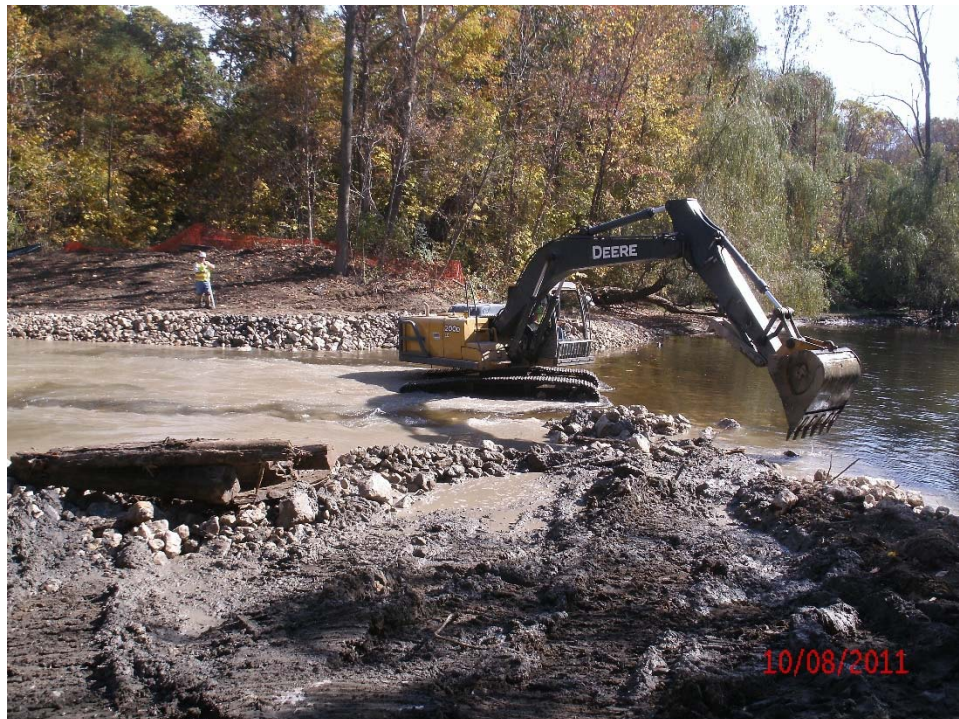
Diversion dam riffle installation - 10/8/11.

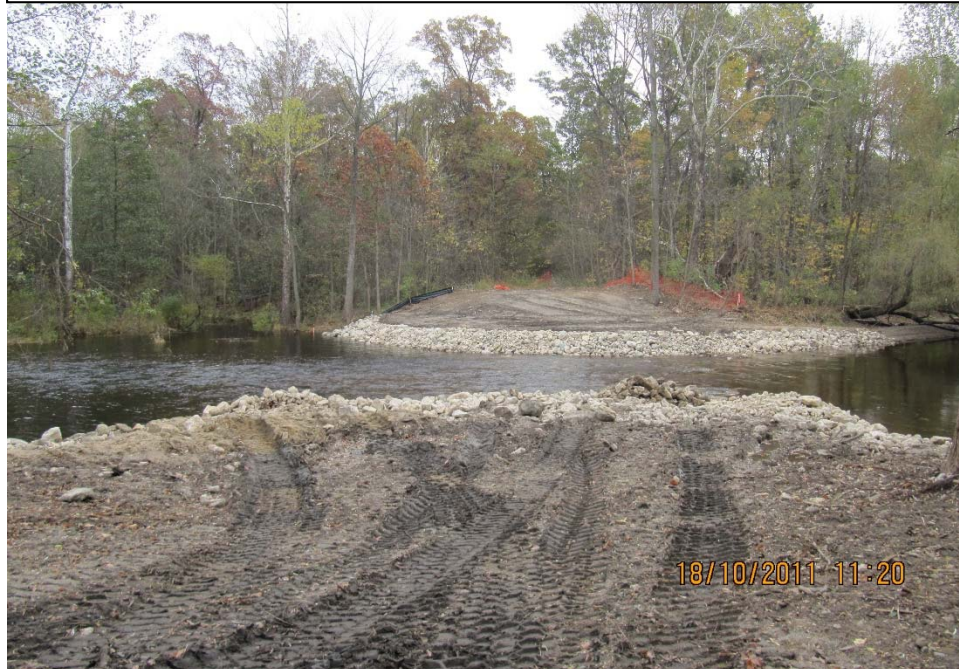
Diversion dam cross-section following removal - 10/18/11.

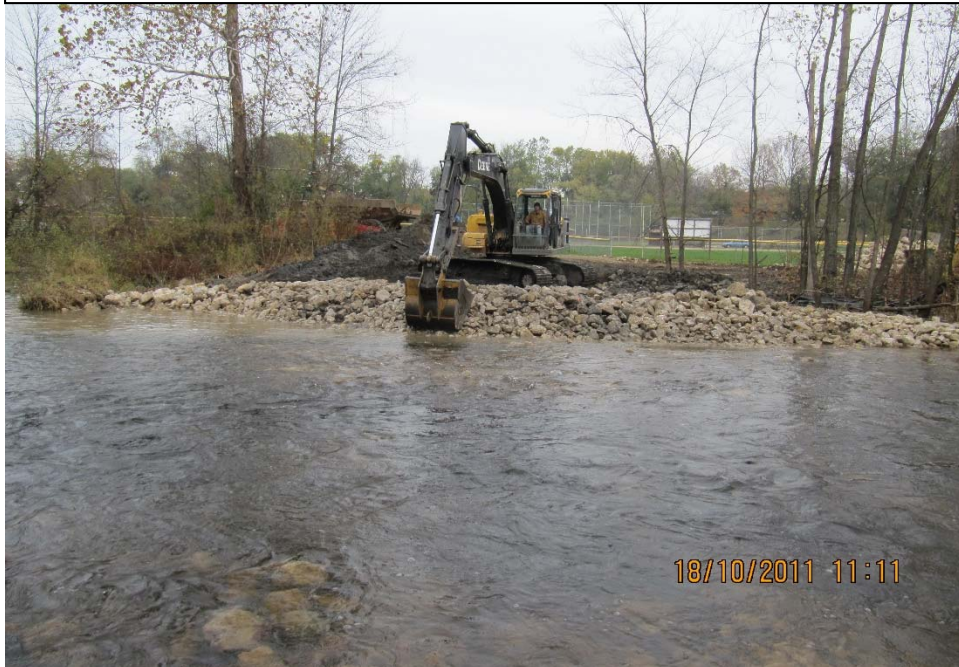
Start of historic channel bankfull bench and riffle construction - 10/18/11.

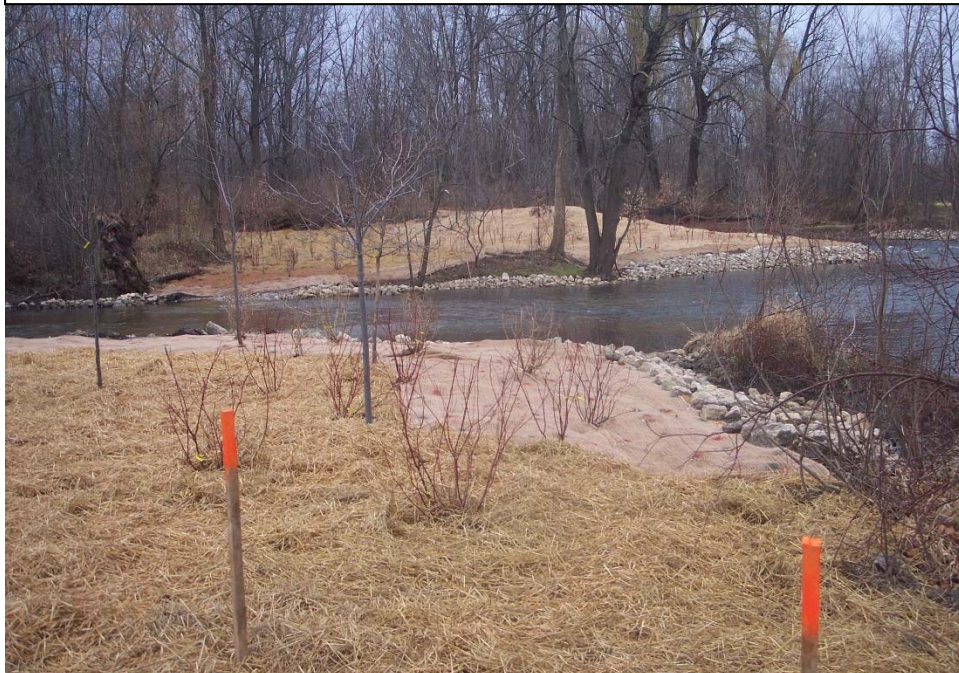
Completed historic channel restoration - 11/22/11.
