Dowagiac River Restoration

Final Assessment Report

June 27, 2013

Inter-Fluve, Inc.
301 S. Livingston St., Suite 200
Madison, WI 53703
608-441-0342

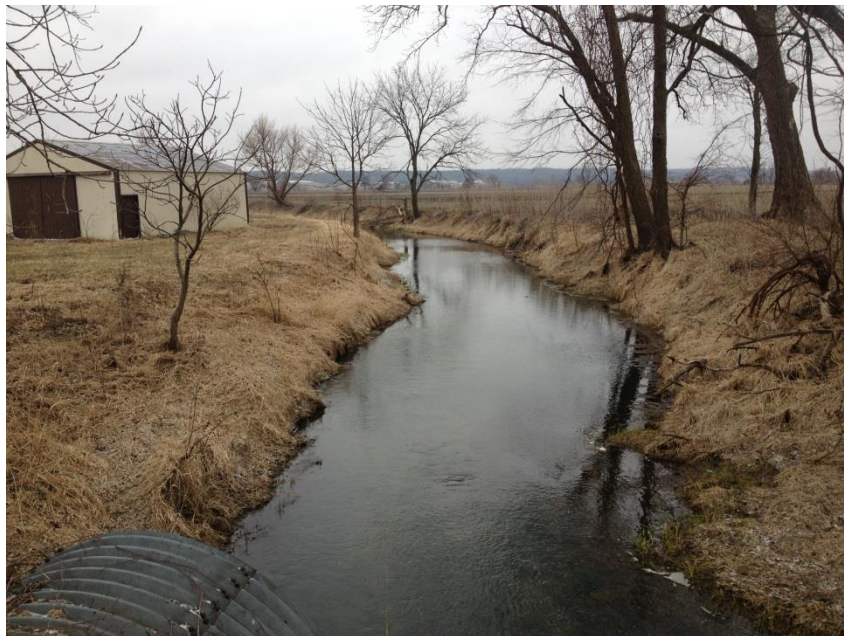
At Old Swamp Rd., Near Decatur – A small tributary enters along the road showing some signs of erosion, the channel is extremely low gradient with little capacity to transport sediment that gets into the channel. This location is just below Pickeral Lake, noted as the area where the historic dredging project occurred.

Figure 14: The Dowagiac looking downstream at Old Swamp Rd.

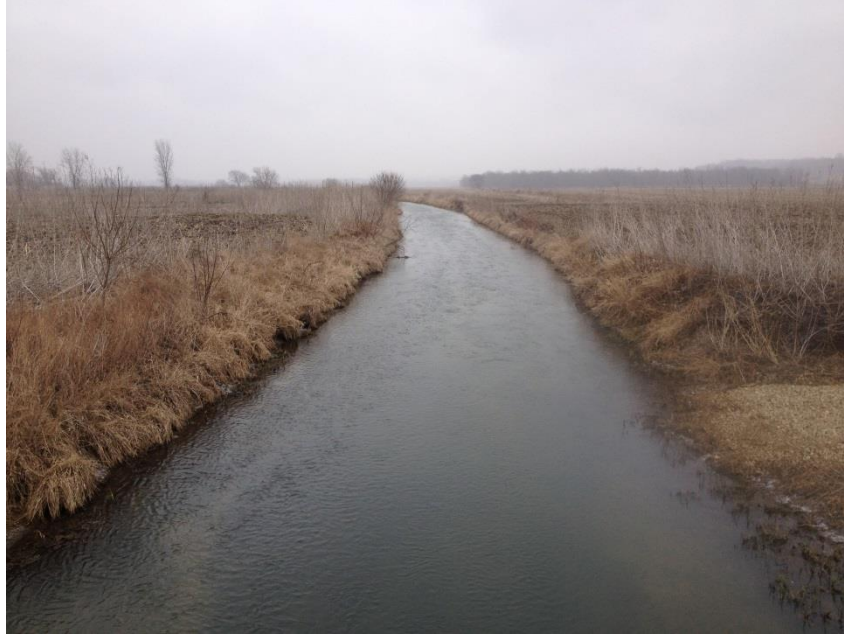
46th Street Bridge – A continued low gradient channel, evidence of some frequent dredging of the channel exists. The channel itself is stable and not contributing sediment from the banks

Figure 15: Looking upstream from 46th street

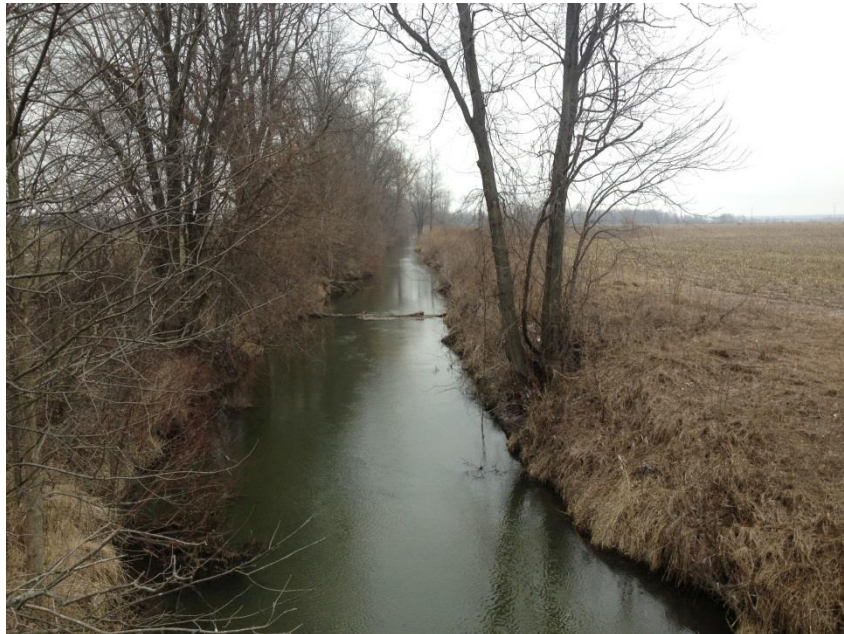
CR 215 / Glenwood Rd. Bridge – Trees are more prolific along the channel here, but the general cross section is maintained. Bed material appears to be sand and fine material, consistent with a wetland channel.

Figure 16: Dowagiac River at CR 215

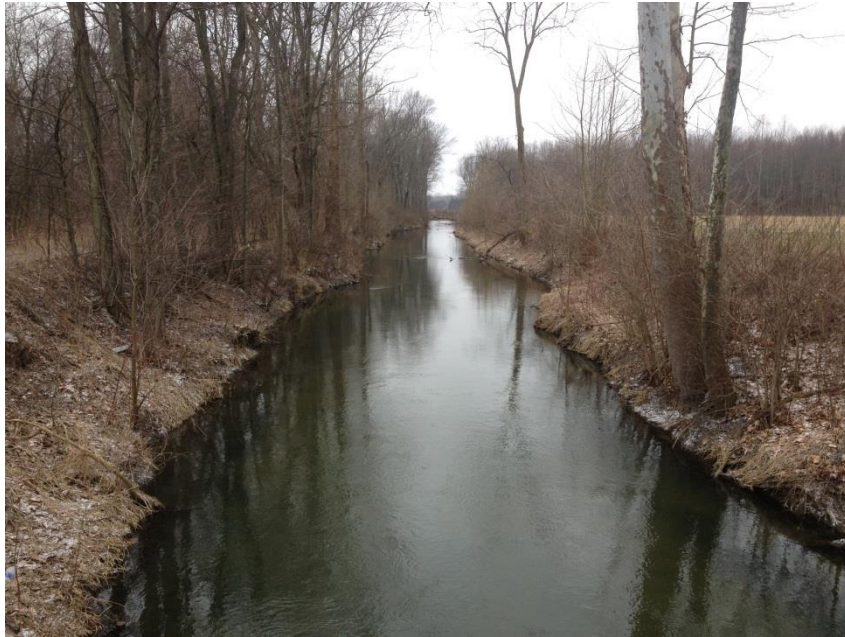
Twin Lakes Rd. Bridge – Trees continue in this section, the channel appears to gain some width here and the adjacent landscape indicates a transition out of the swamps of the upper watershed. The bed is largely sand and fines with no gravels apparent. Bank height begins to increase slightly.

Figure 17: Twin Lakes Rd. - trees and banks indicate a stable channel section. Periodic dredging may still occur here, evidenced by the lack of trees along the right bank in the photo

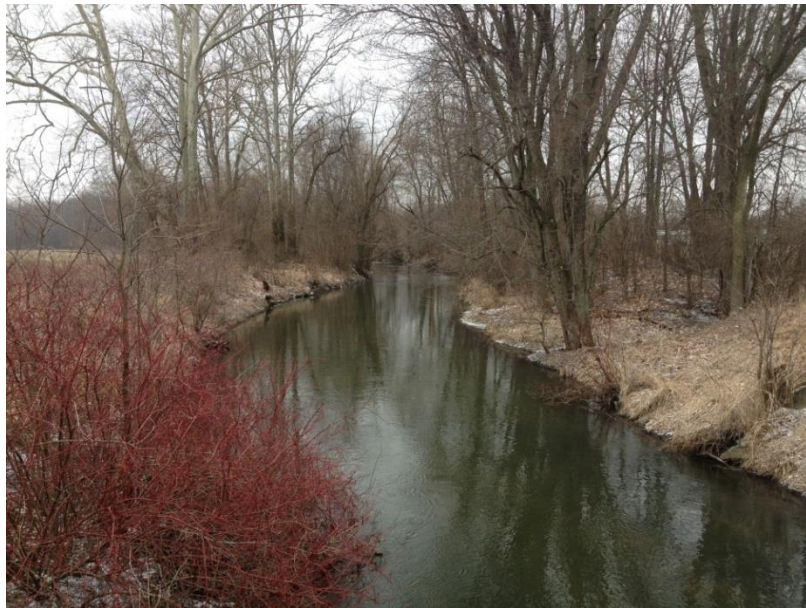
At Dewey Lake Rd. Bridge – A slight floodplain is evident here in the photograph as well as a slight bend – may indicate a location where the old channel and the excavated channel were coincident. Overall similar observations, stable channel, a bed of sands and fines. If there were significant sediment coming in from upstream a small deposit might be expected along the right bank in the photo below.

Figure 18: Dowagiac River at Dewey Lake Rd.

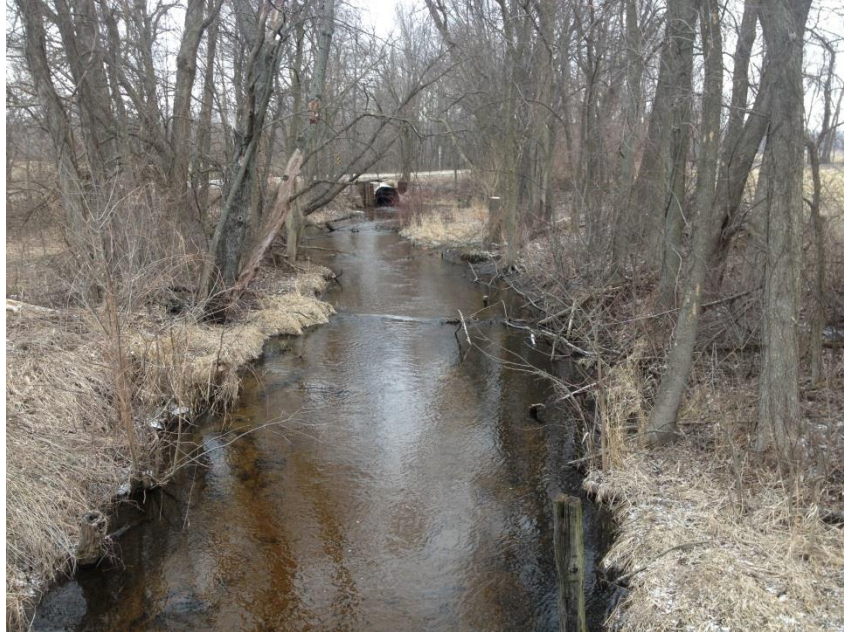
Tributary below Dewey Lake Rd. Bridge – A tributary enters the river below Dewey Lake Rd. and crosses Dewey Lake Rd. just west of the Dowagiac. The channel of the tributary appears to be stable at this location and is contributing a sand load to the channel of the Dowagiac. Investigation of the tributary upstream of this location was not performed but based on observations at this location, rates of sediment delivery might be considered normal, as little evidence of deposition is apparent.

Figure 19: Dowagiac tributary at Dewey Lake Road

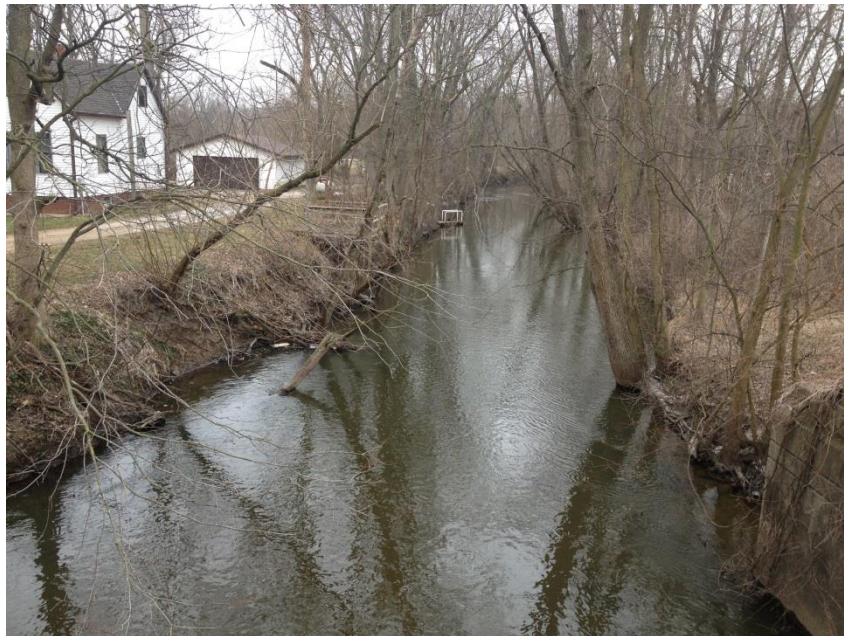
At M-62 – Very similar to upstream sections and to our project area. This is the last stop prior to the confluence with Dowagiac Creek, one of the larger tributaries to the Dowagiac. The creek includes a mill dam that arrests most sediment delivery its upper watershed before it can get to the mainstem Dowagiac. Sand is noted in the bed.

Figure 24: Looking downstream from M-62 at the Dowagiac

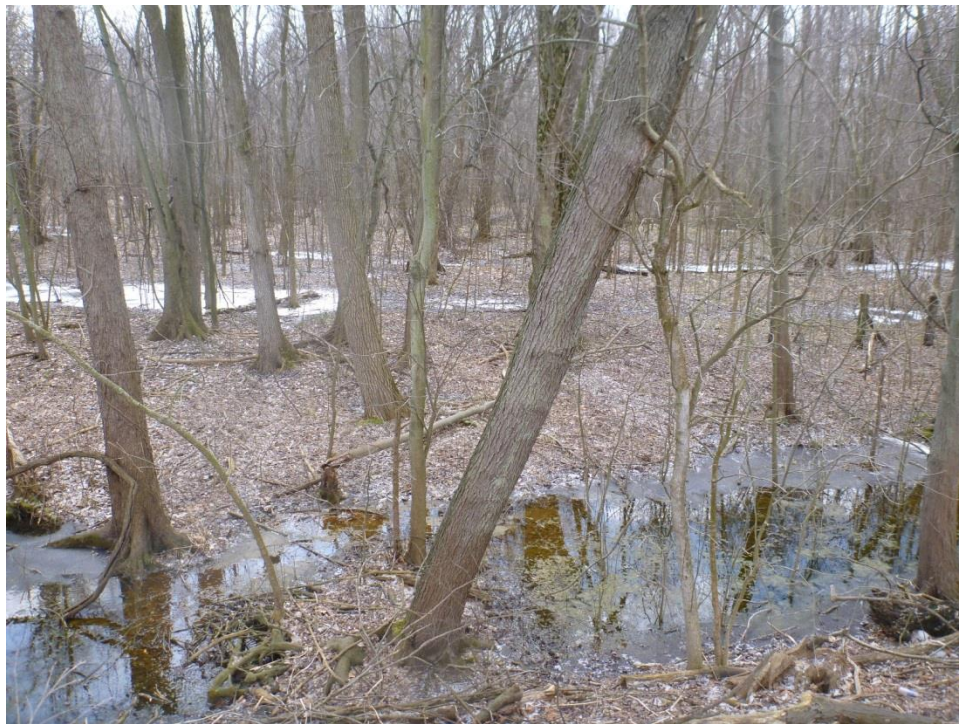
Figure 30. Forested floodplain south of Peavine St. (Location 12). The photograph also exhibits hummocky topography related to meander scroll bars and standing water associated with the latest channel position in the bend.

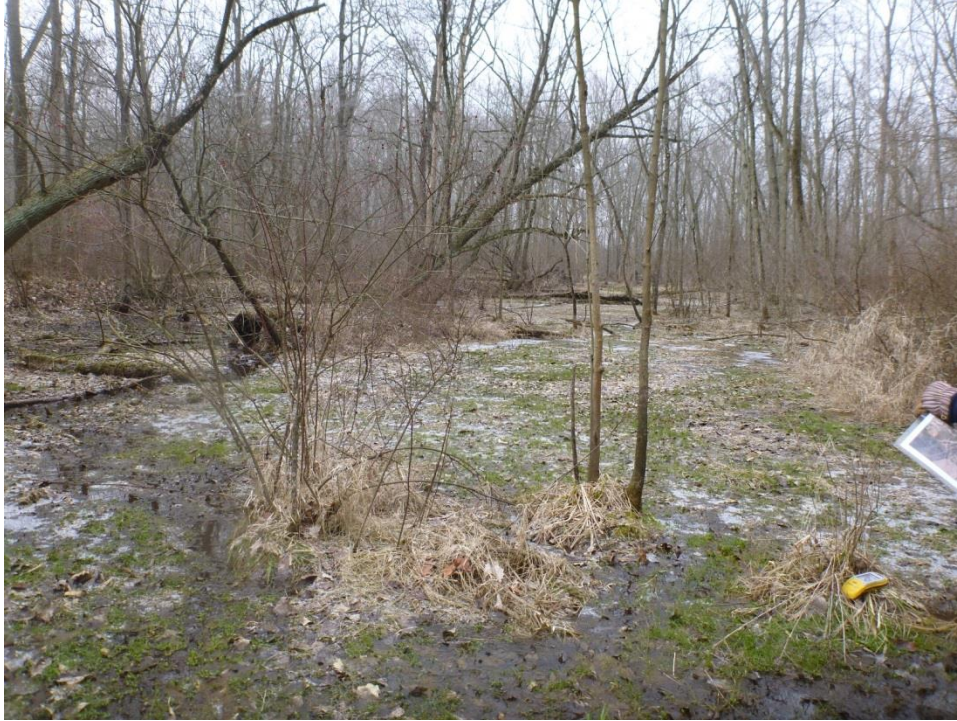
Figure 31. Grassy, muddy wetland along the old channel alignment at photo location 34.

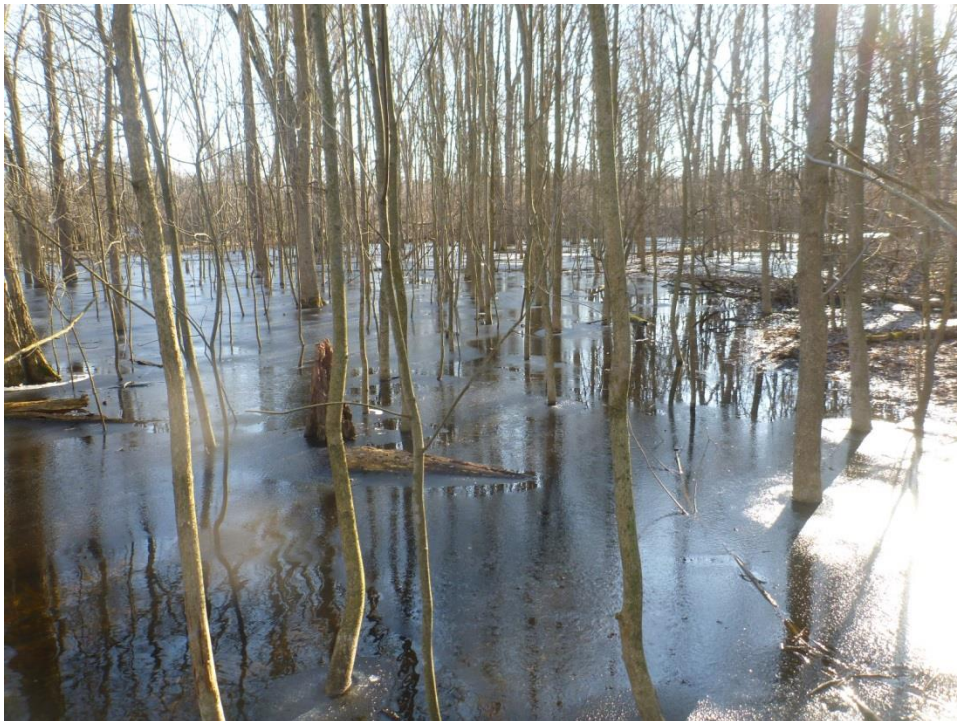
Figure 32. Standing water supporting numerous tree saplings at photo location 29.

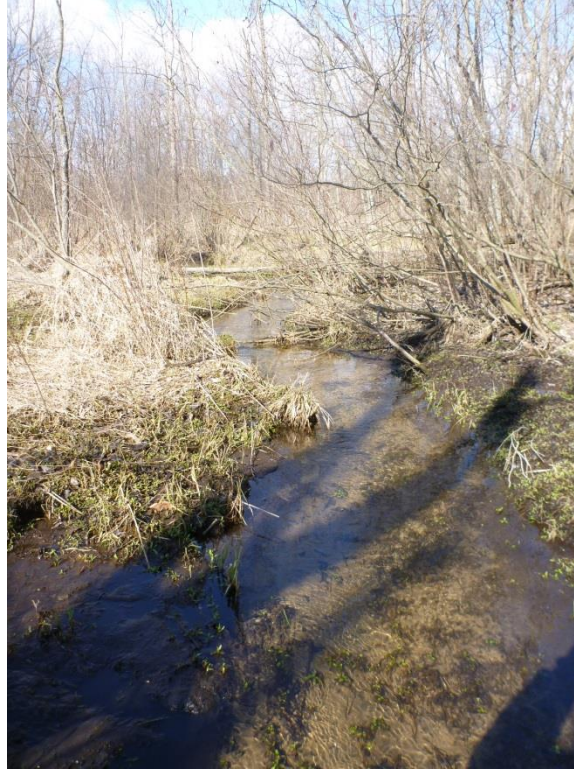
Figure 33. Coldwater tributary draining upstream spring and nearby groundwater seeps at photo location 22.

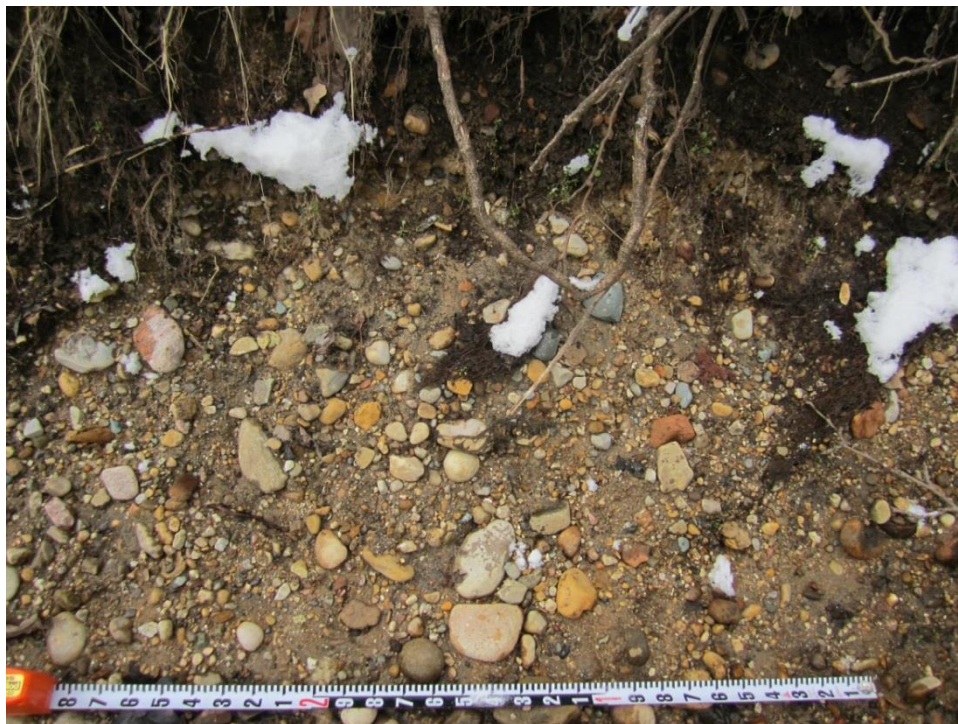
Figure 39. Gravel noted in the spoils along the existing channel near station 22000

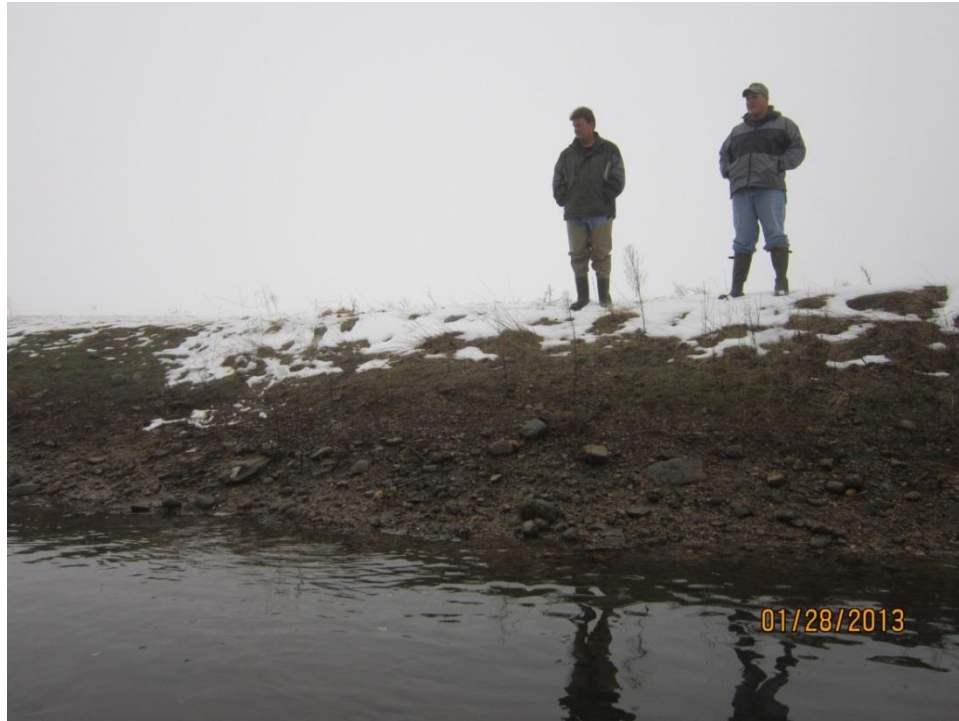
Figure 40. Gravel in the bank of the existing channel just below Peavine St.

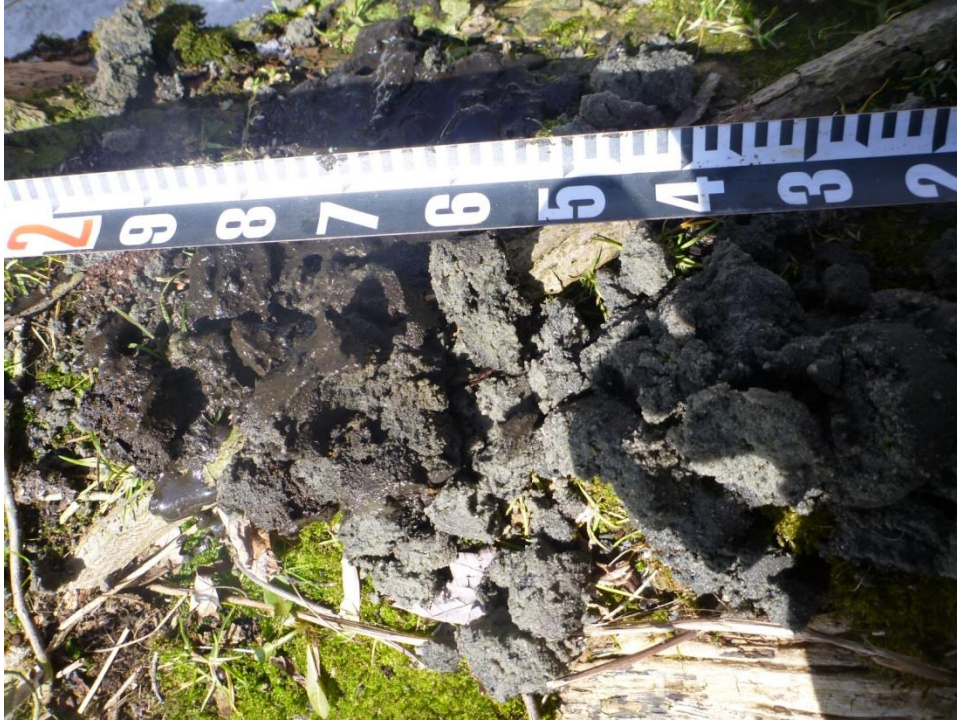
Figure 41. Coarse sand under organics within a DOR core at photo location 31. The sand is relatively coarse with both sediment units including penny-sized chunks of wood.

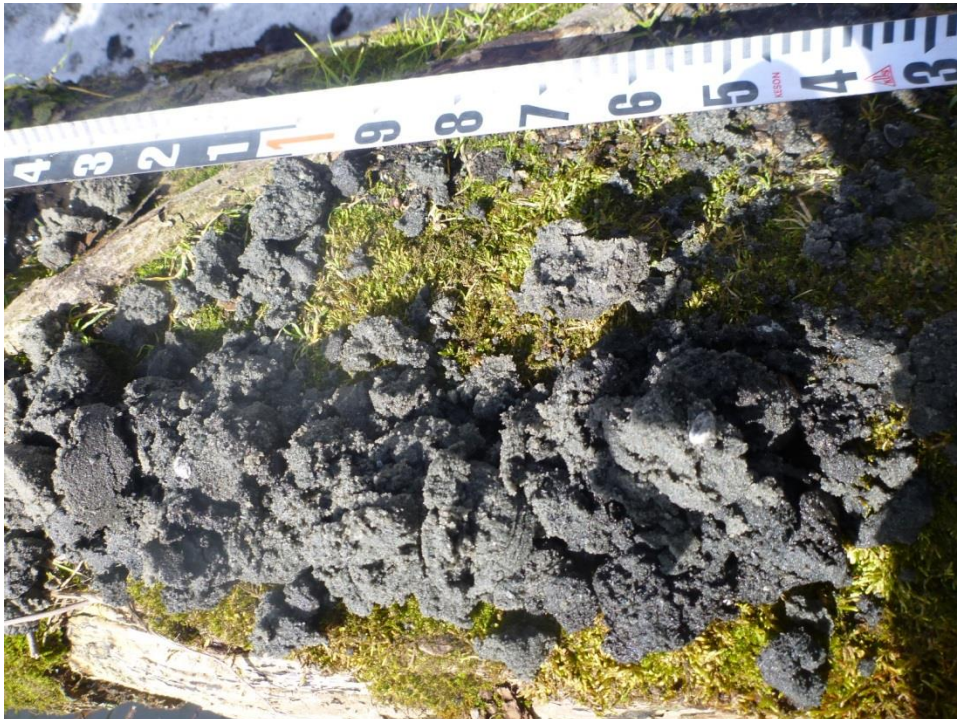
Figure 42. Sand within a DOR core at photo location 14. The sand is fine to coarse with bivalve shells throughout.

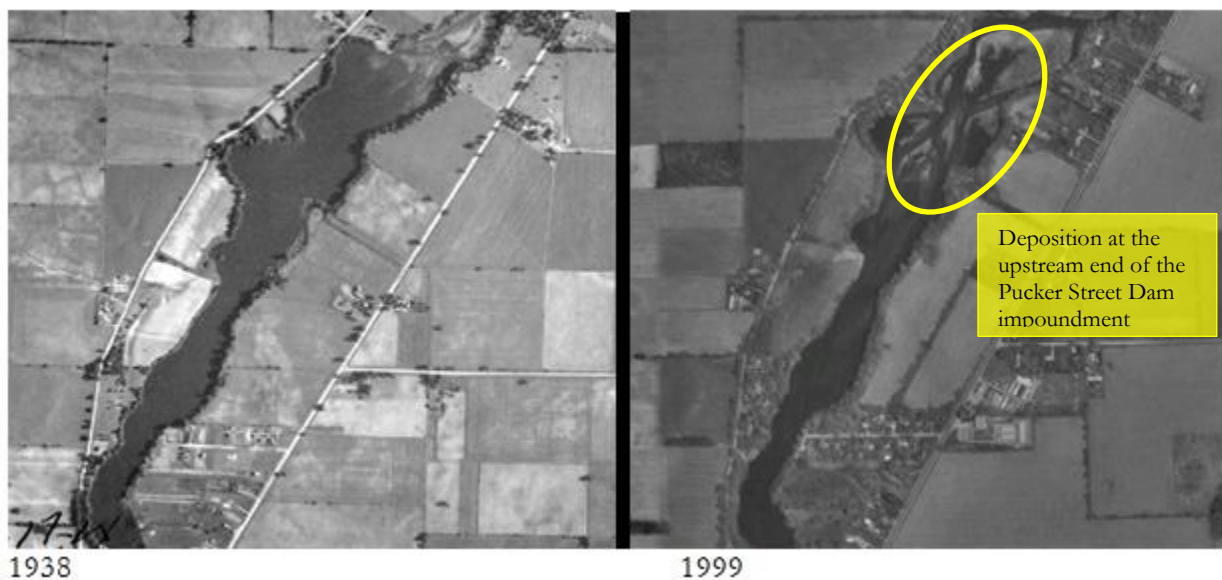
In 1940, just 12 years later, enough sand and silt had settled behind the dam that it had to be dredged. This activity pre-dates the earliest aerial photographs. The 1938 photographs (Figure 45) depict delta formation at the upstream end of the impoundment, indicating continued filling. By 1999, a significant delta had formed over the upper third of the reservoir, leaving low lying vegetated islands and bars of fine material (Figure 45). The wedge of sediment formed despite at least one dredging event and multiple accidental and maintenance related sediment releases. The reservoir was drawn down in the early 2000s, and the corresponding air photos show exposed deposition throughout the former pond. The dam has essentially been abandoned with three gates permanently left open. Monitoring of the sediment up- and downstream of the dam allowed for bedload transport rate estimates of 3 tons/day and 1 ton/day in the fall of 2001 and 2002, respectively (Wesley, 2008), which presumably represent normal rates of transport through the dam reach.

Figure 45. Comparison of the 1999 air photo and 1938 air photo at the Pucker Street Dam impoundment. A sizeable delta formed over the northern (top of figure) third of the reach.

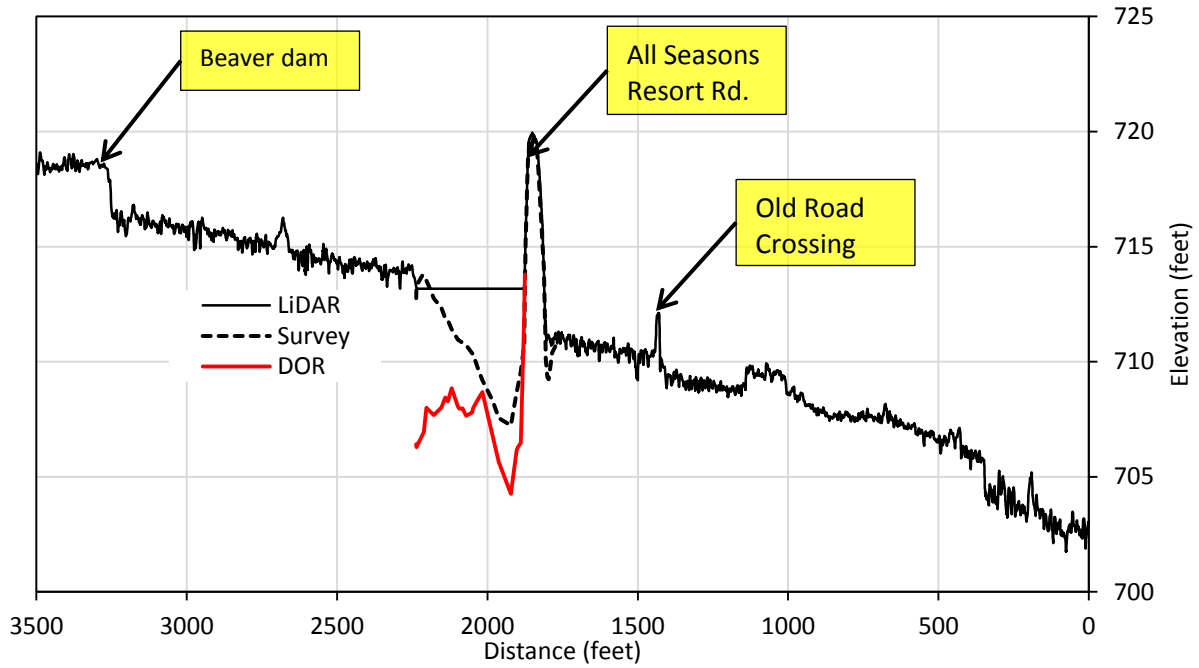
Figure 47. Rodgers Lake Outlet Channel profile for the proposed alignment shown in Figure 46. Note the discontinuity in the profile indicating the pond has been dredged.

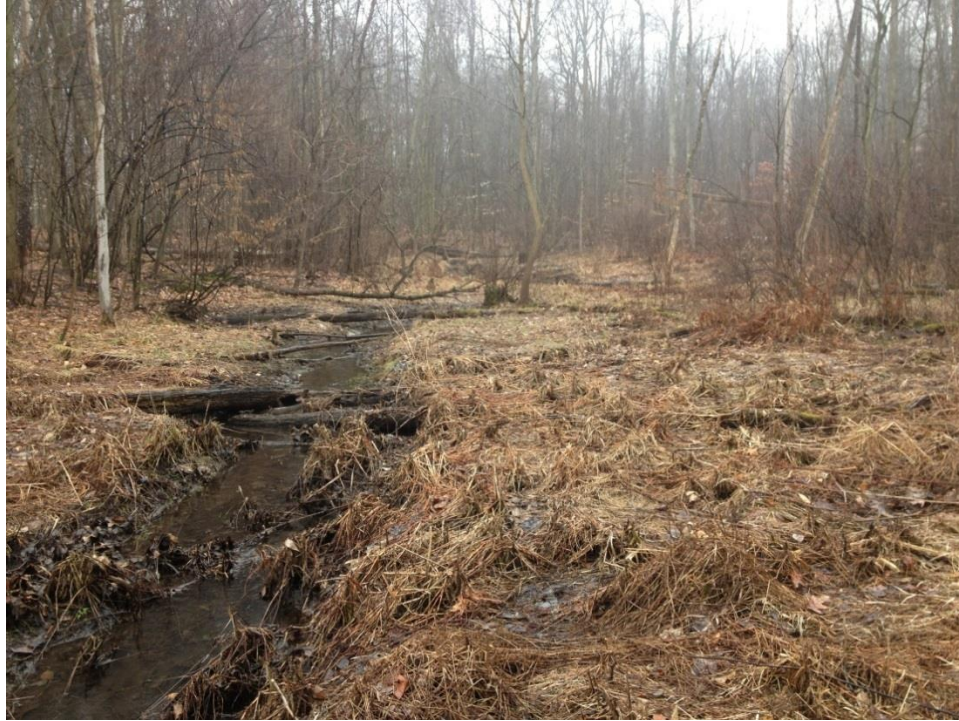
Figure 49. Typical view of the upstream section of channel above Rodgers Pond

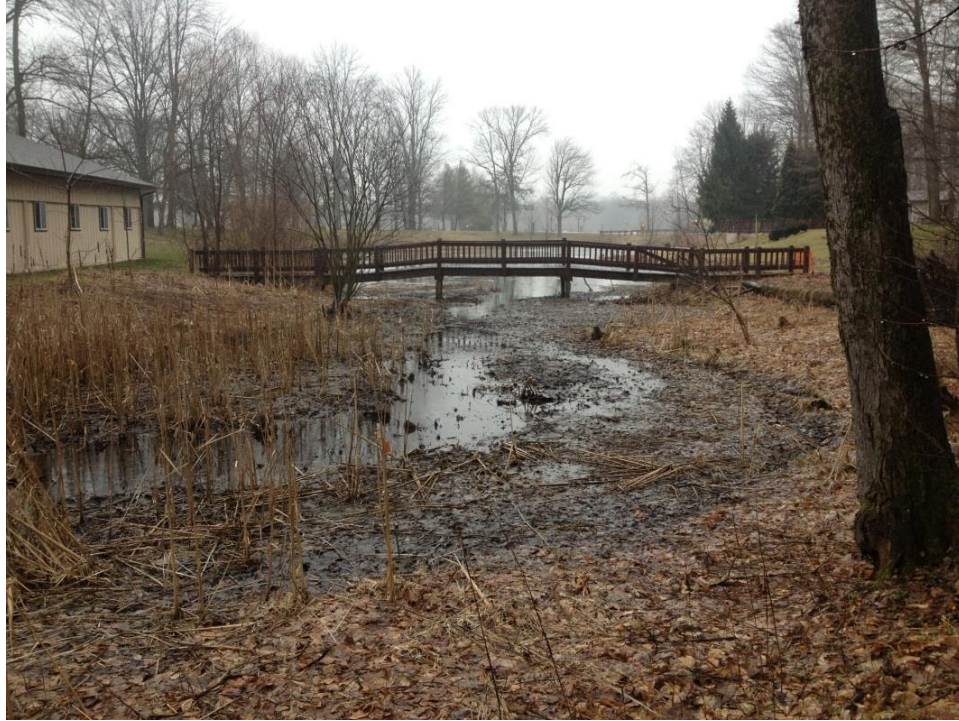
Figure 51. Looking downstream at the Rodgers Pond toward the road

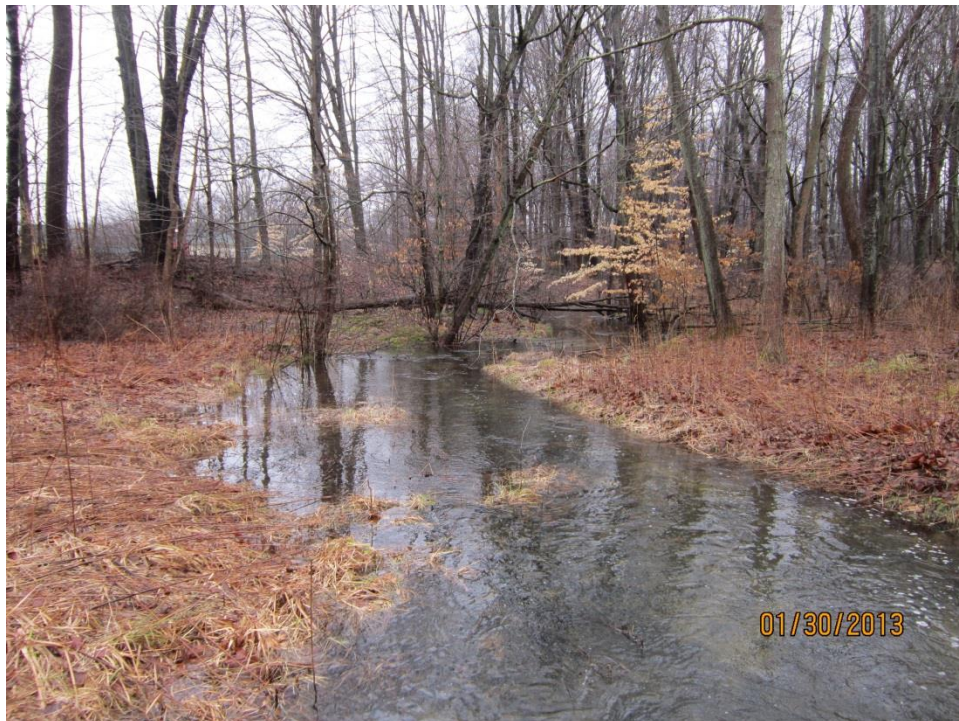
Figure 52: Looking downstream from All Seasons Rd. during the January flood
