## TwinCATS Walk & Roll Top 10 - Update 2017

### **Marquette Woods Road:** St Joseph Ave to Roosevelt Rd

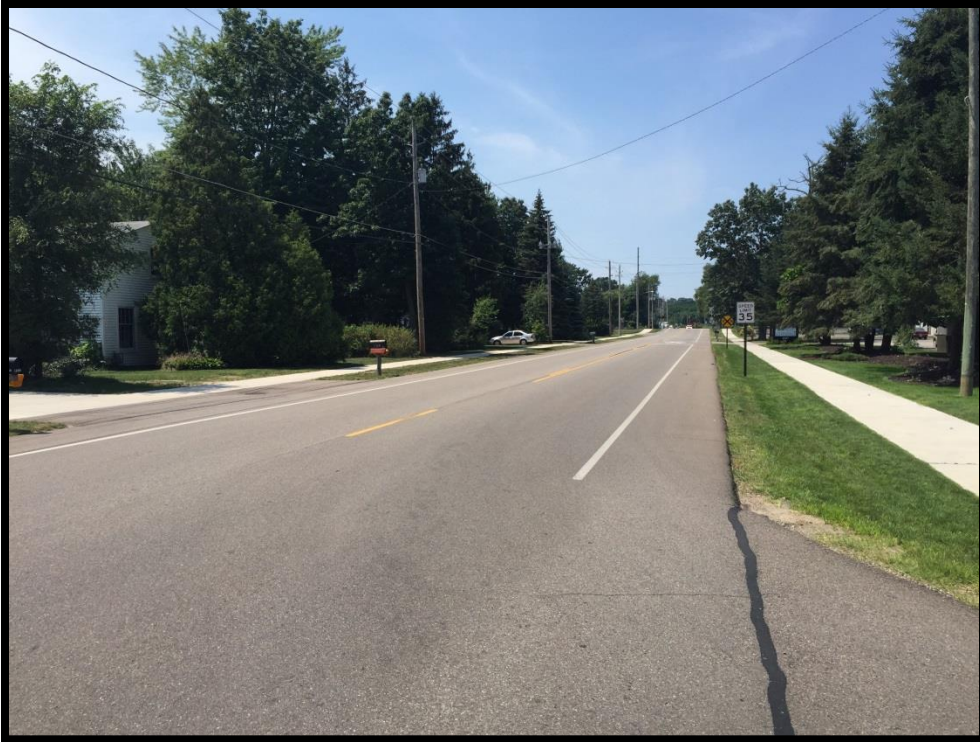
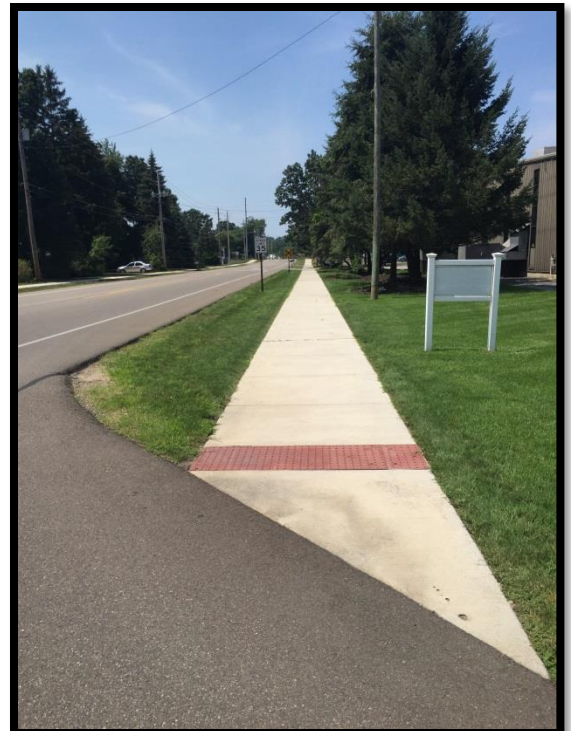
This section is a fairly new constructed road, within the past couple of years. It is a two lane HMA road with a clean wide (4-5') HMA paved shoulder on both sides. There are no bike lane pavement markings but the shoulder appears to be biker friendly. There is also sidewalk on both sides of the road that is in great condition and appears to have been reconstructed at the same time the road was. The sidewalk is complete with sidewalk ramps and detectable warning plates.

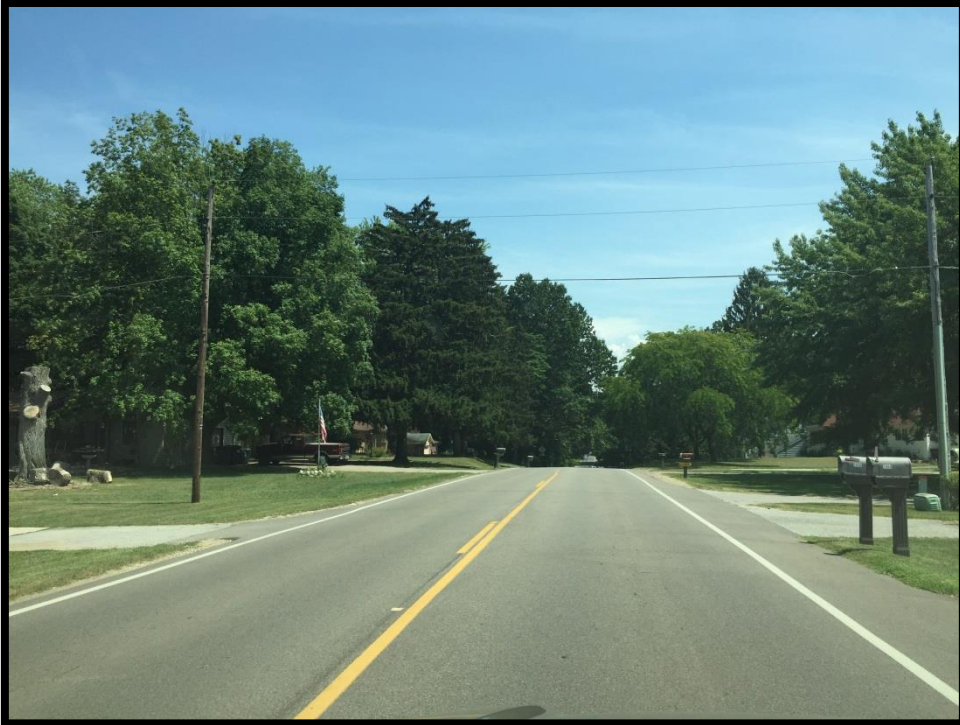
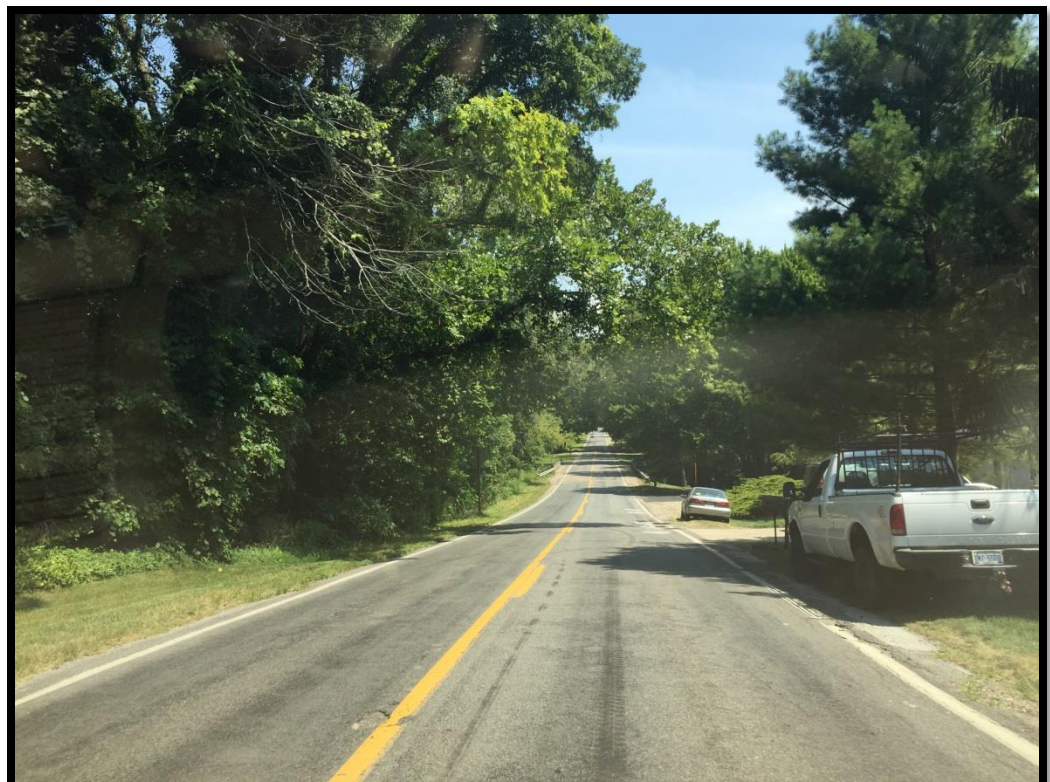
**Marquette Woods Road:** Roosevelt Rd to Cleveland Ave

The first section remains consistent with the newly constructed road, including sidewalks and wide shoulders, however, the recently reconstructed road ends about a tenth of a mile east of S. Roosevelt Rd. There is no sidewalk provided on either side of the road past the S. Roosevelt intersection. The older road is two lanes of HMA with no paved shoulder. There is a narrow gravel shoulder (~3') on one side and no shoulder on the other side. The older road would be a 4 on the PASER scale now.

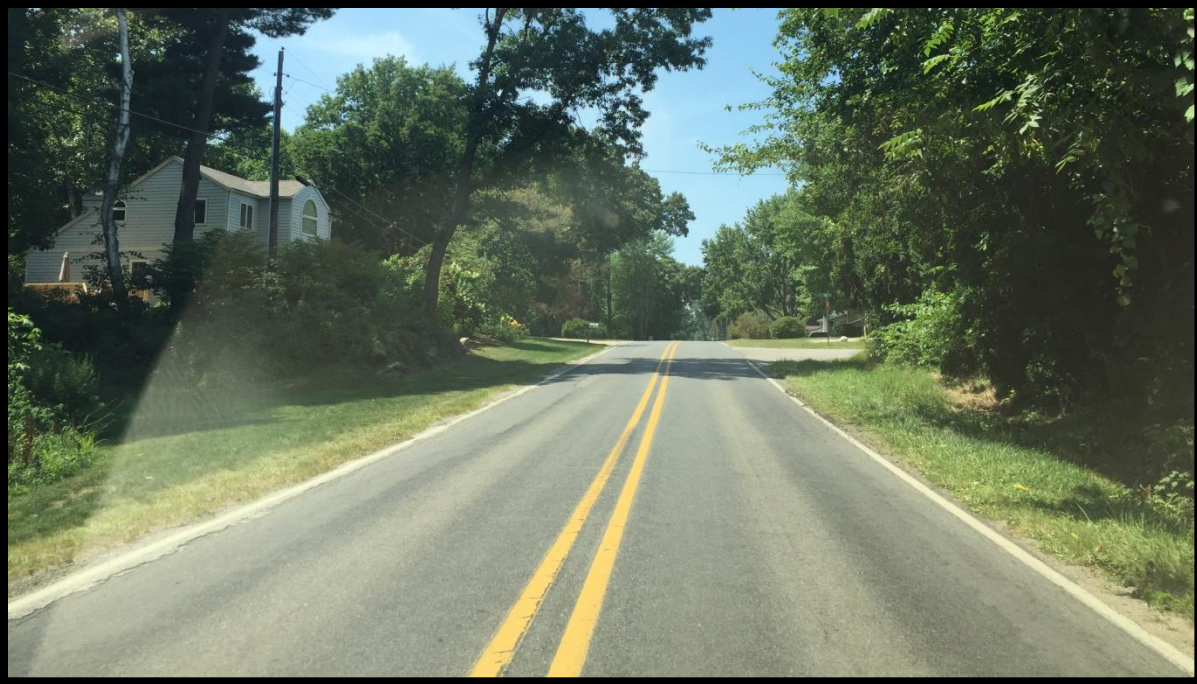
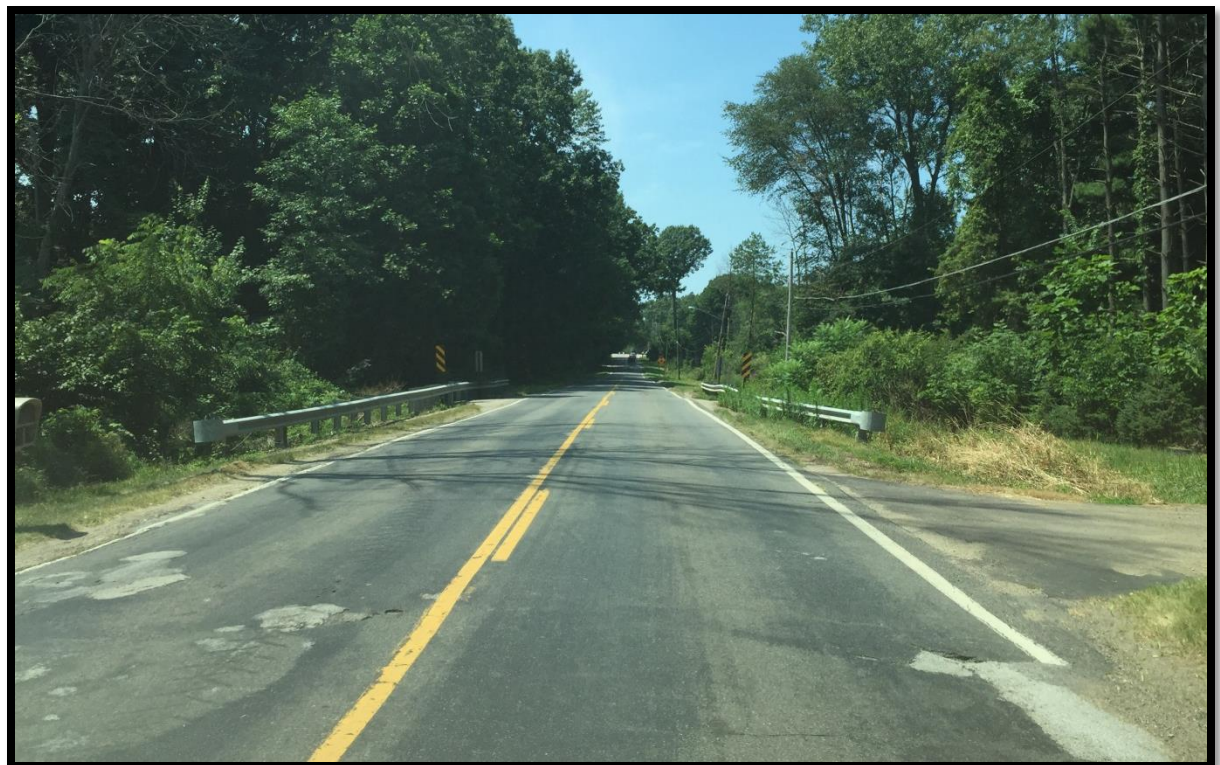
**Marquette Woods Road:** Cleveland Ave to Washington Ave

This section of road is two lanes of HMA with no paved shoulder. There is a narrow gravel shoulder in some parts of this section but the majority of the road does not have any shoulder. There are no sidewalks along this section of road. This section of road has some parts that are deteriorating and would rank as a 3 on the PASER scale.

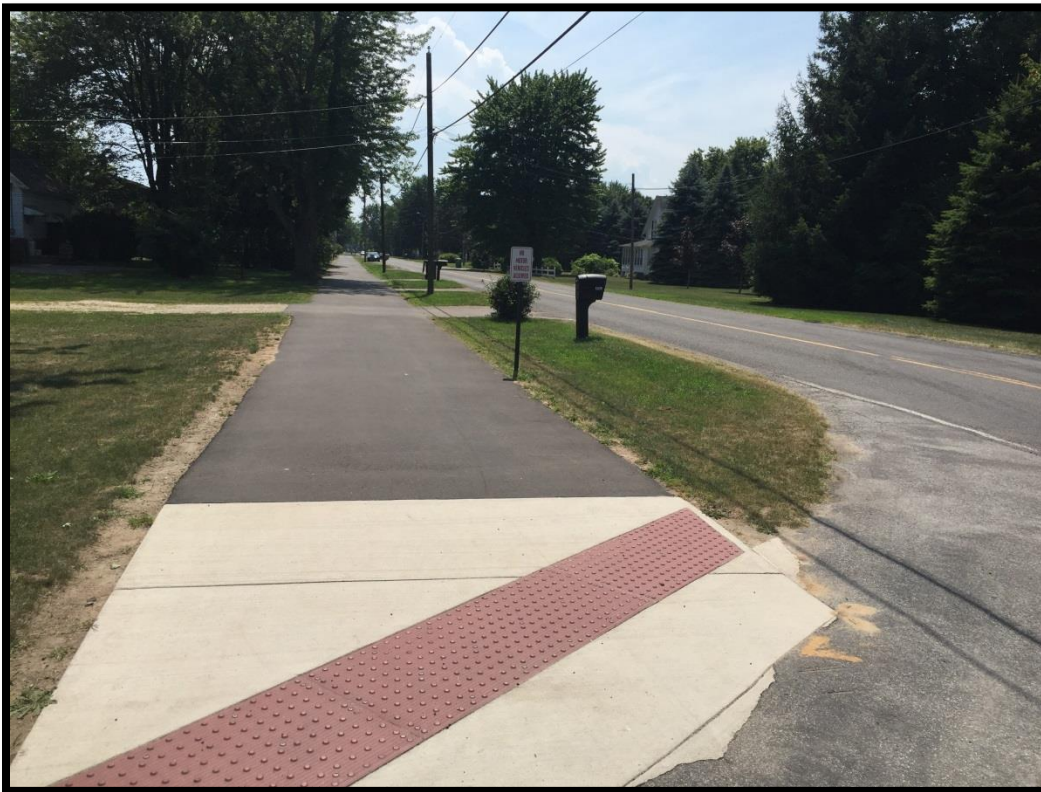
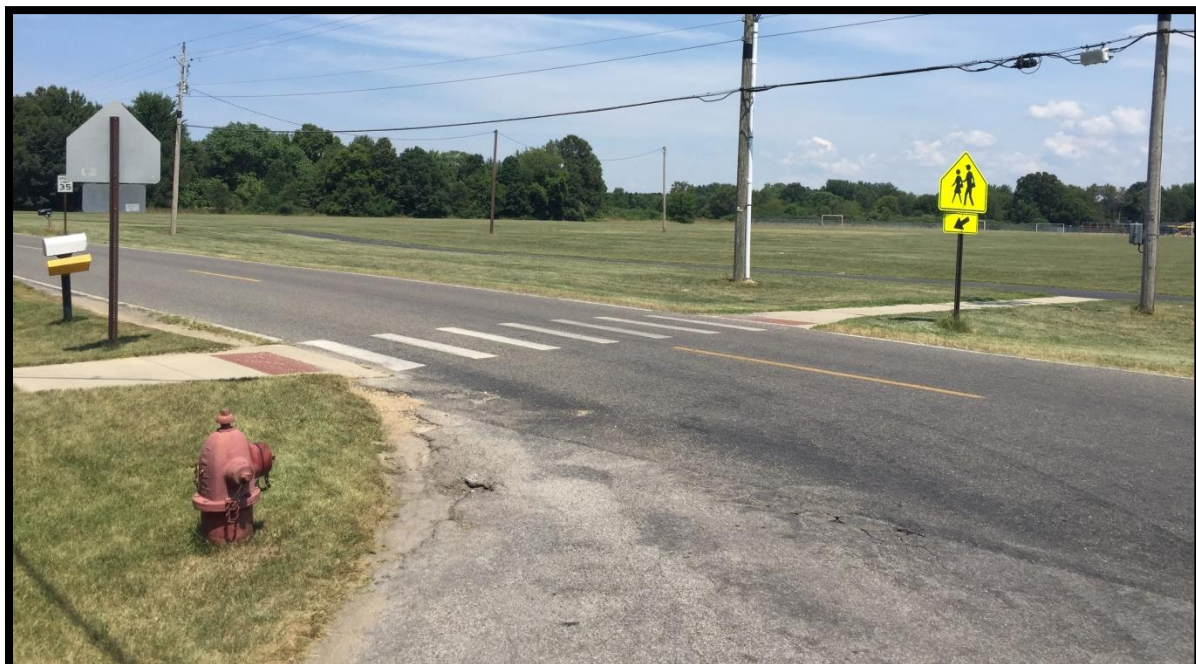
**Roosevelt Road:** Marquette Woods Rd to John Beers Rd

Roosevelt Road is two lanes of paved HMA. It is evident that the road has been chip sealed within the last couple of years, as the road has a rough texture to it. There is no shoulder on this road. There is no sidewalk from Hidden Pines Trail to the north. However, from Hidden Pines to the south there is a fairly new paved HMA multi use path on the east side of the road. This path is about 10' wide and is complete with ramps and detectable warning surfaces. There are connections to this path at John Beers road intersection and at Shiawasse Lane to allow you to cross Roosevelt and access the other side.

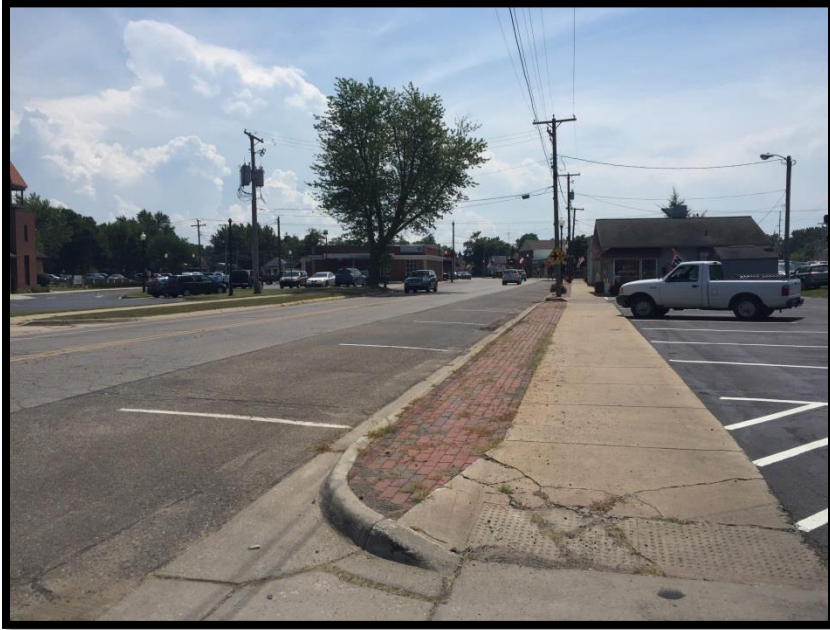
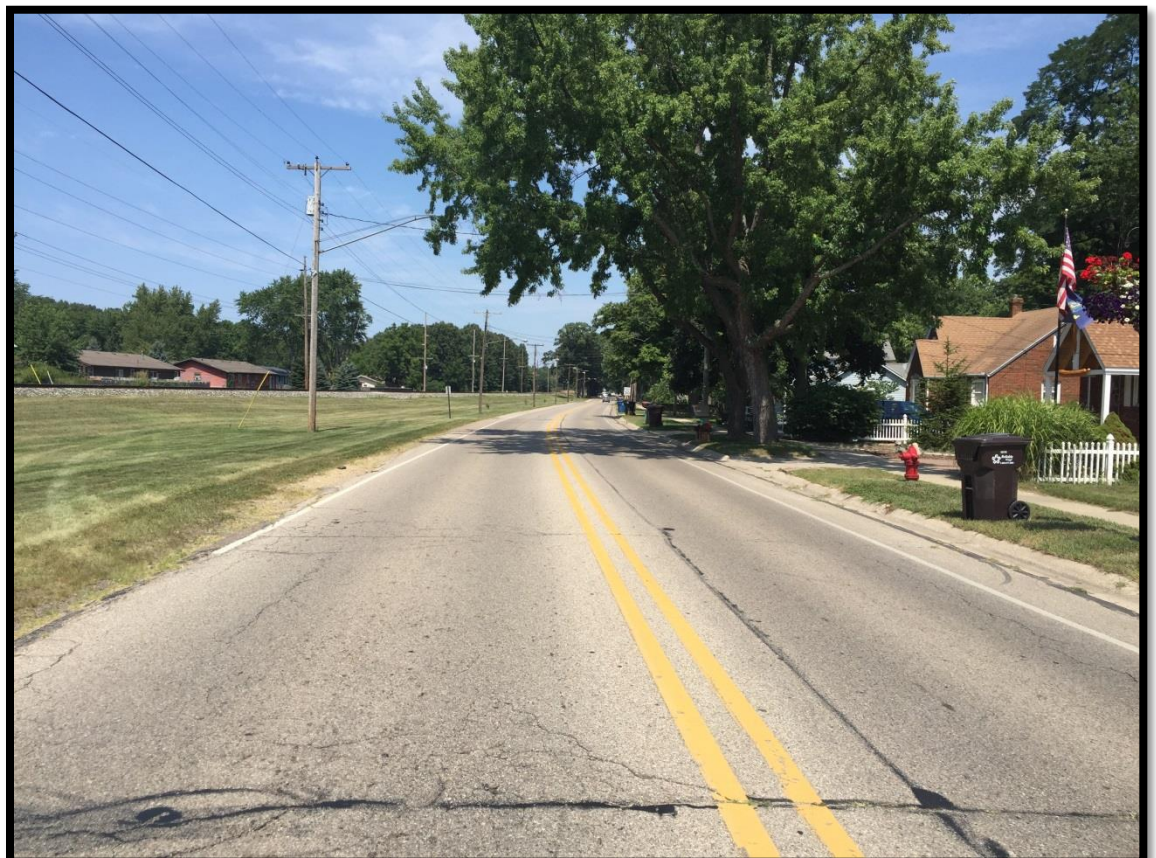
**St. Joseph Avenue:** John Beers Rd to Lincoln Twp Border (North)

St. Joseph Avenue is two lanes of paved HMA. The first cityscape block of St. Joseph Avenue north of John Beers road has sidewalk on both sides of the road. However, this sidewalk appears old and lacks the required ramps and detectable warning surfaces. North of the cityscape the sidewalk discontinues on the west side of the road but continues on the east side of the road. The sidewalk extends to the village limits. There is curb on the side of the road that contains the sidewalk. The west side of the road has no shoulder.

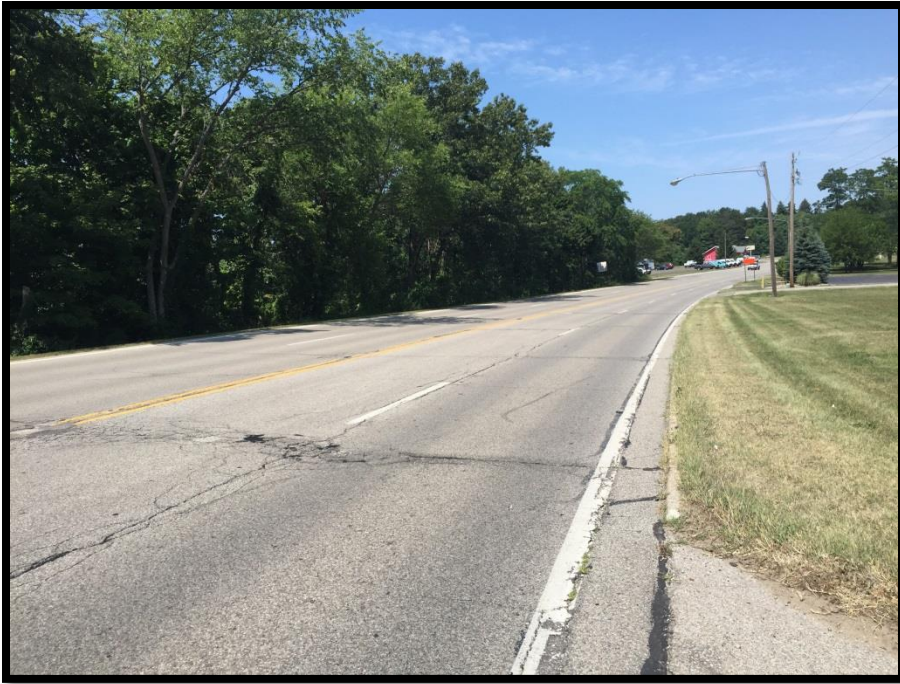
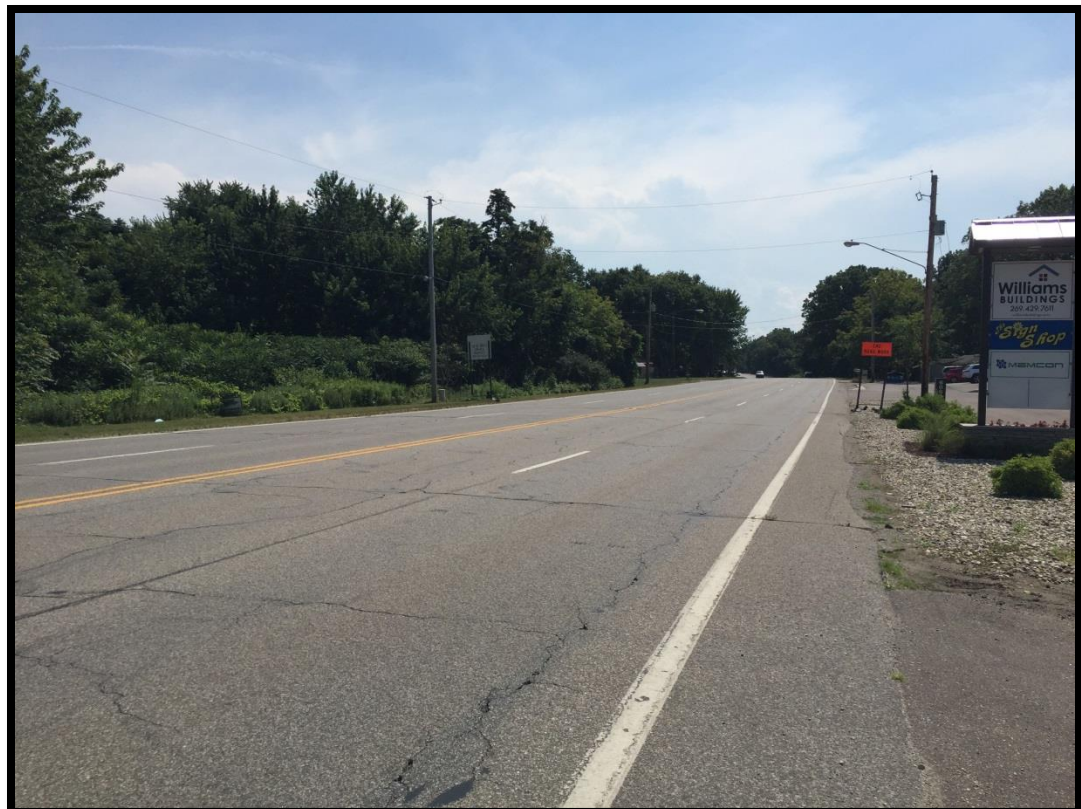
**Red Arrow Highway:** Lincoln Township Borders

Red Arrow Highway is four lanes of paved HMA. The majority of this section is not curbed but there are some sections that have curb near the John Beers intersection. The John Beers intersection was recently redone and now there are sidewalk ramps with detectable warning surfaces at each quadrant, however, there are no sidewalks along the length of Red Arrow Highway. There is a narrow paved HMA shoulder along Red Arrow Highway, this shoulder varies in width from 1' to 3'.

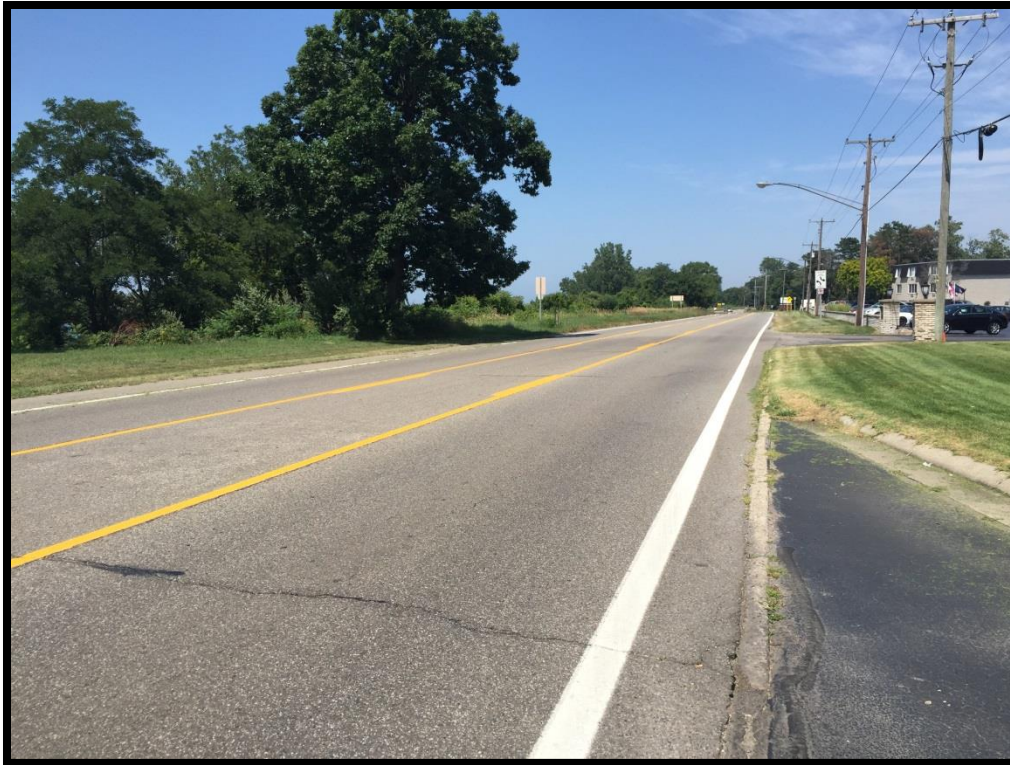
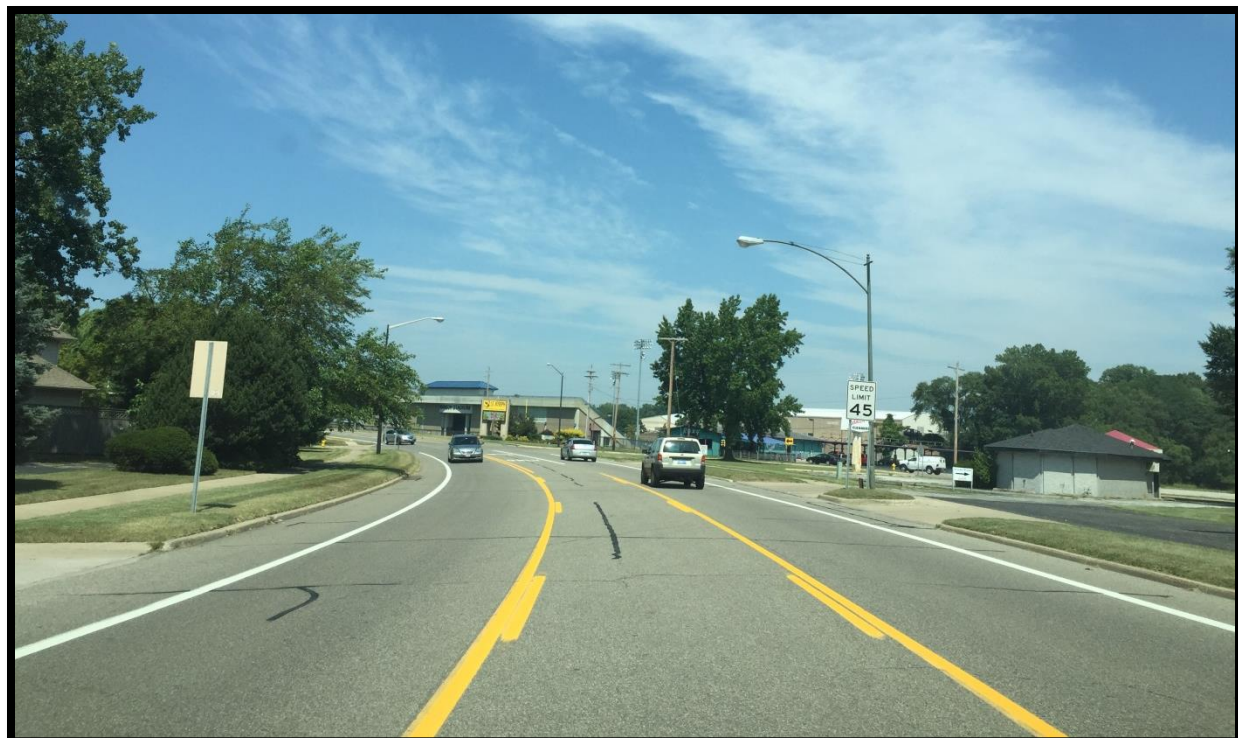
**Lakeshore Drive:** Cleveland Ave to Hilltop Rd

Lakeshore Drive is three lanes of paved HMA. The two outer lanes are travel lanes, while the middle lane is a turn lane. There are older sidewalks along both sides of Lakeshore Drive starting at the bridge and going north to Cleveland Avenue. There is also curb along this same section. South of the bridge to Hilltop Rd there are no sidewalks, or curb. Both sections of Lakeshore Drive have been recently re-striped. There is a paved HMA shoulder on both side of Lakeshore Drive. The width varies but stays around 3' to 4'.

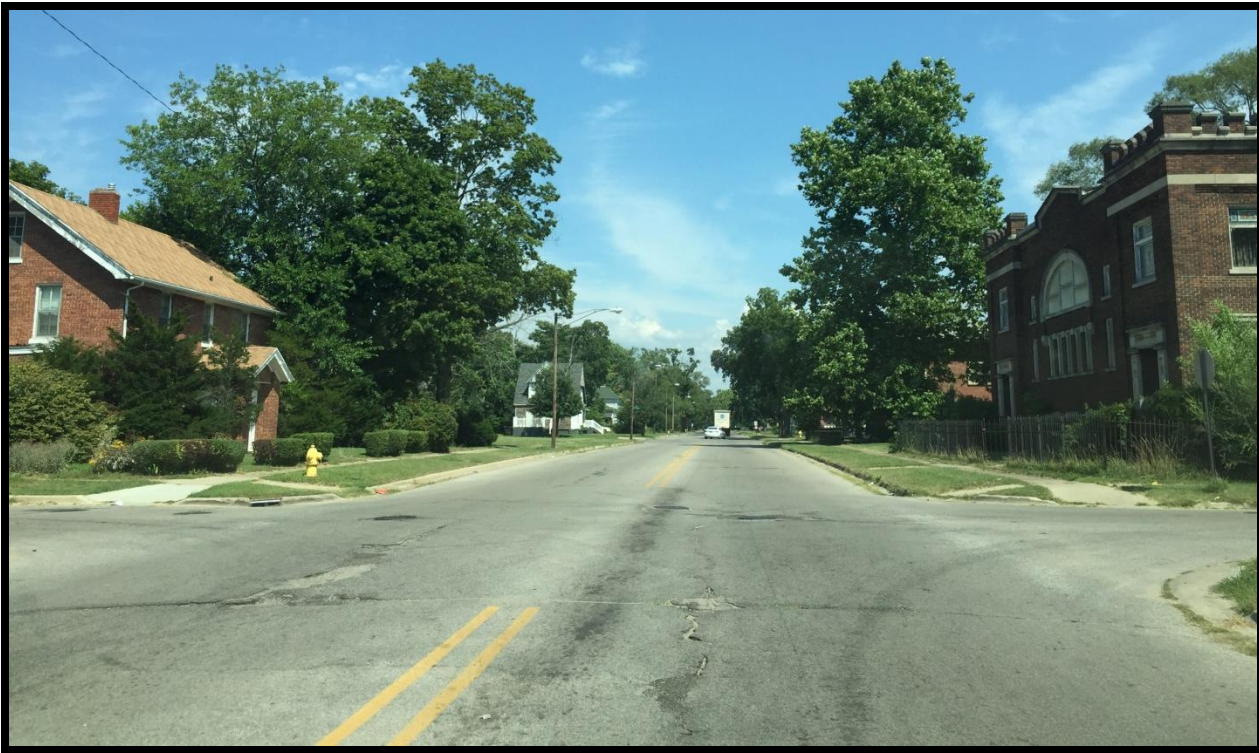
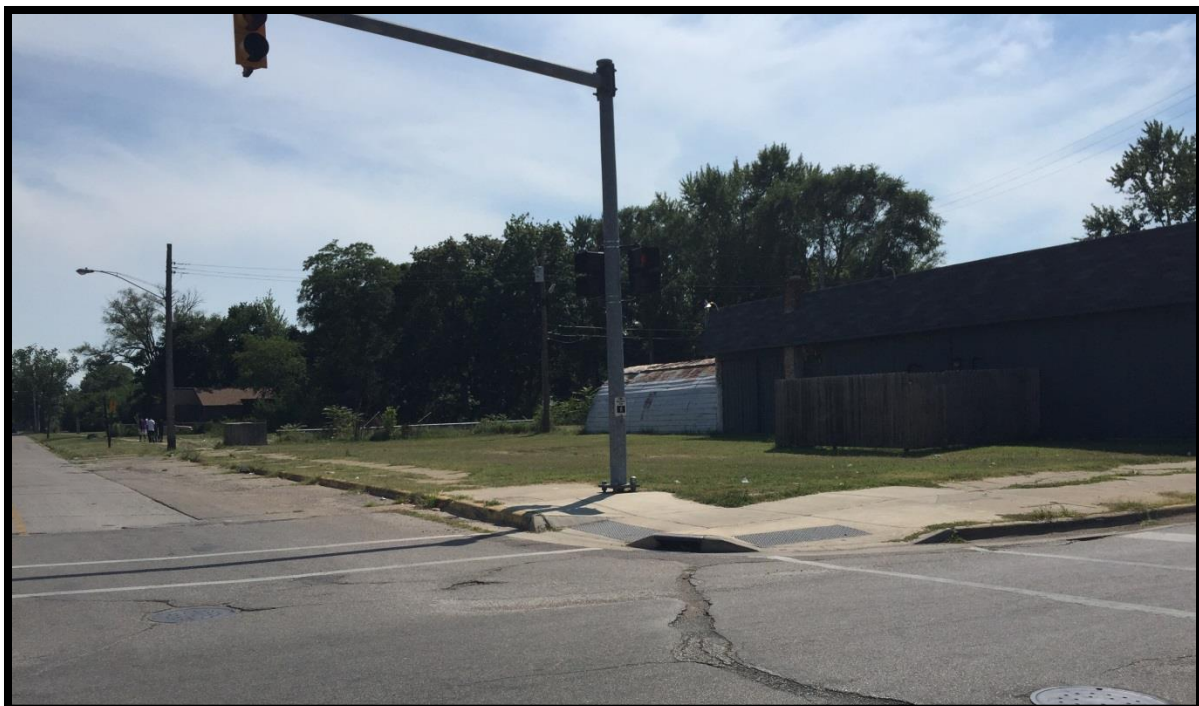
**Empire Avenue:** Colfax Ave to Pipestone St

Empire Avenue is two lanes of paved HMA. There is curb on both sides, along with sidewalk on both sides. The sidewalk is older and in tough shape. The ramps and detectable warning surfaces appear to be recently replaced at each major intersection; Colfax, Broadway, and Pipestone. At the minor road intersections the ramps could use some repair. There are no white lane edge stripes so it is hard to tell if there is a shoulder or not. However, it appears that there is room for a shoulder or for roadside parking.

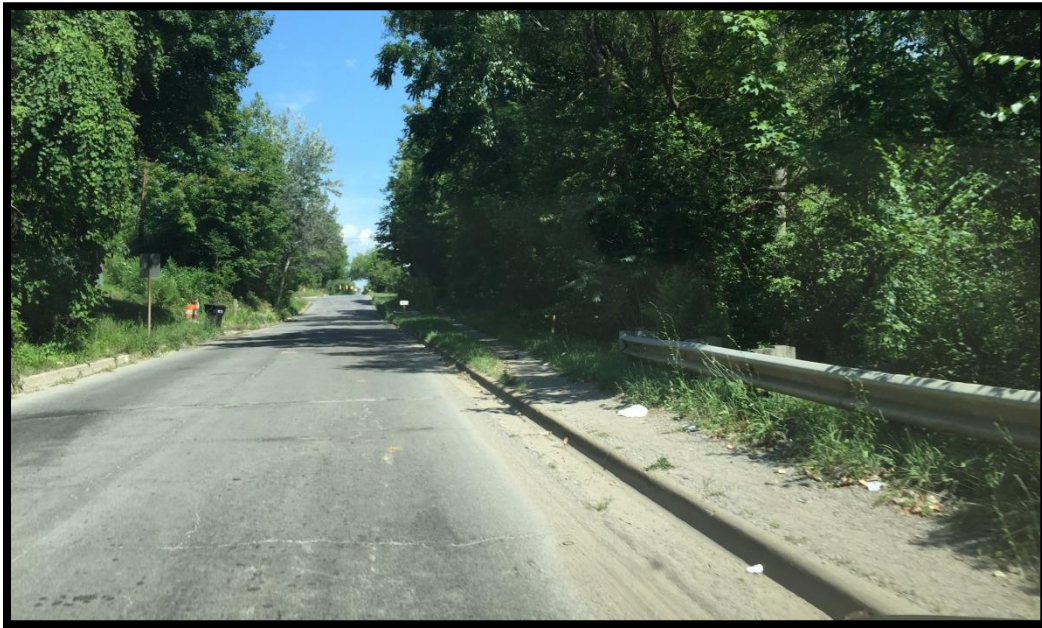
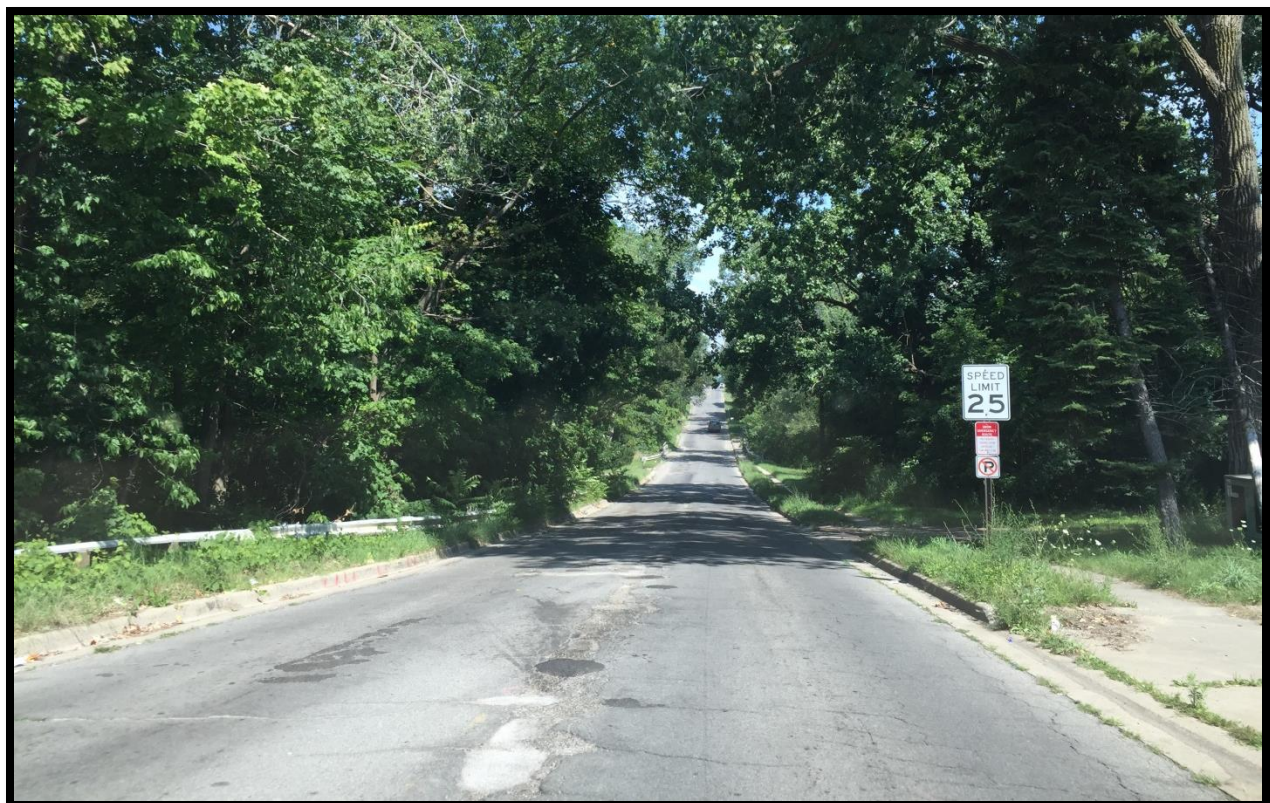
**Empire Avenue:** Pipestone St to M-139

Empire Avenue is two lanes of paved HMA. There is curb on both sides of the road. At the intersection with Pipestone there are recently redone sidewalk ramps and new detectable warning surfaces. There is sidewalk running along Empire Avenue on the south side until the intersection with S. Fair Avenue when it ends. After this there is just a walking trail along the right-of-way in the grass. It would be beneficial to extend this sidewalk to the intersection of M-139. There are no sidewalk ramps at the intersection of Empire and M-139.

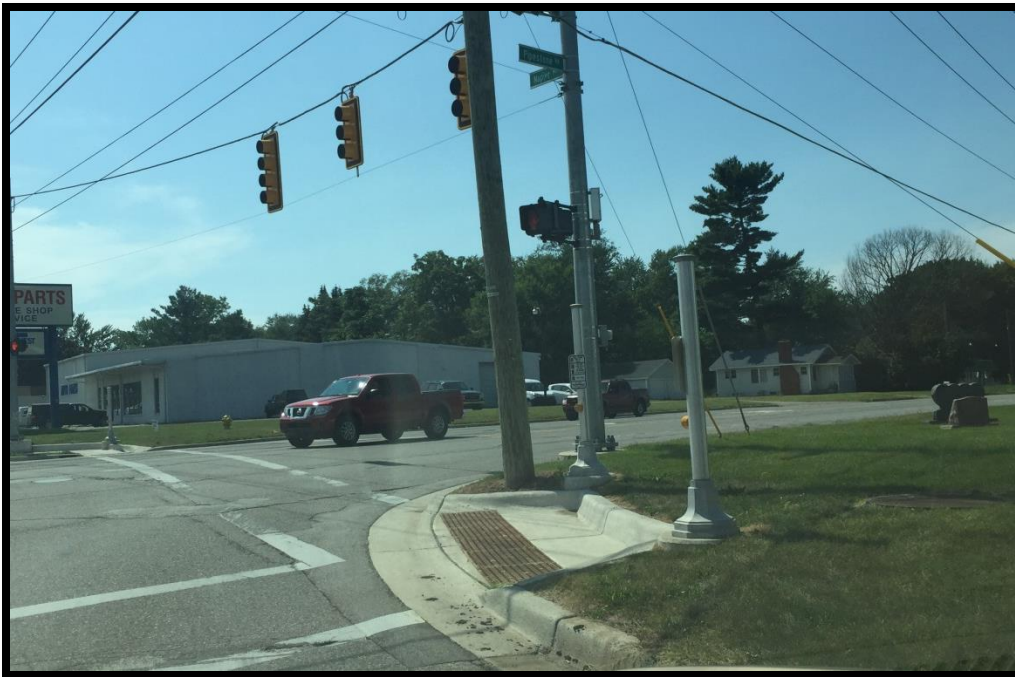
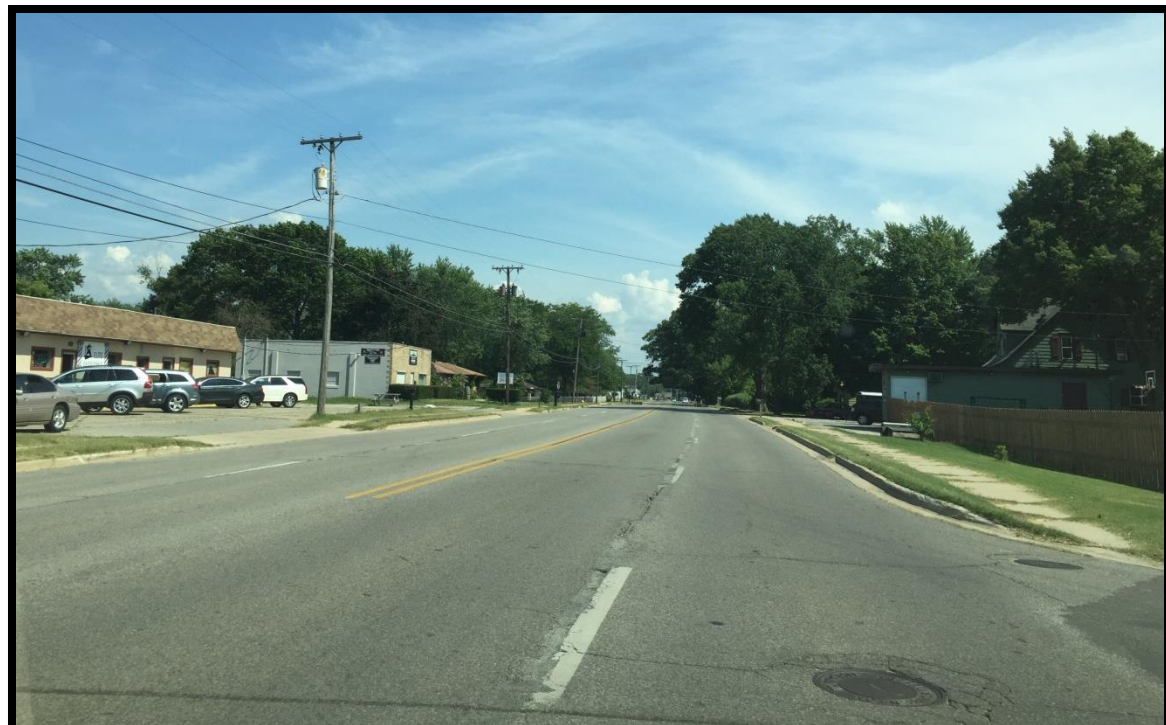
**Pipestone Road:** M-139 to Napier Ave

Pipestone Road is four lanes of paved HMA. There is curb on both sides of the road with little to no shoulder. There is also sidewalk running along the majority of Pipestone road on both sides. However, the sidewalk ends on both sides a block before the intersection of Pipestone and M-139 and a block before the intersection of Pipestone and Napier Ave. It would be extremely beneficial to extend the sidewalk to each of the intersections. The sidewalk is in rough shape in some locations and is overgrowing with weeds. The sidewalk ramps at most of the intersections could use some work. At the intersection of Pipestone and Napier there are fairly new sidewalk ramps and detectable warning surfaces, along with pedestrian crossing buttons.
