2018 Pavement Condition Report For Van Buren County, Michigan

Prepared by the Southwest Michigan Planning Commission
376 W Main St
Benton Harbor, MI 49022
(269) 925-1137

2018 Van Buren County Pavement Condition Report

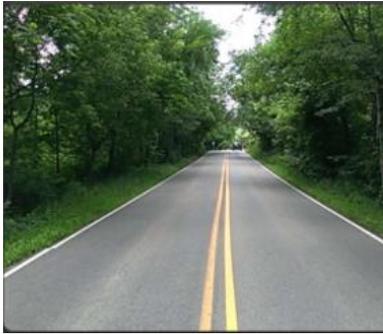
Good Condition

PASER Rating 8-10
Requires Routine Maintenance

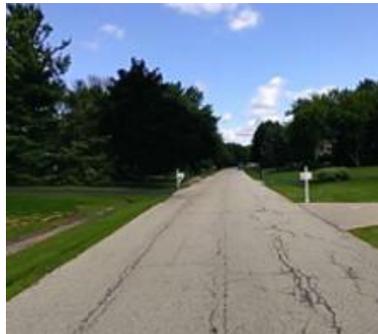
Fair Condition

PASER Rating 5-7
Requires Capital Preventative Maintenance

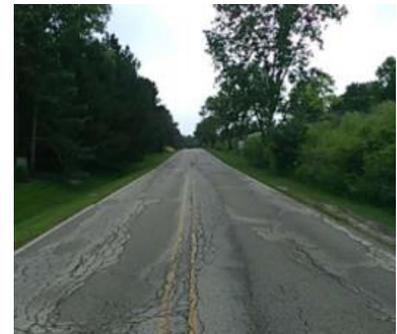
Poor Condition

PASER Rating 1-4
Requires Structural Improvements or Reconstruction

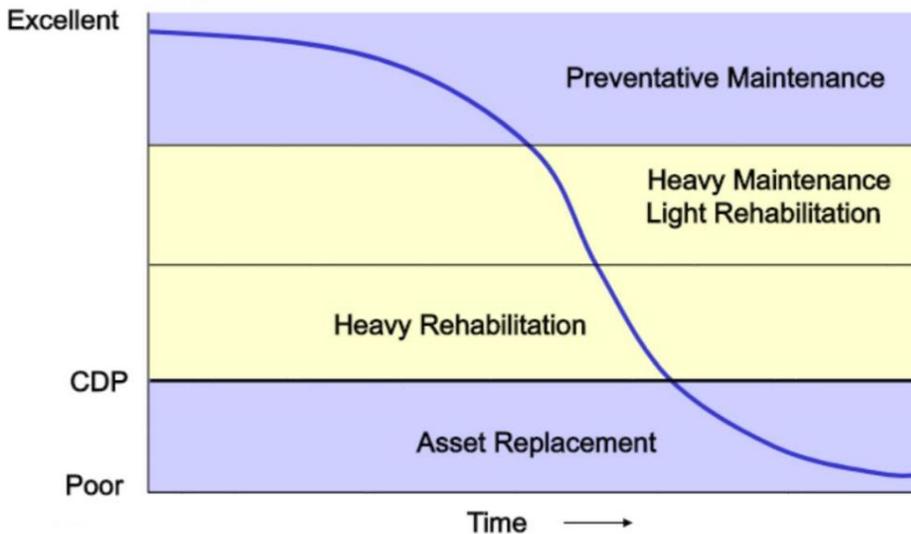
Condition Rating

The costs for rehabilitation are exponentially higher than the cost to perform preventative maintenance, and a full reconstruction is the most expensive treatment option. Asset management best practices encourage preventative maintenance to slow decay and save money.

It is vital to know pavement condition to monitor when a road is close to reaching a point where treatments that are more expensive become necessary and to ensure fewer roads cross the critical distress point (CDP) at which maintenance is no longer effective.

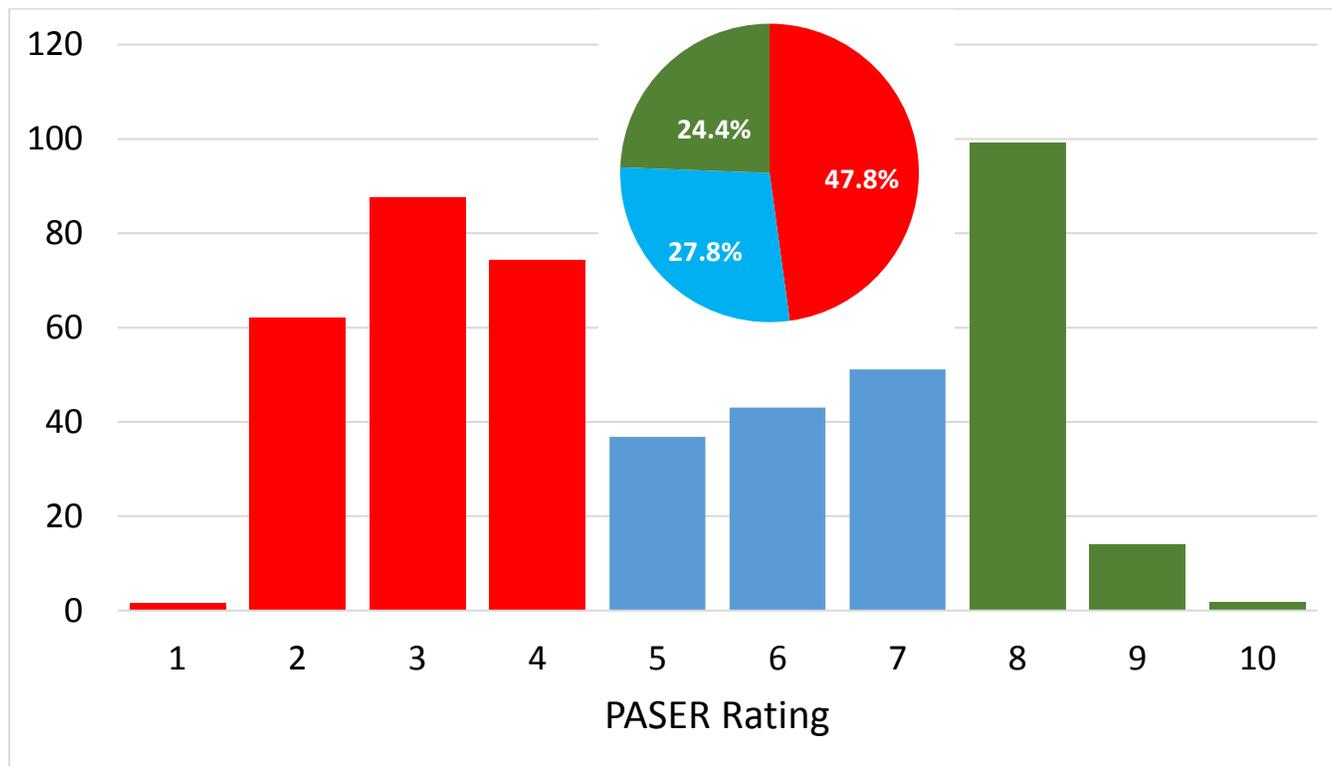
2017/2018 All Federal Aid Miles by PASER Rating

While just under half of the rated roads are in poor condition (PASER rating of 1-4), many of these are rated 3 or less. At a rating of 4, a structural overlay is recommended, but certain capital preventive maintenance (CPM) can still be performed. Once a road deteriorates below a four more costly treatments, such as full reconstruction are required.

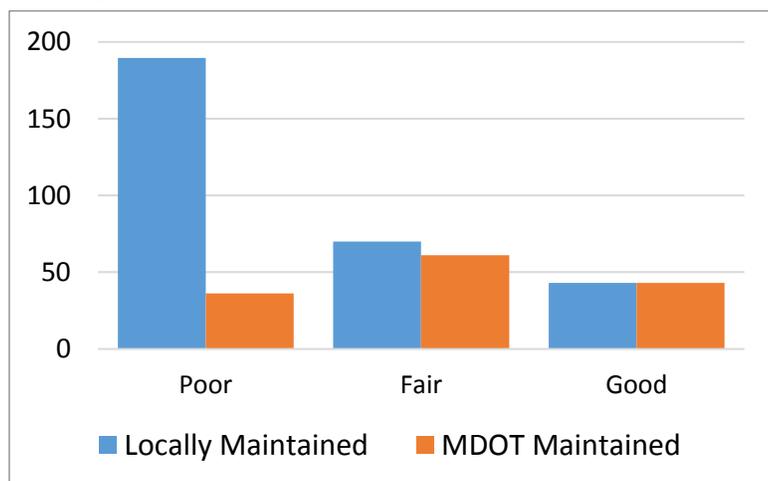
2017/2018 Local and MDOT Maintained Federal Aid Miles by PASER

Local: 303 miles		
Good	Fair	Poor
14.3%	23.1%	62.6%

MDOT: 140 miles		
Good	Fair	Poor
30.7%	43.5%	25.8%

Locally maintained roads are in overall worse condition than MDOT maintained roads. Among the reasons is that far more federal and state funding is applied to the Interstate followed by other highways and major arterials, which are mostly maintained by MDOT (the National Highway System).

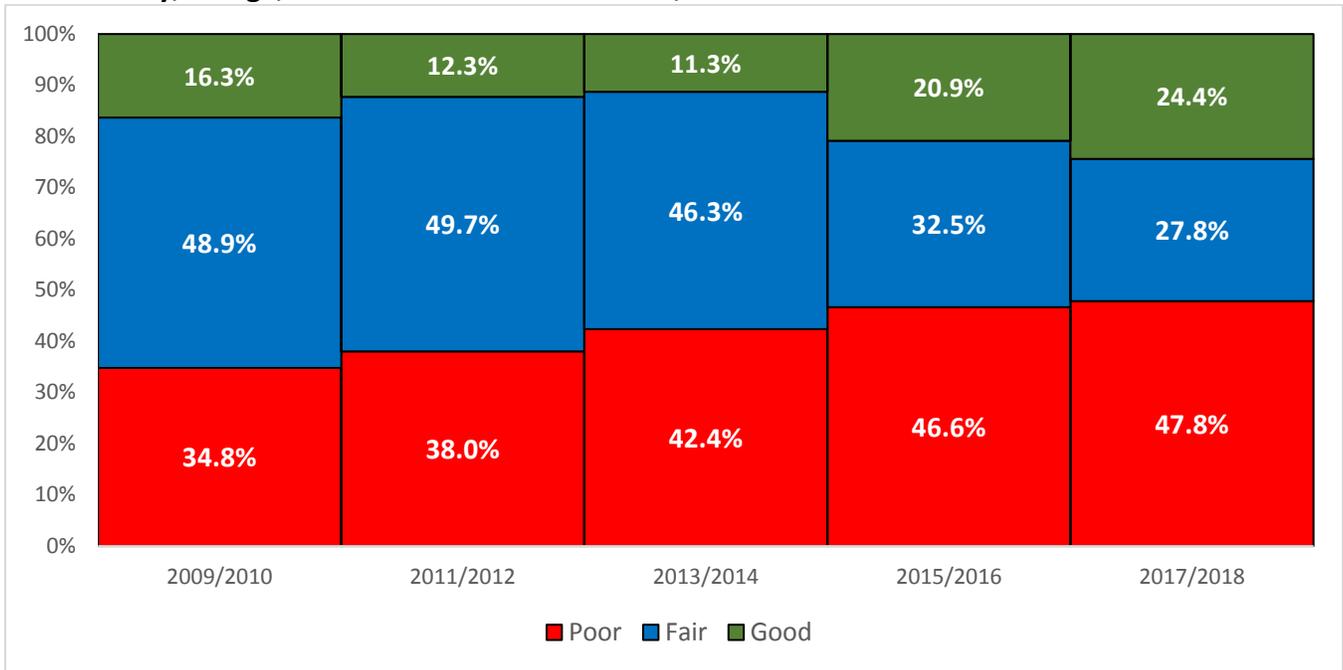
Ten Year Trend in Countywide PASER Ratings 2009-2018

Includes City, Village, Van Buren Road Commission, and MDOT Maintained Roads

Because half of the county is rated, each year ratings are paired into full county ratings, with 2017 & 2018 being the most recent rating for the entire county.

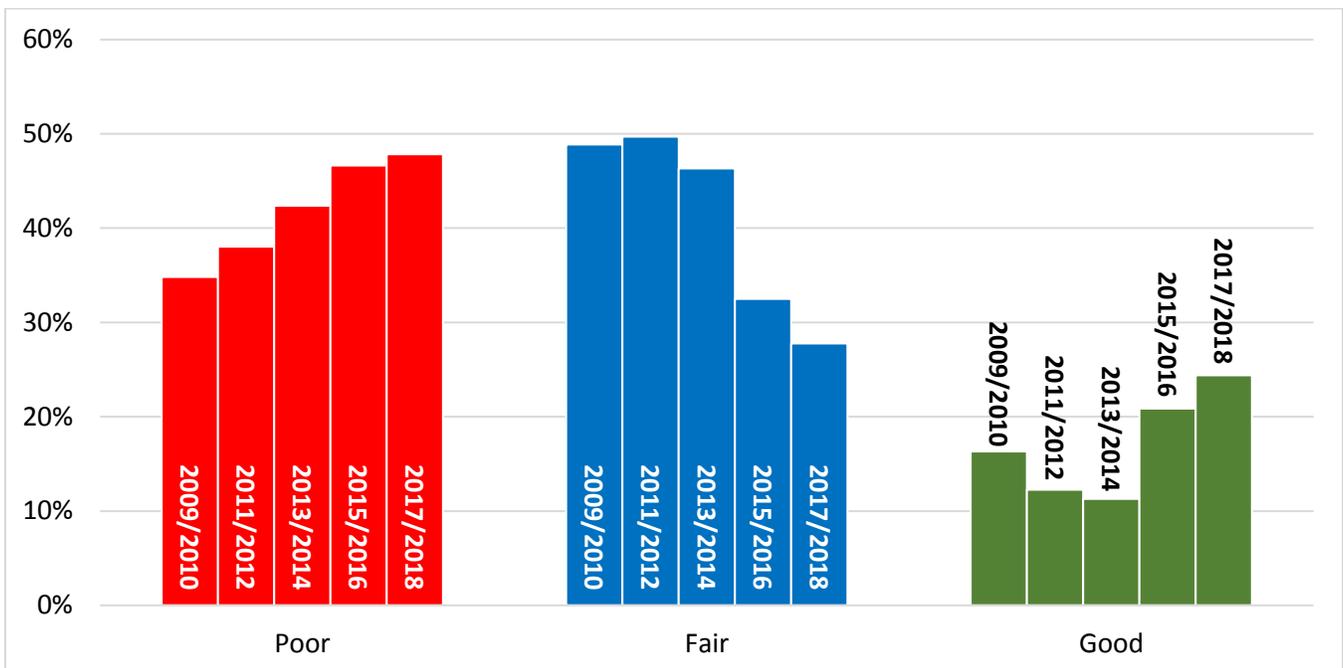
Changes in roads rated good, fair, and poor between 2009 and 2018

Includes City, Village, Van Buren Road Commission, and MDOT Maintained Roads

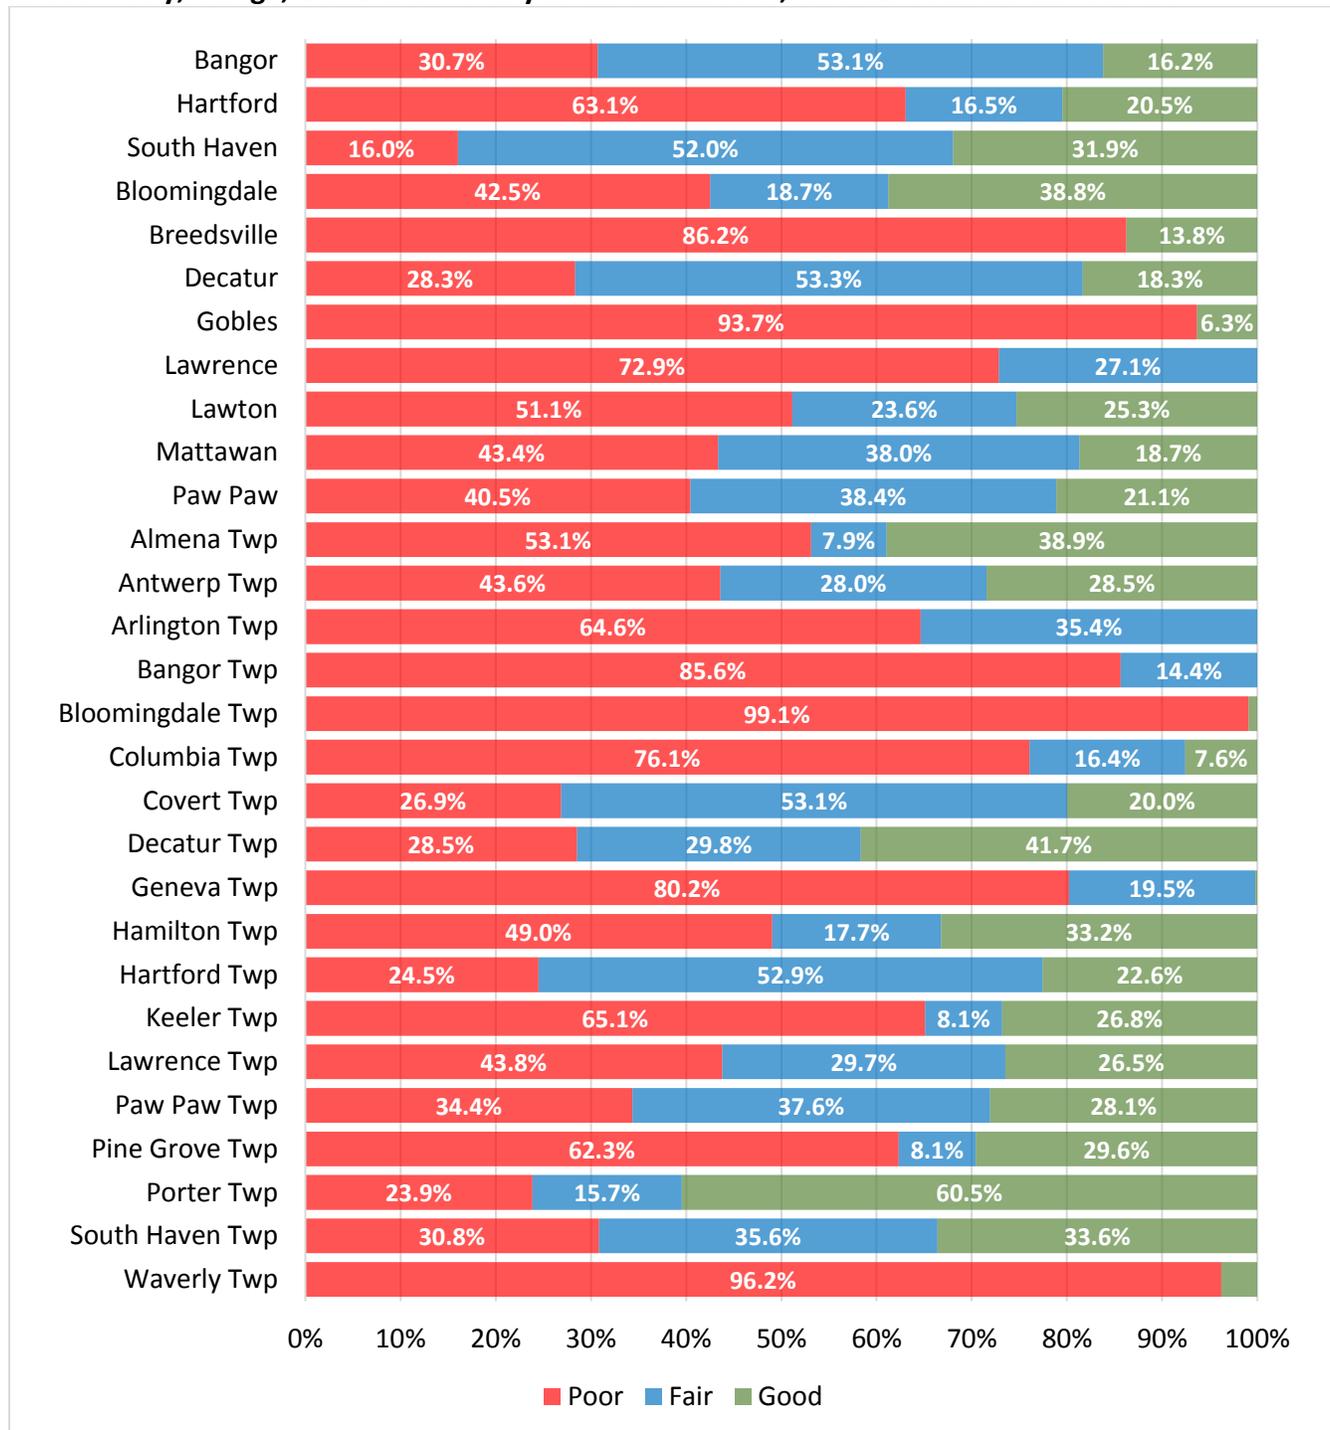
2017/2018 All Federal Aid Road Ratings

Includes City, Village, Van Buren County Road Commission, and MDOT Maintained Roads

Total Miles Rated: 471

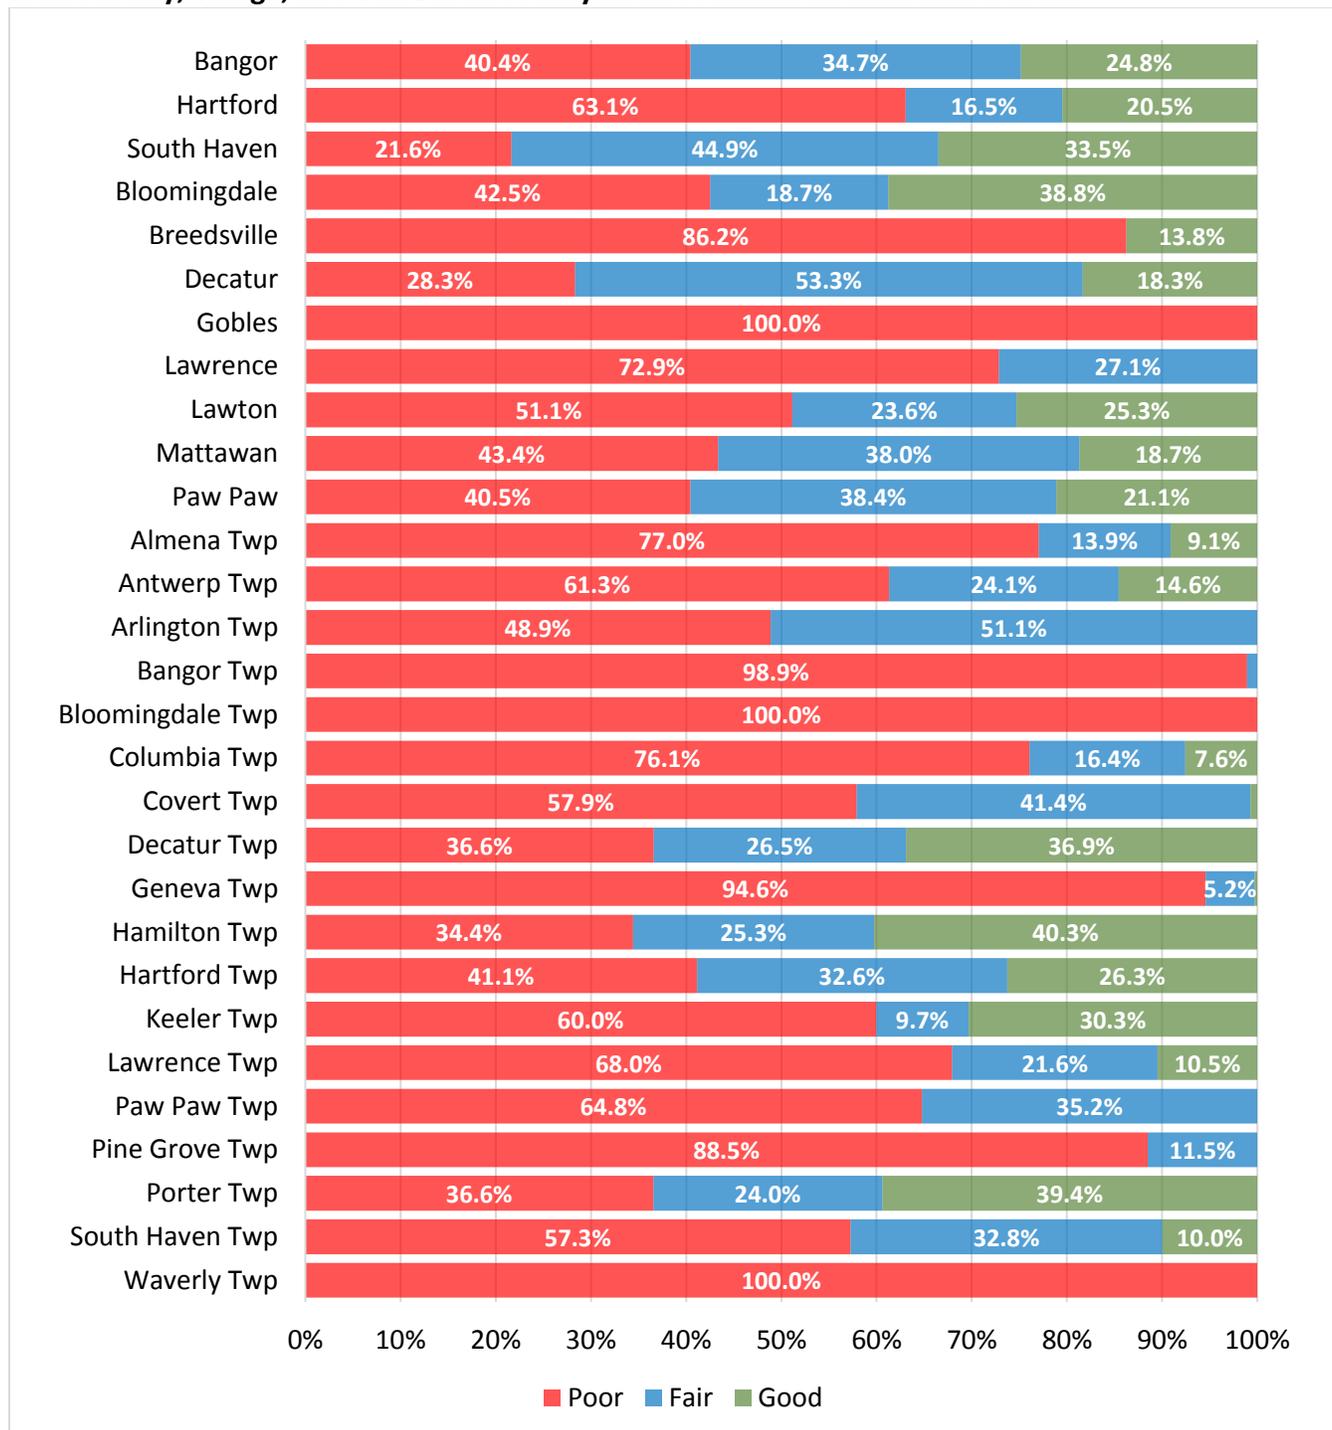
2017/2018 Locally Maintained Federal Aid Road Ratings

Includes City, Village, and Van Buren County Road Commission Maintained Roads

Total Miles of Locally Maintained Roads Rated: 303

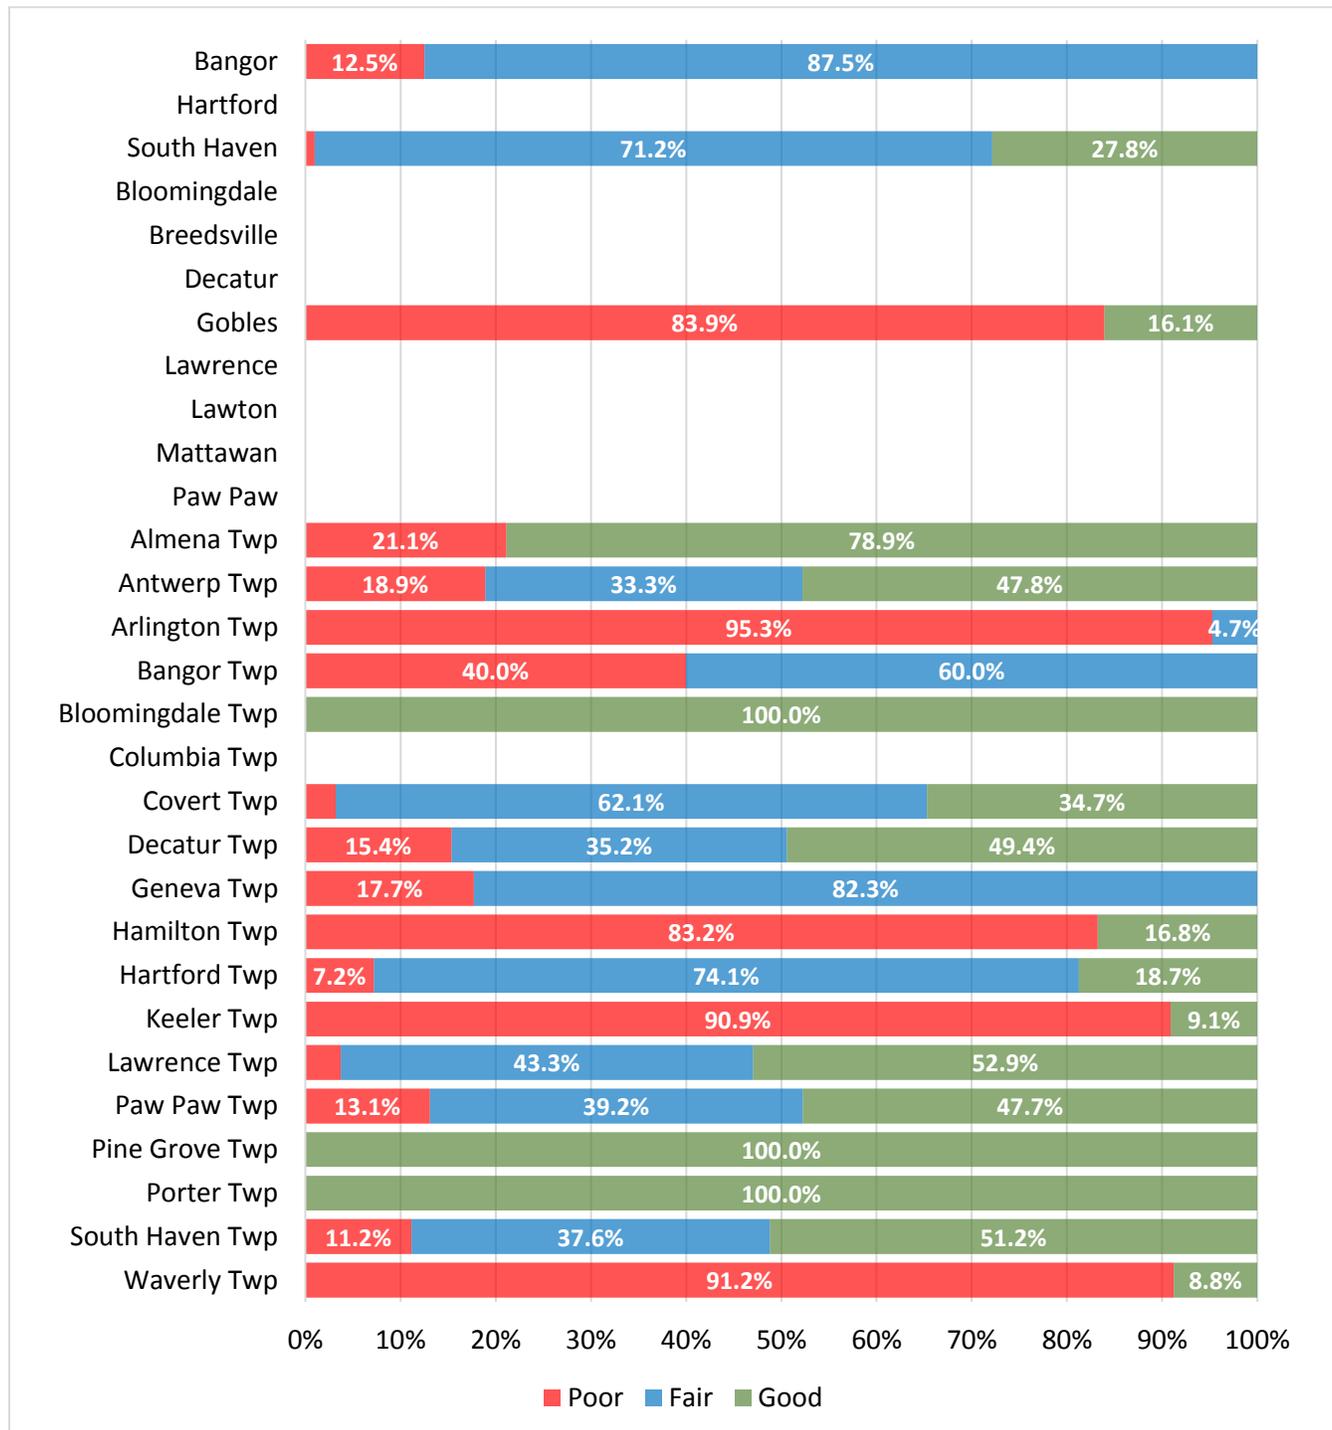
2017/2018 MDOT Maintained Federal Aid Road Ratings

Roads Maintained by MDOT Only

Total Miles of MDOT Maintained Roads Rated: 169
