The State of Michigan Transportation

2019 Pavement Condition Report For Van Buren County, Michigan

Prepared by the Southwest Michigan Planning Commission
376 W Main St
Benton Harbor, MI 49022
(269) 925-1137

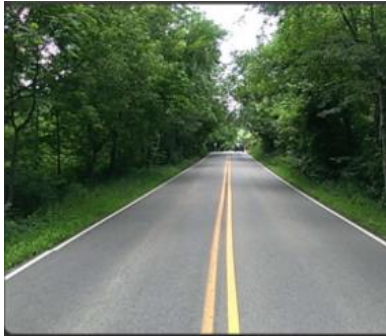
Good Condition

PASER Rating 8-10
Requires Routine Maintenance

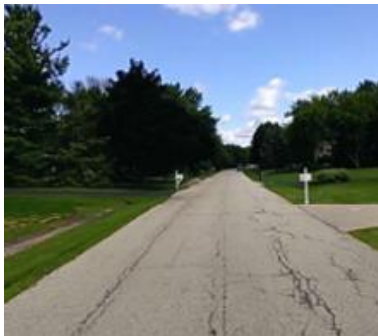
Fair Condition

PASER Rating 5-7
Requires Capital Preventative Maintenance

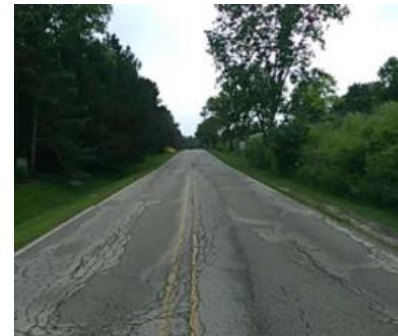
Poor Condition

PASER Rating 1-4
Requires Structural Improvements or Reconstruction
